Atlanta Public Schools/Relocation Sites

Grove Park (Woodson Park Academy – KIPP)

School Assessment Report

November 10, 2020

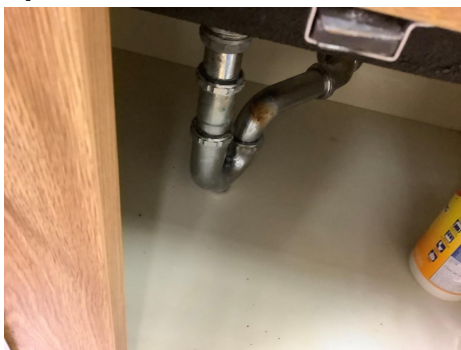
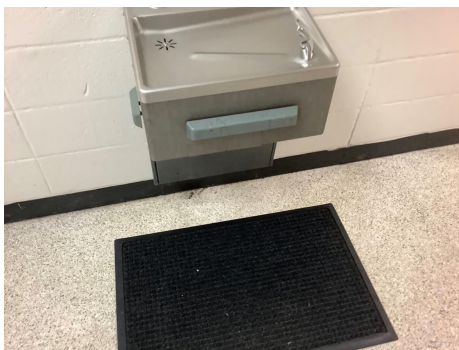
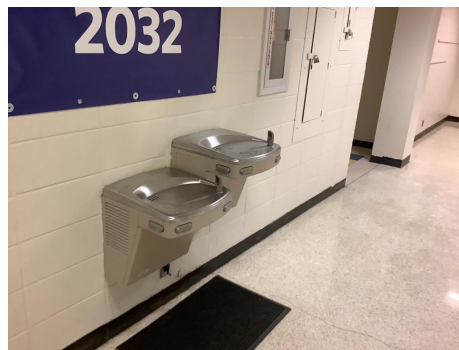
System: D2020 - Domestic Water Distribution

Note: New water heater installed 2011

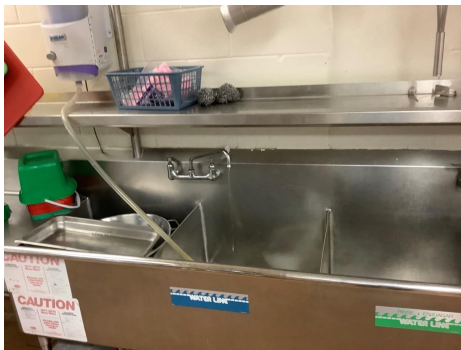
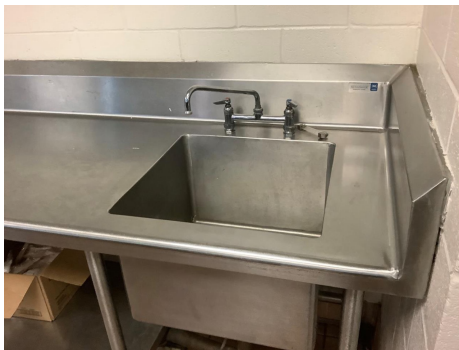
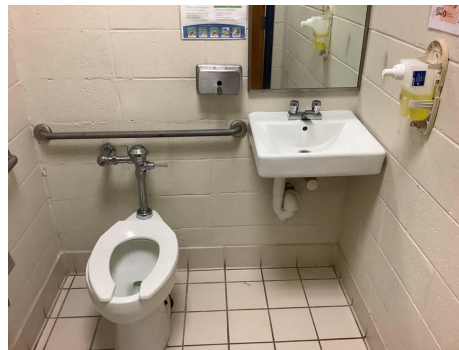
System: D2010 - Plumbing Fixtures

Notes: The plumbing fixtures are beyond its expected service life and should be scheduled for replacement.

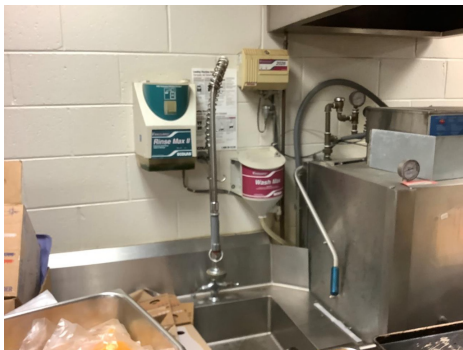
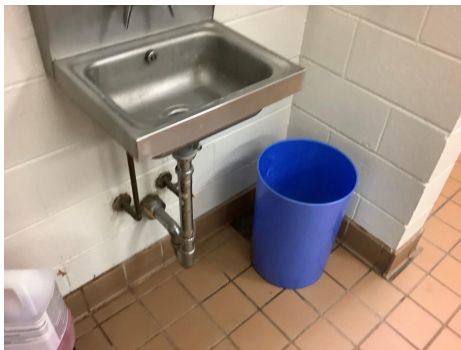
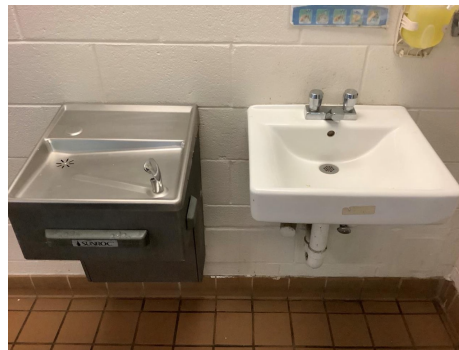
System: D2020 - Domestic Water Distribution

Notes: The domestic water distribution is beyond its expected service life and should be scheduled for replacement.

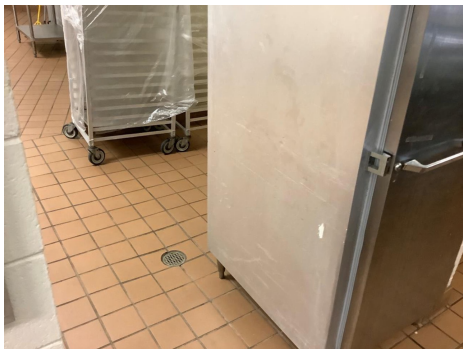
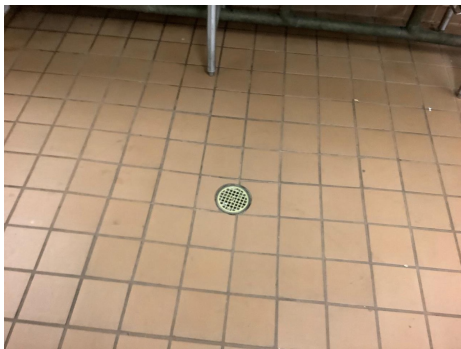
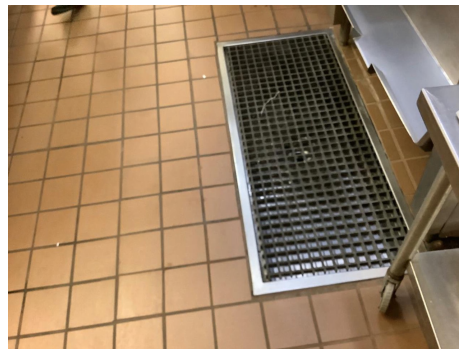
System: D2030 - Sanitary Waste

Notes: The sanitary waste is beyond its expected service life and should be scheduled for replacement.

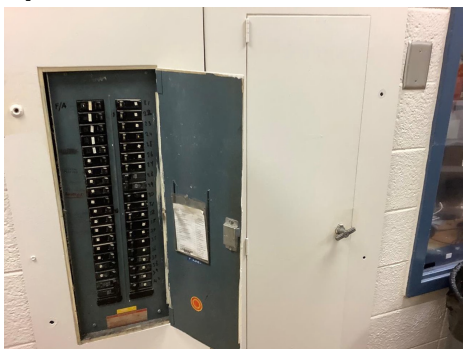
System: D5010 - Electrical Service/Distribution

Notes: The electrical service distribution is beyond its expected service life and should be scheduled for replacement.

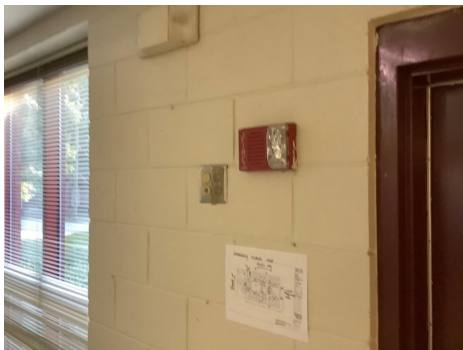
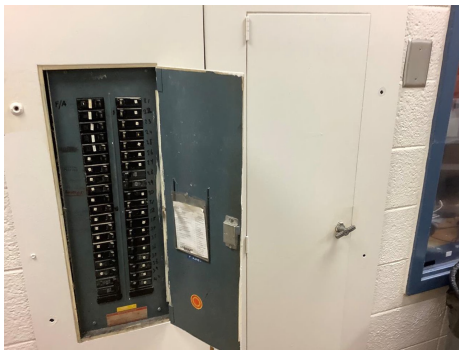
System: D5020 - Branch Wiring

Notes: The branch and wiring is beyond its expected service life and should be scheduled for replacement.

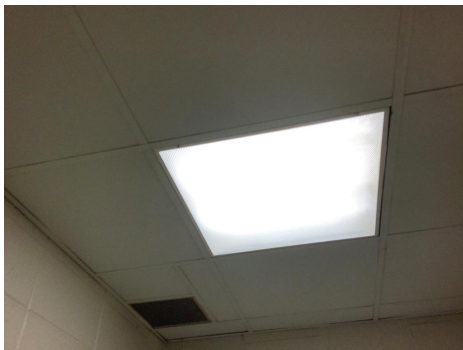
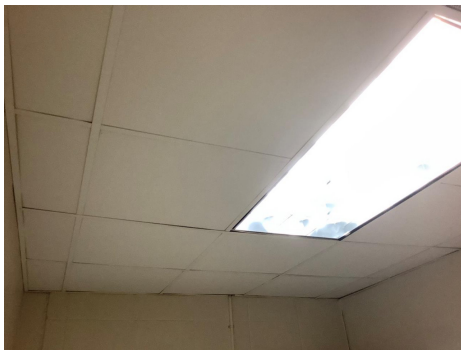
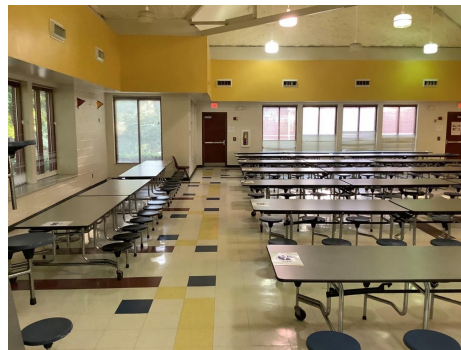
System: D5020 - Lighting

Notes: The lighting is beyond its expected service life and should be scheduled for replacement.
