Atlanta Public Schools/Charter Schools
Herndon ES (KIPP Ways)

Revised
School Assessment Report

November 10, 2020

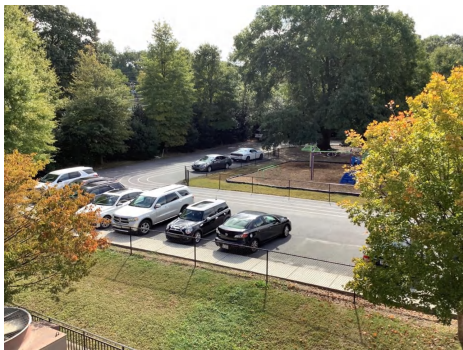
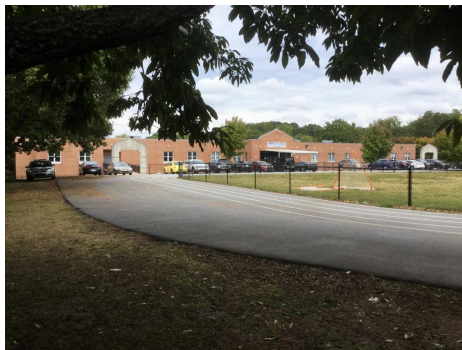
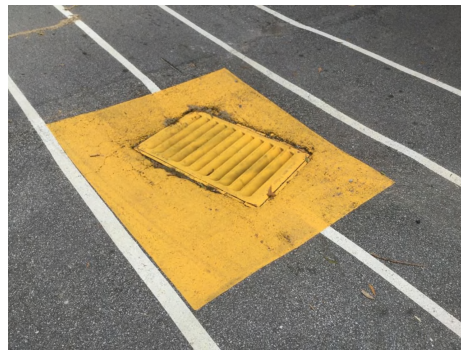
System: G2040950 - Track

Notes: This school has an area for sports activities that include a playing field and a track . This deficiency provides a budgetary consideration for the upgrades to the track site.
