Atlanta Public Schools/Charter Schools

Hill, C.W. ES (The Kindezi School)

School Assessment Report

November 10, 2020

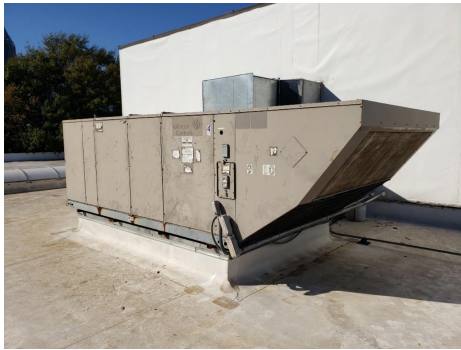
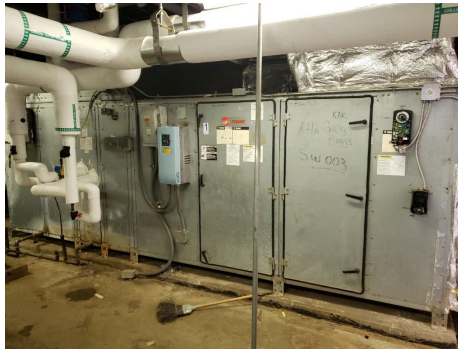
System: D3040 - Distribution Systems

Note: AHUs in mechanical penthouse were substantially renovated in 2000. However, little of the remainder of the Distribution Systems were upgraded in 2000.

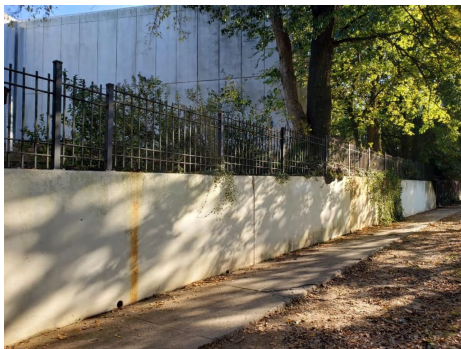
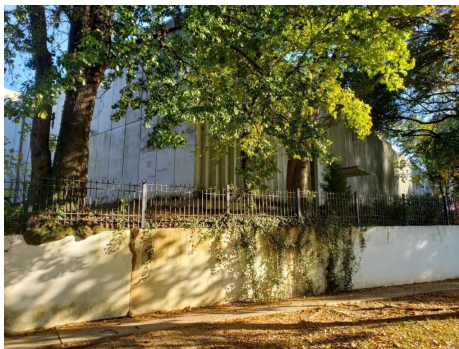
System: G2040210 - Concrete Retaining Walls

Notes: Sections of the retaining wall is failing and needs to be repaired
