Atlanta Public Schools/ Grady Cluster

Hope-Hill Elementary School

School Assessment Report

November 10, 2020

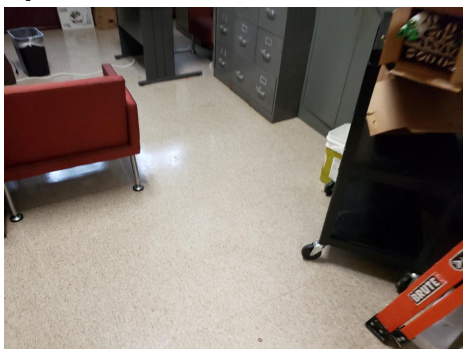
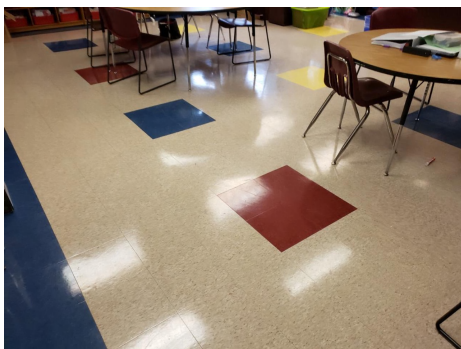
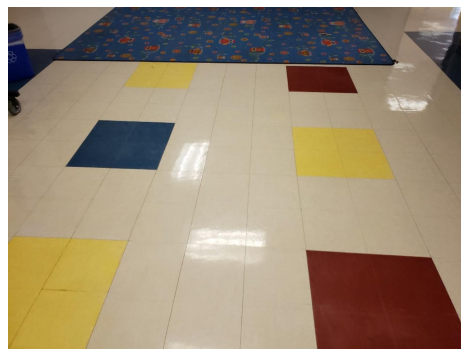
System: C3020903 - VCT

Notes: The VCT flooring is in poor conditions, with different areas separating from the substrate, and should be replaced.

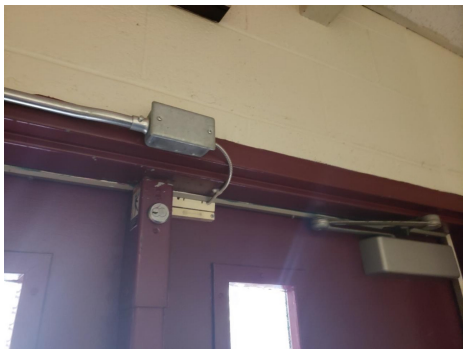
System: D5030810 - Security & Detection Systems

Notes: The security system is beyond its expected service life and should be scheduled for replacement.
