Atlanta Public Schools/Relocation Sites

# Inman MS (Morningside relocation site)

## School Assessment Report

November 10, 2020

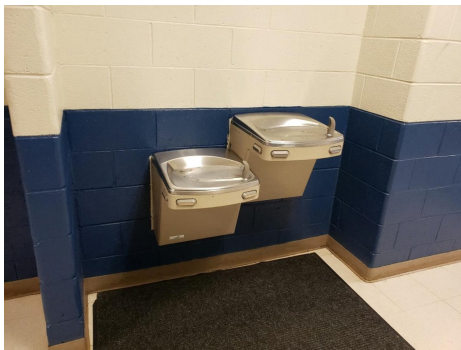
**System:** D2010 - Plumbing Fixtures

**Notes:** Plumbing fixtures are in operational conditions. However, they are aged, beyond its expected service life and should be replaced with a low-flow water fixture.

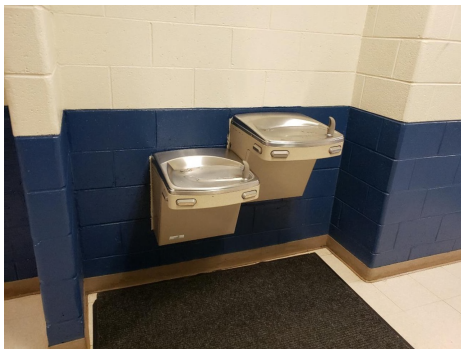
**System:** D2020 - Domestic Water Distribution

**Notes:** The domestic water distribution system is beyond its expected service life and should be replaced.

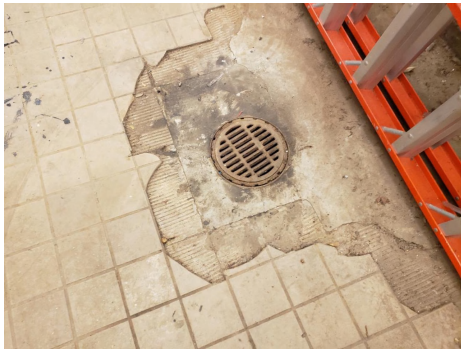
**System:** D2030 - Sanitary Waste

**Notes:** The sanitary waste system is beyond its expected service life and should be replaced.
