Atlanta Public Schools/ N. Atlanta Cluster

Jackson Elementary School

School Assessment Report

November 10, 2020

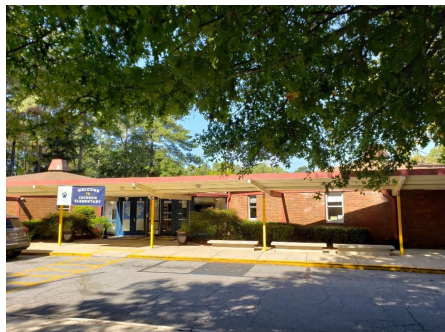
1). East Elevation - Nov 22, 2019

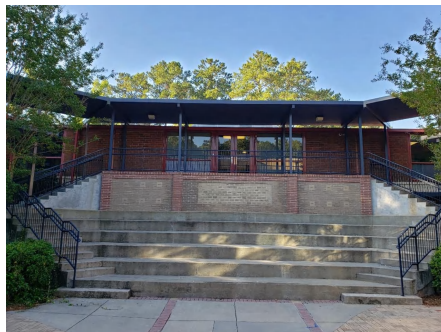
2). North Elevation - Nov 22, 2019

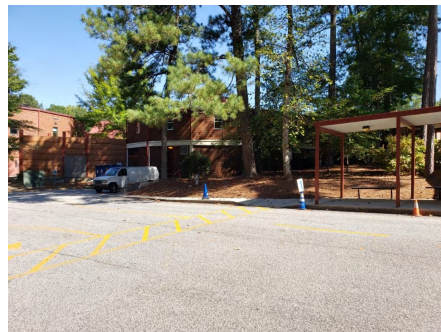
3). South Elevation - Nov 22, 2019

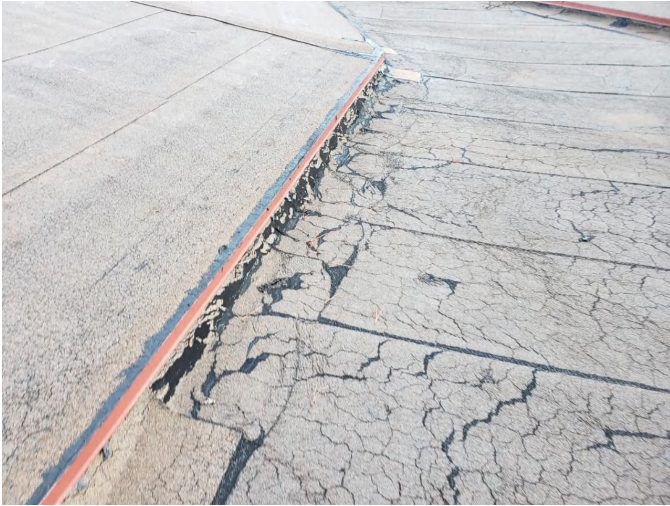
System: B3010105 - Built-Up

Location: 1967 Bldg 2010
Distress: Beyond Expected Life
Category: Deferred Maintenance
Priority: 3 - Necessary (Years 2-5)
Correction: Renew System
Qty: 30,277.00
Unit of Measure: S.F.
Estimate: \$339,874.00
Assessor Name: Eduardo Lopez
Date Created: 10/15/2020

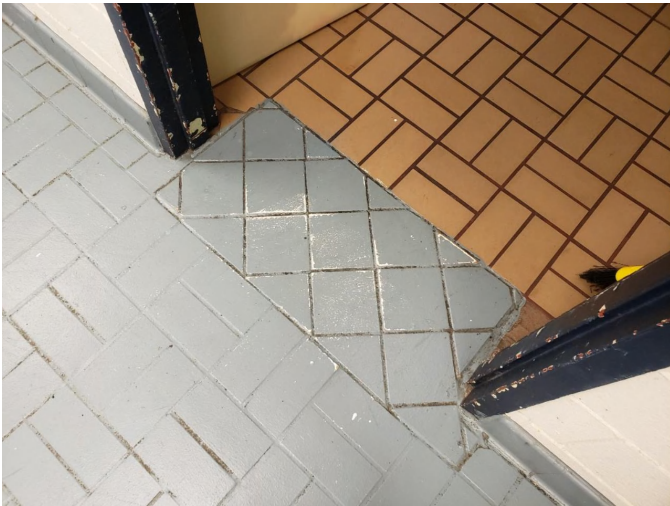
System: C3020405 - Epoxy

Location: 1967 Bldg 2010
Distress: Beyond Expected Life
Category: Deferred Maintenance
Priority: 3 - Necessary (Years 2-5)
Correction: Renew System
Qty: 720.00
Unit of Measure: S.F.
Estimate: \$14,698.00
Assessor Name: Eduardo Lopez
Date Created: 10/15/2020

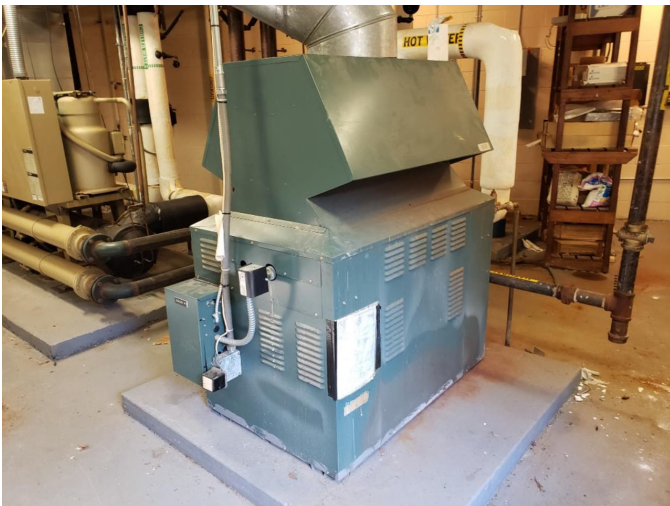
System: D3020 - Heat Generating Systems

Location: 1993 Bldg 2011
Distress: Beyond Expected Life
Category: Deferred Maintenance
Priority: 3 - Necessary (Years 2-5)
Correction: Renew System
Qty: 36,256.00
Unit of Measure: S.F.
Estimate: \$147,562.00
Assessor Name: Eduardo Lopez
Date Created: 10/15/2020

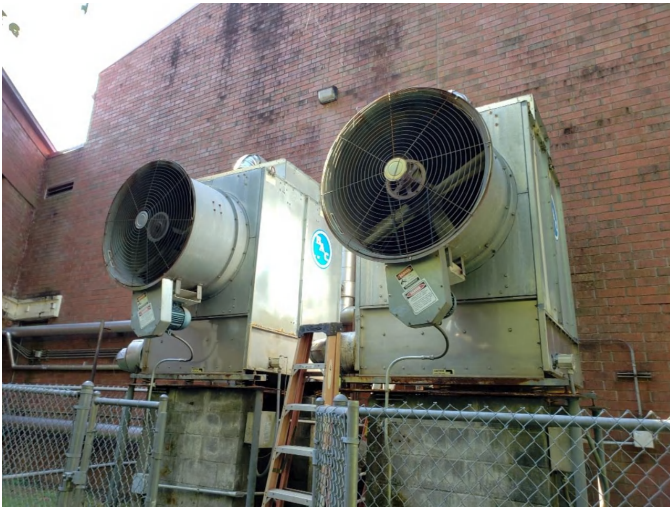
System: D3030 - Cooling Generating Systems

Location: 1993 Bldg 2011
Distress: Beyond Expected Life
Category: Deferred Maintenance
Priority: 3 - Necessary (Years 2-5)
Correction: Renew System
Qty: 36,256.00
Unit of Measure: S.F.
Estimate: \$249,659.00
Assessor Name: Eduardo Lopez
Date Created: 10/15/2020

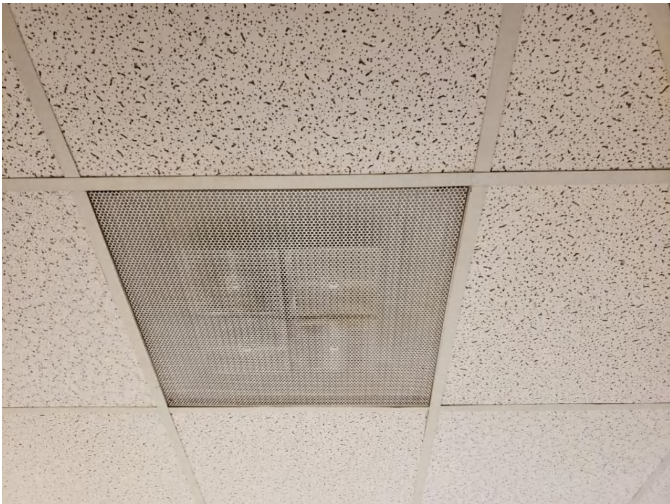
System: D3040 - Distribution Systems

Location: 1993 Bldg 2011
Distress: Beyond Expected Life
Category: Deferred Maintenance
Priority: 3 - Necessary (Years 2-5)
Correction: Renew System
Qty: 36,256.00
Unit of Measure: S.F.
Estimate: \$1,048,886.00
Assessor Name: Eduardo Lopez
Date Created: 10/15/2020

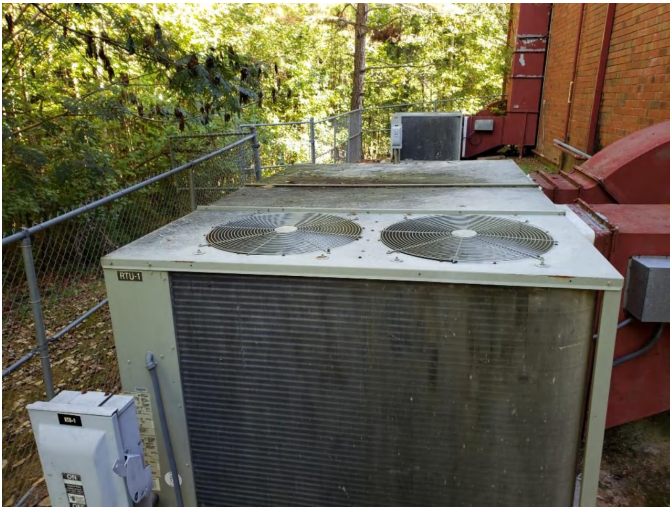
System: D3050 - Terminal & Package Units

Location: 1993 Bldg 2011
Distress: Beyond Expected Life
Category: Deferred Maintenance
Priority: 3 - Necessary (Years 2-5)
Correction: Renew System
Qty: 36,256.00
Unit of Measure: S.F.
Estimate: \$584,664.00
Assessor Name: Eduardo Lopez
Date Created: 10/15/2020

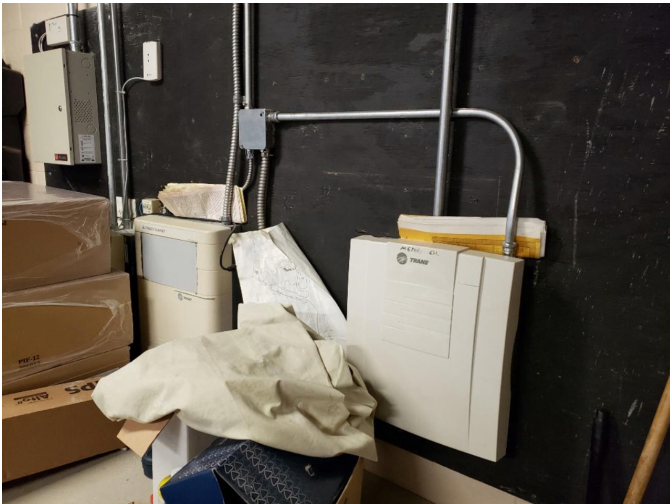
System: D3060 - Controls & Instrumentation

Location: 1993 Bldg 2011
Distress: Beyond Expected Life
Category: Deferred Maintenance
Priority: 3 - Necessary (Years 2-5)
Correction: Renew System
Qty: 36,256.00
Unit of Measure: S.F.
Estimate: \$90,930.00
Assessor Name: Eduardo Lopez
Date Created: 10/15/2020

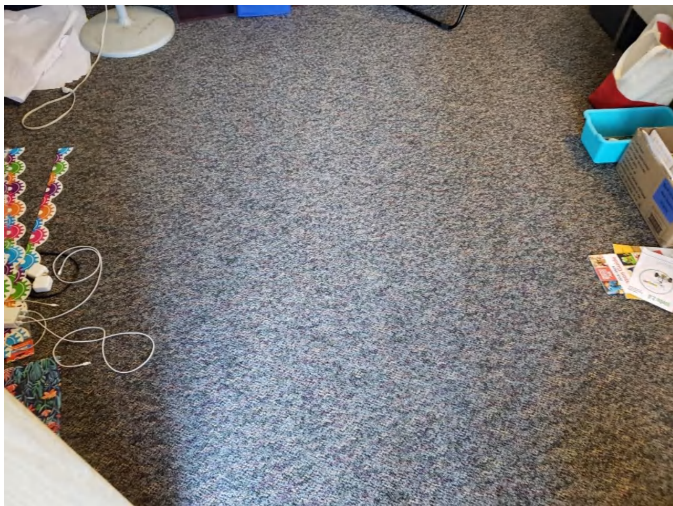
System: C3020901 - Carpet

Location: 2005 Bldg 2012_2020
Distress: Beyond Expected Life
Category: Deferred Maintenance
Priority: 3 - Necessary (Years 2-5)
Correction: Renew System
Qty: 167.00
Unit of Measure: S.F.
Estimate: \$1,378.00
Assessor Name: Eduardo Lopez
Date Created: 10/15/2020

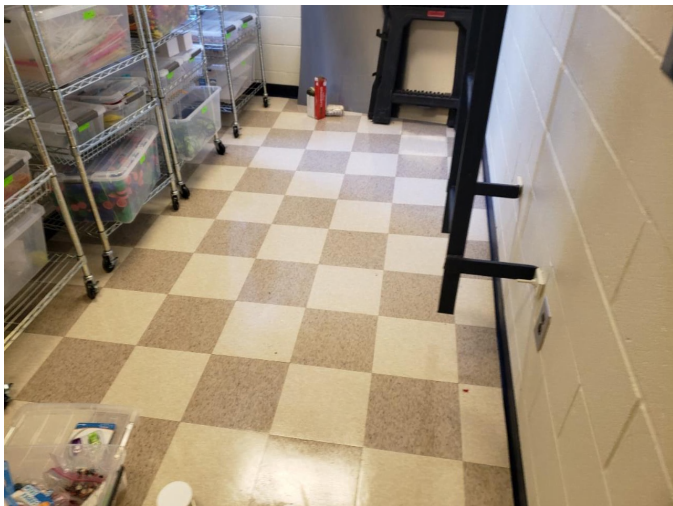
System: C3020903 - VCT

Location: 2005 Bldg 2012_2020
Distress: Beyond Expected Life
Category: Deferred Maintenance
Priority: 3 - Necessary (Years 2-5)
Correction: Renew System
Qty: 17,376.00
Unit of Measure: S.F.
Estimate: \$93,726.00
Assessor Name: Eduardo Lopez
Date Created: 10/15/2020

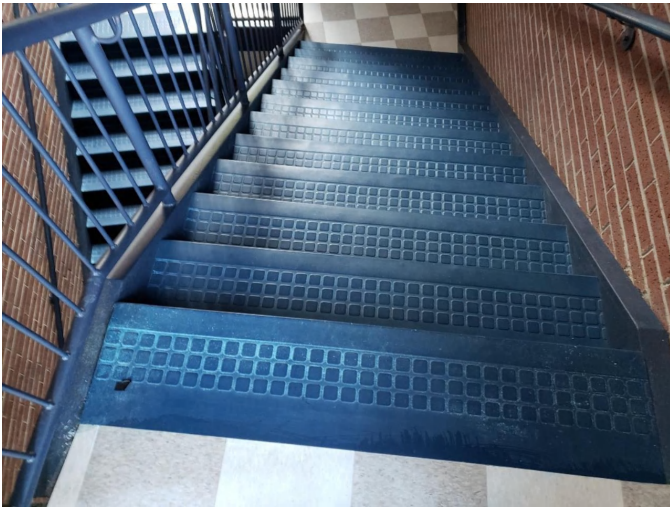
System: C3020999 - Other -Rubber or Neoprene

Location: 2005 Bldg 2012_2020
Distress: Beyond Expected Life
Category: Deferred Maintenance
Priority: 3 - Necessary (Years 2-5)
Correction: Renew System
Qty: 233.00
Unit of Measure: S.F.
Estimate: \$6,836.00
Assessor Name: Eduardo Lopez
Date Created: 10/15/2020

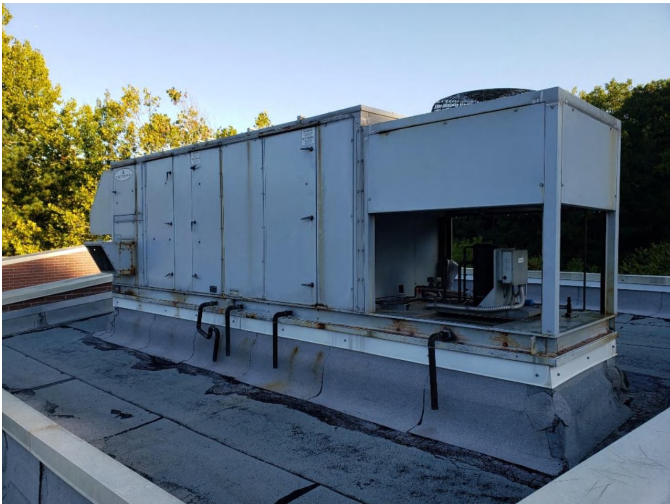
System: D3050 - Terminal & Package Units

Location: 2005 Bldg 2012_2020
Distress: Beyond Expected Life
Category: Deferred Maintenance
Priority: 3 - Necessary (Years 2-5)
Correction: Renew System
Qty: 18,952.00
Unit of Measure: S.F.
Estimate: \$148,015.00
Assessor Name: Eduardo Lopez
Date Created: 10/15/2020

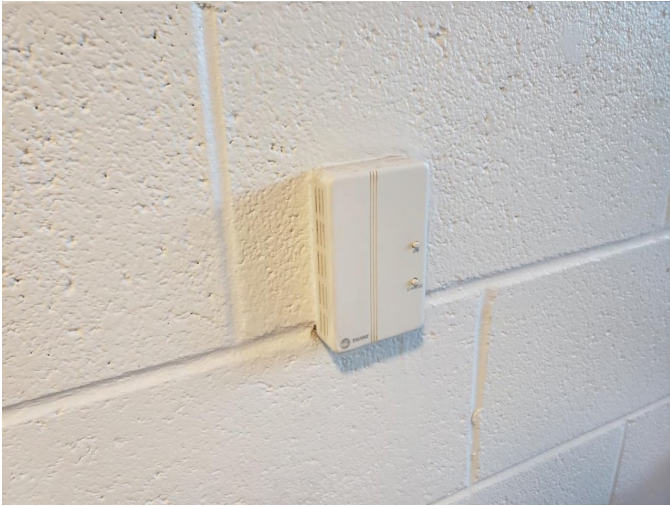
System: D3060 - Controls & Instrumentation

Location: 2005 Bldg 2012_2020
Distress: Beyond Expected Life
Category: Deferred Maintenance
Priority: 3 - Necessary (Years 2-5)
Correction: Renew System
Qty: 18,952.00
Unit of Measure: S.F.
Estimate: \$49,408.00
Assessor Name: Eduardo Lopez
Date Created: 10/15/2020

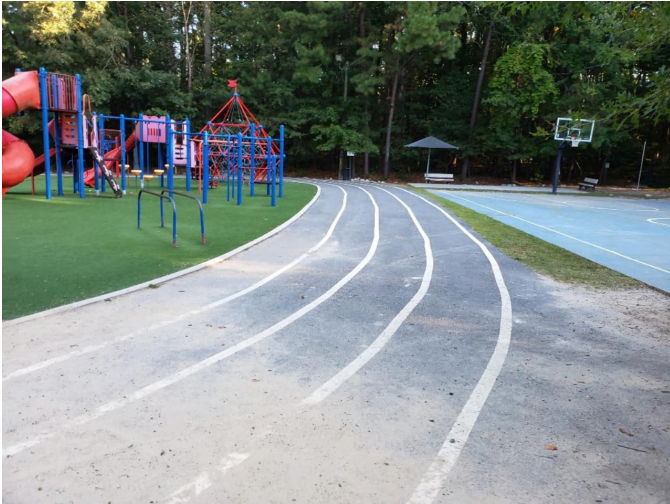
System: G2040950 - Track

Location: Site
Distress: Beyond Expected Life
Category: Deferred Maintenance
Priority: 3 - Necessary (Years 2-5)
Correction: Renew System
Qty: 95,591.00
Unit of Measure: S.F.
Estimate: \$84,120.00
Assessor Name: Eduardo Lopez
Date Created: 10/15/2020
