Atlanta Public Schools/ Mays Cluster

# Mays High School

## School Assessment Report

November 10, 2020

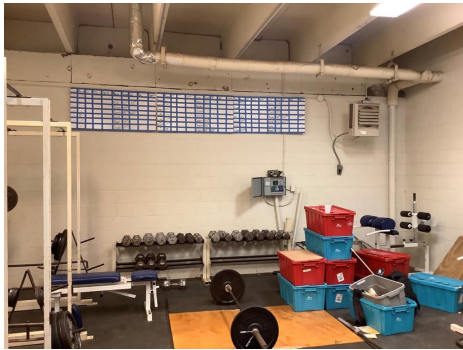
**System:** C3020999 - Other - Rubber or Neoprene

**Notes:** The Neoprene floor finish is beyond its expected service life, worn and damaged, and is recommended for replacement.

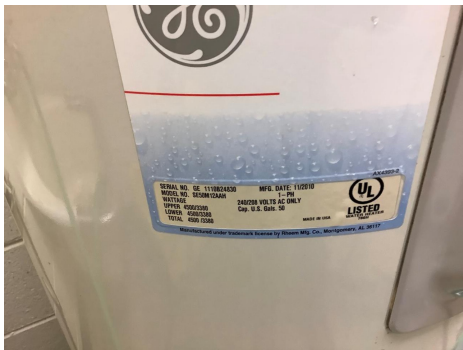
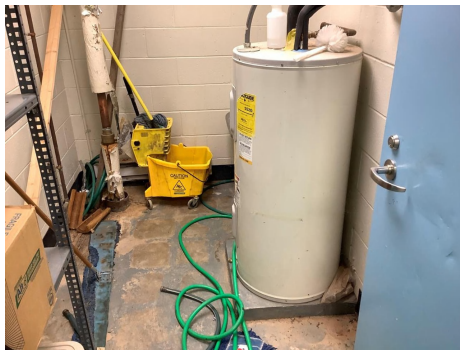
**System:** D2020 - Domestic Water Distribution

**Notes:** The domestic water distribution system consists of galvanized and copper pipes, valves and domestic water supply. The system is beyond its expected life cycle and upgrades are recommended.

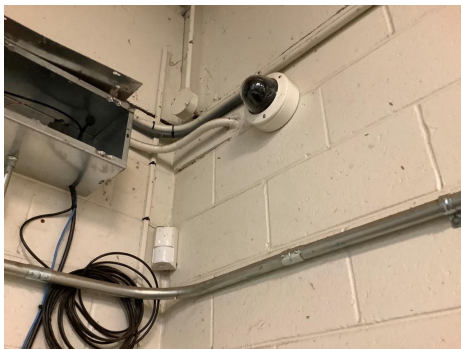
**System:** D5030810 - Security & Detection Systems

**Notes:** The security system is aged and should be replaced and upgraded.
