Atlanta Public Schools/ Grady Cluster

Morningside Elementary School

School Assessment Report

November 10, 2020

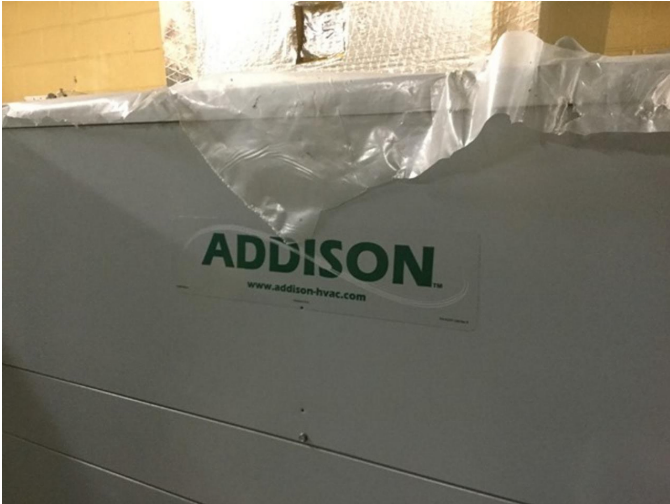
System: D3060 - Controls & Instrumentation

Location: Throughout building
Distress: Inadequate
Category: Facility Integrity
Priority: 1 - Critical Immediate Need
Correction: Control and Instrumentation Study
Qty: 56,340.00
Unit of Measure: S.F.
Estimate: \$27,699.22
Assessor Name: Sam Mandola
Date Created: 06/13/2014

Notes: Conduct a controls and instrumentation study to include testing and adjusting, and overall design review to improve HVAC system and components. Replace damaged and malfunctioning controls and equipment, and retest.

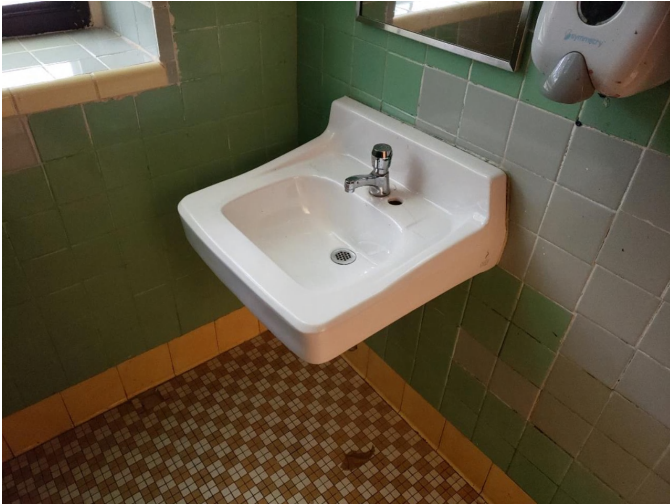
System: C3010220 - Tile

Location: Restrooms
Distress: Beyond Expected Life
Category: Deferred Maintenance
Priority: 3 - Necessary (Years 2-5)
Correction: Renew System
Qty: 2,260.00
Unit of Measure: S.F.
Estimate: \$31,358.00
Assessor Name: Homero Guerrero
Date Created: 12/05/2019

Notes: The ceramic tile in the restrooms are aged, patched throughout renovations and should be replaced

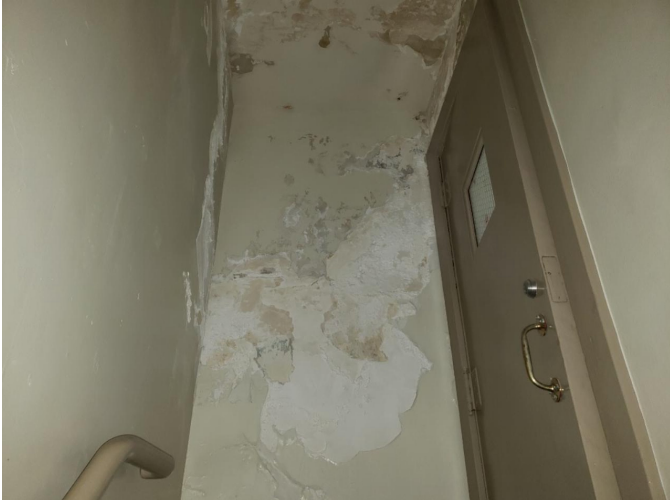
System: C3010230 - Paint & Covering

Location: Multi-purpose room and balcony
Distress: Damaged
Category: Appearance
Priority: 3 - Necessary (Years 2-5)
Correction: Paint
Qty: 6,000.00
Unit of Measure: S.F.
Estimate: \$10,169.27
Assessor Name: Sam Mandola
Date Created: 12/05/2019

Notes: The wall finishes are aged, scuffed and fading, and should be replaced.

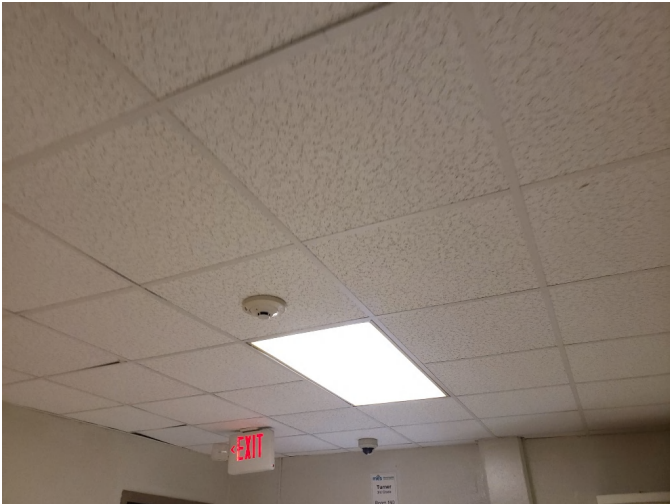
System: D4010 - Sprinklers

Location: Throughout building
Distress: Missing
Category: Code Compliance
Priority: 4 - Recommended (Years 6-10)
Correction: Renew System
Qty: 56,340.00
Unit of Measure: S.F.
Estimate: \$249,135.00
Assessor Name: Homero Guerrero
Date Created: 08/19/2013

Notes: Facility has no fire protection system. Install per owner standards.

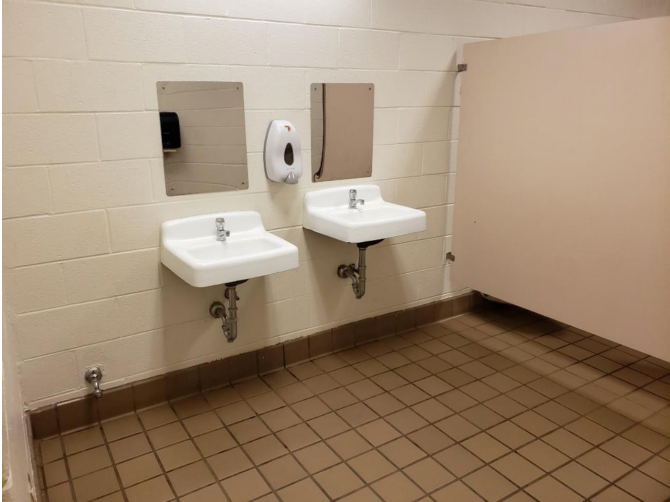
System: D2010 - Plumbing Fixtures

Location: Throughout building
Distress: Beyond Expected Life
Category: ADA Compliance
Priority: 4 - Recommended (Years 6-10)
Correction: Renew System
Qty: 30,152.00
Unit of Measure: S.F.
Estimate: \$207,958.00
Assessor Name: Sam Mandola
Date Created: 09/17/2015

Notes: The restroom fixtures are from original construction with few exceptions. The systems are beyond the expected life cycle and upgrades are warranted. The new restroom fixtures should include all aspects of the current ADA standards.

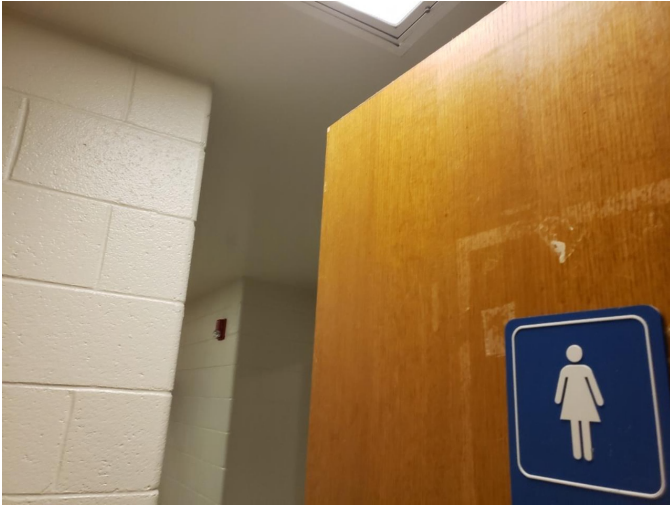
System: C1020 - Interior Doors

Location: First floor restrooms
Distress: Non Compliant
Category: ADA Compliance
Priority: 1 - Critical Immediate Need
Correction: Change door swing for code compliance
Qty: 2.00
Unit of Measure: Ea.
Estimate: \$964.30
Assessor Name: Sam Mandola
Date Created: 11/20/2019

Notes: The restrooms are ADA compliant. However, the entry doors open in the opposite direction where maneuvering clearance is needed. Change door swing to comply with ADA standards.

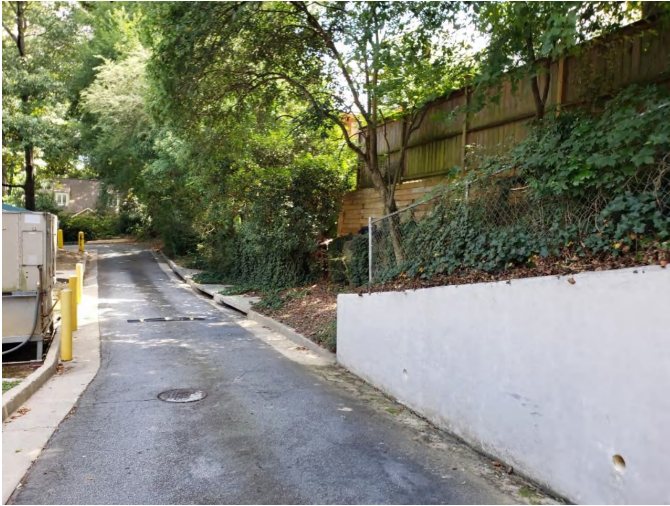
System: G3020 - Sanitary Sewer

Location: Site
Distress: Beyond Expected Life
Category: Deferred Maintenance
Priority: 3 - Necessary (Years 2-5)
Correction: Renew System
Qty: 96,463.00
Unit of Measure: S.F.
Estimate: \$233,440.00
Assessor Name: Sam Mandola
Date Created: 02/21/2020

Notes: The site sanitary sewer system is function, but is well beyond its expected service life. This deficiency provides a budgetary consideration for a new sanitary sewer system system.

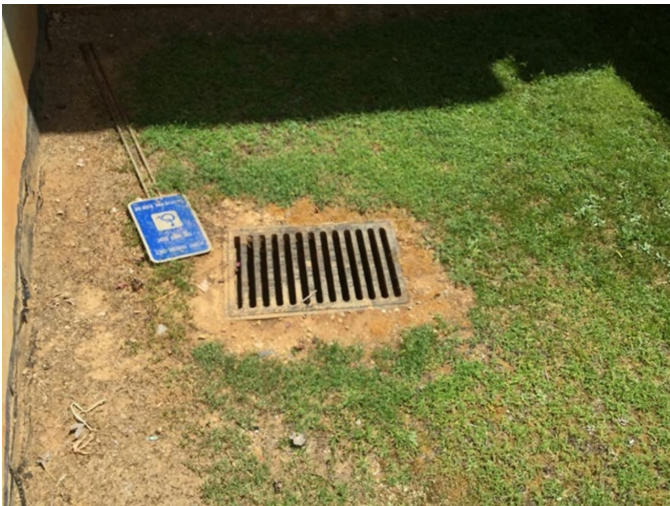
System: G3030 - Storm Sewer

Location: Site
Distress: Beyond Expected Life
Category: Deferred Maintenance
Priority: 3 - Necessary (Years 2-5)
Correction: Renew System
Qty: 96,463.00
Unit of Measure: S.F.
Estimate: \$132,637.00
Assessor Name: Sam Mandola
Date Created: 02/21/2020

Notes: The site storm sewer system is functional, but is well beyond its expected service life. This project provides a budgetary consideration for a new rainwater drainage system.
