Atlanta Public Schools/ Carver Cluster

Price Middle School

School Assessment Report

November 10, 2020

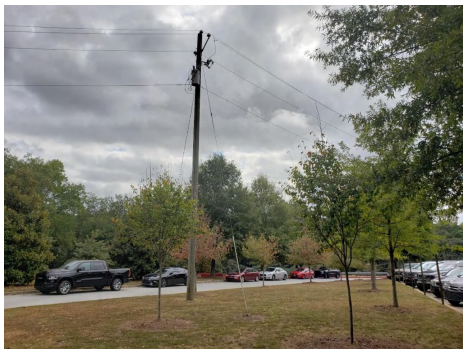
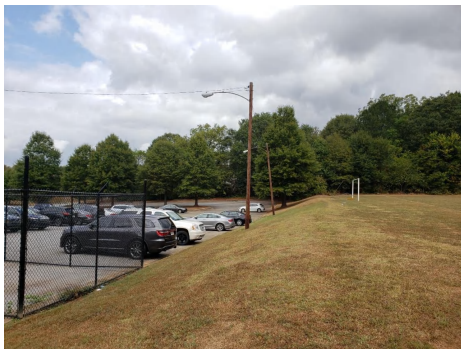
System: G4020 - Site Lighting

Location: Site
Distress: Missing
Category: Safety
Priority: 1 - Critical Immediate Need
Correction: Add Site Lighting
Qty: 6.00
Unit of Measure: Ea.
Estimate: \$38,832.63
Assessor Name: Eduardo Lopez
Date Created: 10/08/2019
