Atlanta Public Schools/Charter Schools

Slaton ES (Atlanta Neighborhood Charter)

School Assessment Report

November 10, 2020

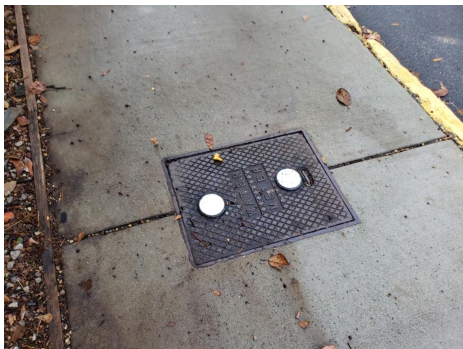
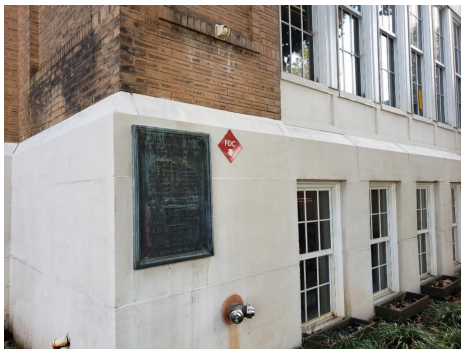
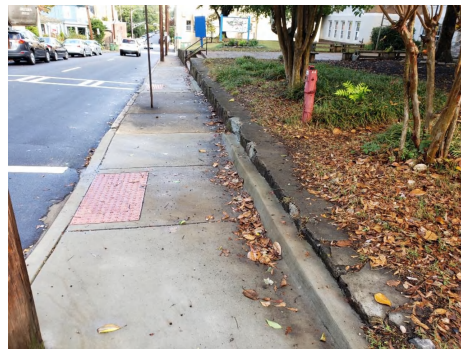
System: G3010 - Water Supply

Notes: The water supply system is original and beyond its service life and should be scheduled for replacement and upgrade.
