Atlanta Public Schools/ Douglass Cluster

# Stanton, F. L. Elementary School

## School Assessment Report

November 10, 2020

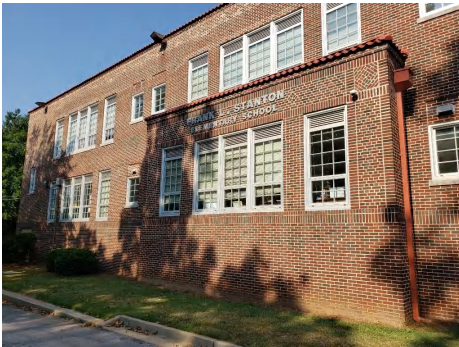
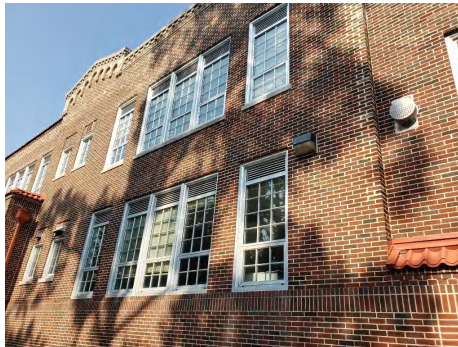
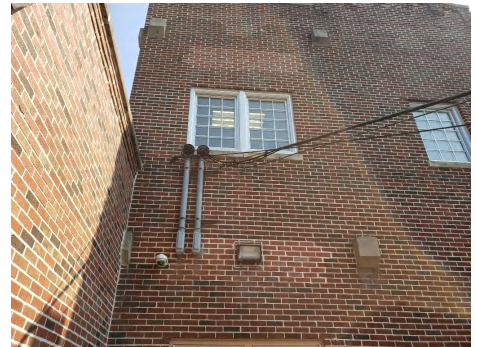
**System:** B2020 - Exterior Windows

**Note:** Main façade exterior windows are later age and in better condition. Average age is estimated 2000.

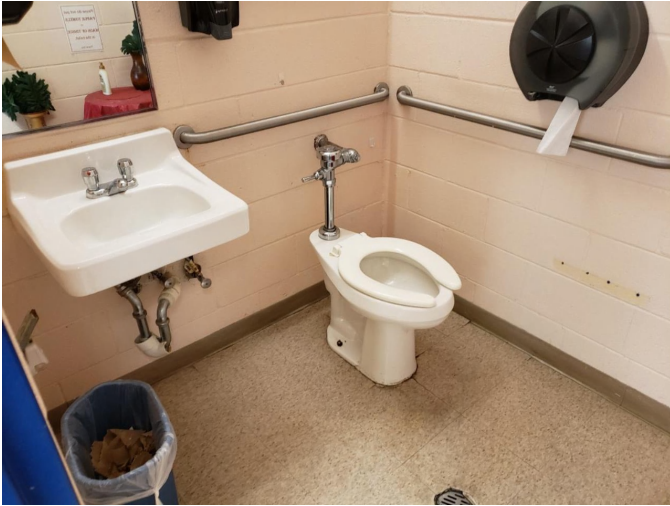
**System: D2010 - Plumbing Fixtures**

**Location:** Throughout Building  
**Distress:** Beyond Expected Life  
**Category:** ADA Compliance  
**Priority:** 3 - Necessary (Years 2-5)  
**Correction:** Renew System  
**Qty:** 2,897.00  
**Unit of Measure:** S.F.  
**Estimate:** \$21,351.00  
**Assessor Name:** Eduardo Lopez  
**Date Created:** 01/26/2020

**Notes:** Plumbing fixtures are in operational conditions. However, they are aged, beyond its expected service life and should be replaced with a low-flow water fixture.

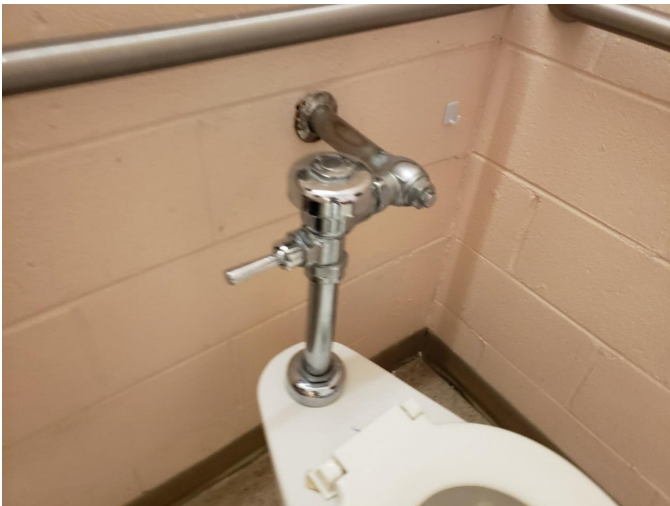
**System: D2020 - Domestic Water Distribution**

**Location:** Throughout Building  
**Distress:** Beyond Expected Life  
**Category:** Deferred Maintenance  
**Priority:** 3 - Necessary (Years 2-5)  
**Correction:** Renew System  
**Qty:** 2,897.00  
**Unit of Measure:** S.F.  
**Estimate:** \$2,422.00  
**Assessor Name:** Eduardo Lopez  
**Date Created:** 10/06/2020

**Notes:** The domestic water distribution is beyond its expected service life and should be scheduled for replacement.

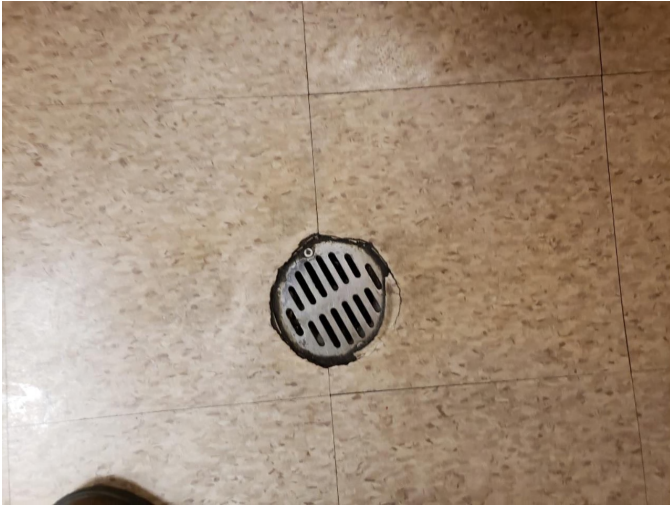
**System: D2030 - Sanitary Waste**

**Location:** Throughout Building  
**Distress:** Beyond Expected Life  
**Category:** Deferred Maintenance  
**Priority:** 3 - Necessary (Years 2-5)  
**Correction:** Renew System  
**Qty:** 2,897.00  
**Unit of Measure:** S.F.  
**Estimate:** \$5,800.00  
**Assessor Name:** Eduardo Lopez  
**Date Created:** 10/06/2020

**Notes:** The sanitary waste system is beyond its expected service life and should be scheduled for replacement.

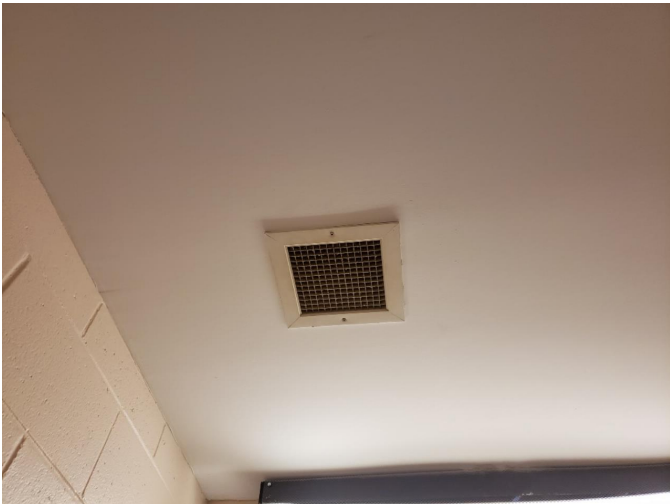
**System: D3040 - Distribution Systems**

**Location:** Throughout building  
**Distress:** Beyond Expected Life  
**Category:** Deferred Maintenance  
**Priority:** 3 - Necessary (Years 2-5)  
**Correction:** Renew System  
**Qty:** 2,897.00  
**Unit of Measure:** S.F.  
**Estimate:** \$35,787.00  
**Assessor Name:** Eduardo Lopez  
**Date Created:** 08/13/2014

**Notes:** The distribution system is aged, becoming logistically unsupportable, and should be replaced.

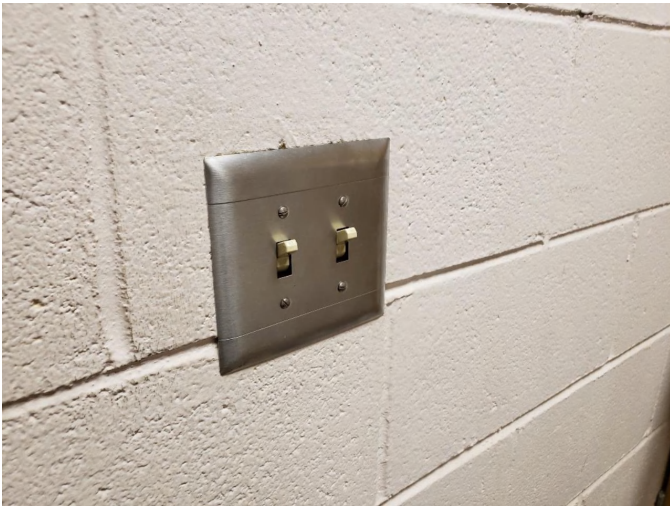
**System: D5020 - Branch Wiring**

**Location:** Throughout Building  
**Distress:** Beyond Expected Life  
**Category:** Deferred Maintenance  
**Priority:** 3 - Necessary (Years 2-5)  
**Correction:** Renew System  
**Qty:** 2,897.00  
**Unit of Measure:** S.F.  
**Estimate:** \$15,041.00  
**Assessor Name:** Eduardo Lopez  
**Date Created:** 01/26/2020

**Notes:** The original branch wiring system is operating, but is aged, in poor condition, and should be replaced.

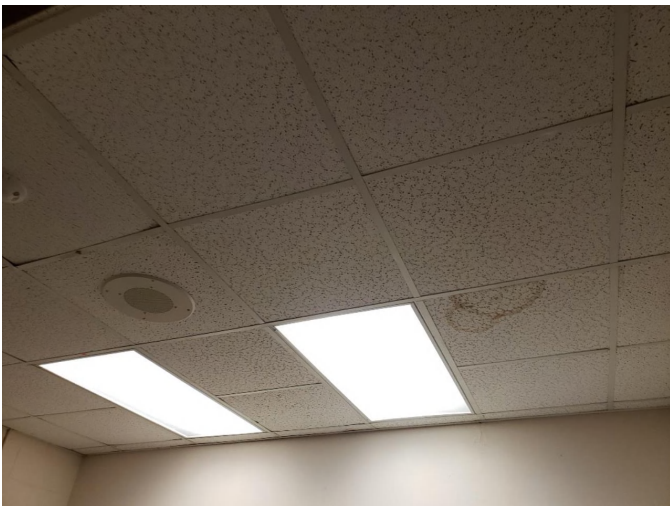
**System: D5020 - Lighting**

**Location:** Throughout Building  
**Distress:** Beyond Expected Life  
**Category:** Deferred Maintenance  
**Priority:** 3 - Necessary (Years 2-5)  
**Correction:** Renew System  
**Qty:** 2,897.00  
**Unit of Measure:** S.F.  
**Estimate:** \$22,626.00  
**Assessor Name:** Eduardo Lopez  
**Date Created:** 01/26/2020

**Notes:** The original lighting system is operating, but is aged, in poor condition, and should be replaced.

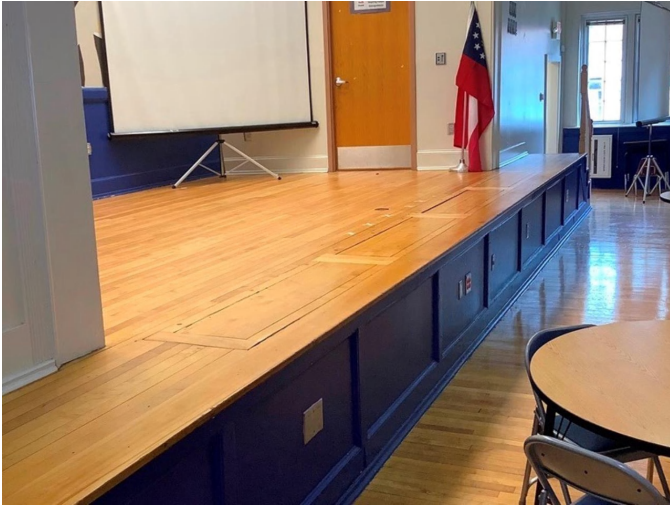
#### System: D1010 - Elevators and Lifts

**Location:** Stage  
**Distress:** Missing  
**Category:** ADA Compliance  
**Priority:** 2 - Trending Critical (Year 1)  
**Correction:** Renew System  
**Qty:** 13,454.00  
**Unit of Measure:** S.F.  
**Estimate:** \$23,383.00  
**Assessor Name:** Eduardo Lopez  
**Date Created:** 01/26/2020

**Notes:** Stage is not ADA accessible and a wheelchair lift should be provided per ADA standards.

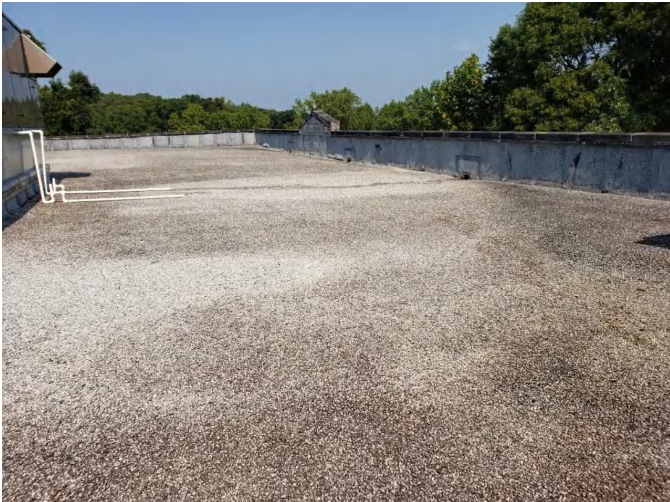
#### System: B3010105 - Built-Up

**Location:** Roof  
**Distress:** Beyond Expected Life  
**Category:** Deferred Maintenance  
**Priority:** 3 - Necessary (Years 2-5)  
**Correction:** Renew System  
**Qty:** 13,516.00  
**Unit of Measure:** S.F.  
**Estimate:** \$151,724.00  
**Assessor Name:** Eduardo Lopez  
**Date Created:** 01/26/2020

**Notes:** The built-up roof covering is in deteriorating conditions, beyond its expected life and should be scheduled for replacement.

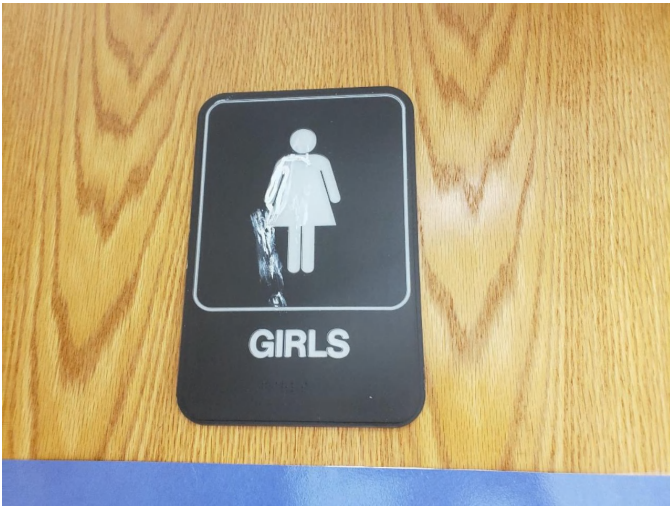
**System: C1030 - Fittings**

**Location:** Throughout building  
**Distress:** Beyond Expected Life  
**Category:** ADA Compliance  
**Priority:** 3 - Necessary (Years 2-5)  
**Correction:** Renew System  
**Qty:** 13,454.00  
**Unit of Measure:** S.F.  
**Estimate:** \$39,810.00  
**Assessor Name:** Eduardo Lopez  
**Date Created:** 09/30/2019

**Notes:** The fittings throughout the building are aged, in marginal condition, and should be replaced.

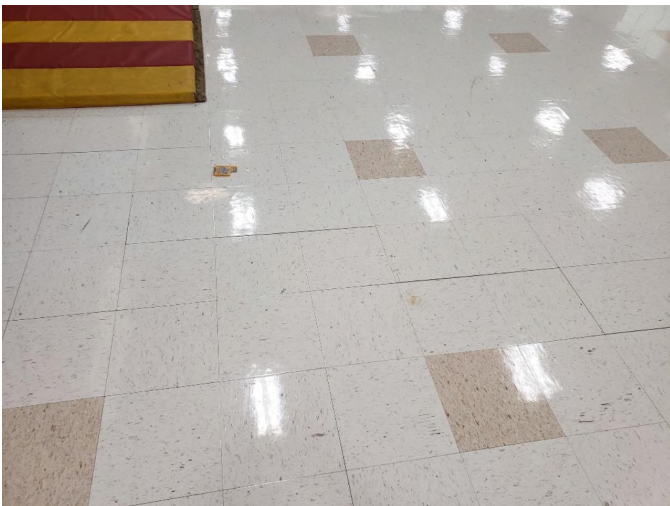
**System: C3020903 - VCT**

**Location:** Throughout building  
**Distress:** Beyond Expected Life  
**Category:** Deferred Maintenance  
**Priority:** 3 - Necessary (Years 2-5)  
**Correction:** Renew System  
**Qty:** 12,320.00  
**Unit of Measure:** S.F.  
**Estimate:** \$66,454.00  
**Assessor Name:** Eduardo Lopez  
**Date Created:** 01/24/2020

**Notes:** The VCT flooring is in poor conditions, with different areas separating from the substrate, and should be replaced.

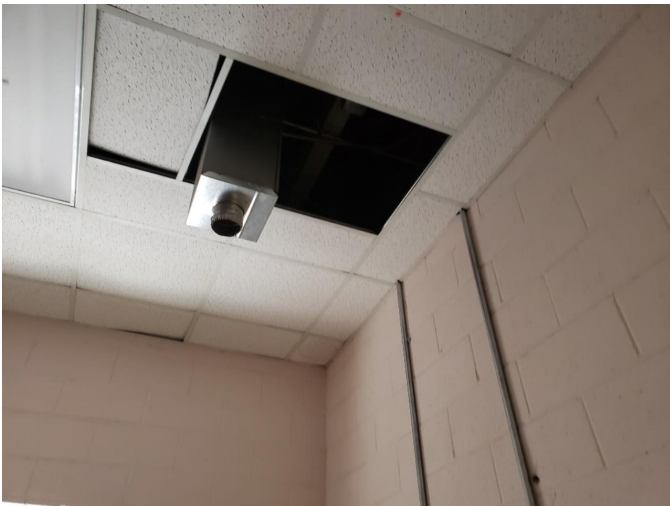
**System: D3040 - Distribution Systems**

**Location:** Throughout building  
**Distress:** Beyond Expected Life  
**Category:** Deferred Maintenance  
**Priority:** 3 - Necessary (Years 2-5)  
**Correction:** Renew System  
**Qty:** 13,454.00  
**Unit of Measure:** S.F.  
**Estimate:** \$159,094.00  
**Assessor Name:** Eduardo Lopez  
**Date Created:** 01/25/2020

**Notes:** The distribution system is aged, becoming logistically unsupportable, and should be replaced.

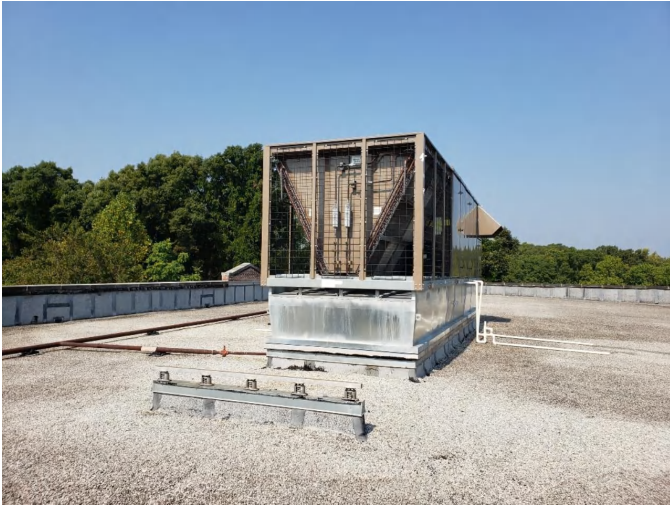
**System: D3050 - Terminal & Package Units**

**Location:** Throughout building  
**Distress:** Beyond Expected Life  
**Category:** Deferred Maintenance  
**Priority:** 3 - Necessary (Years 2-5)  
**Correction:** Renew System  
**Qty:** 13,454.00  
**Unit of Measure:** S.F.  
**Estimate:** \$101,524.00  
**Assessor Name:** Eduardo Lopez  
**Date Created:** 09/17/2015

**Notes:** The terminal and package units are aged, rusted, not energy efficient, and should be replaced.

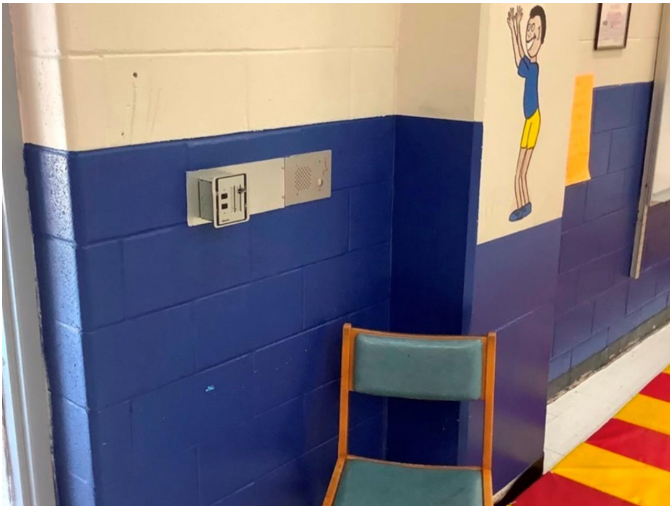
**System: D3060 - Controls & Instrumentation**

**Location:** Throughout building  
**Distress:** Beyond Expected Life  
**Category:** Deferred Maintenance  
**Priority:** 3 - Necessary (Years 2-5)  
**Correction:** Renew System  
**Qty:** 13,454.00  
**Unit of Measure:** S.F.  
**Estimate:** \$33,299.00  
**Assessor Name:** Eduardo Lopez  
**Date Created:** 09/17/2015

**Notes:** The system is beyond its expected service life and should be scheduled for replacement.

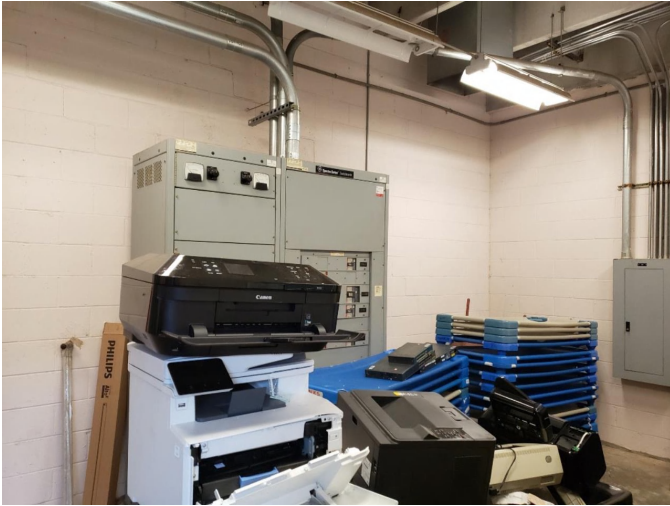
**System: D5010 - Electrical Service/Distribution**

**Location:** Throughout building  
**Distress:** Beyond Expected Life  
**Category:** Deferred Maintenance  
**Priority:** 3 - Necessary (Years 2-5)  
**Correction:** Renew System  
**Qty:** 13,454.00  
**Unit of Measure:** S.F.  
**Estimate:** \$34,631.00  
**Assessor Name:** Eduardo Lopez  
**Date Created:** 09/30/2019

**Notes:** The original electrical service is operating but is in marginal condition and should be replaced.

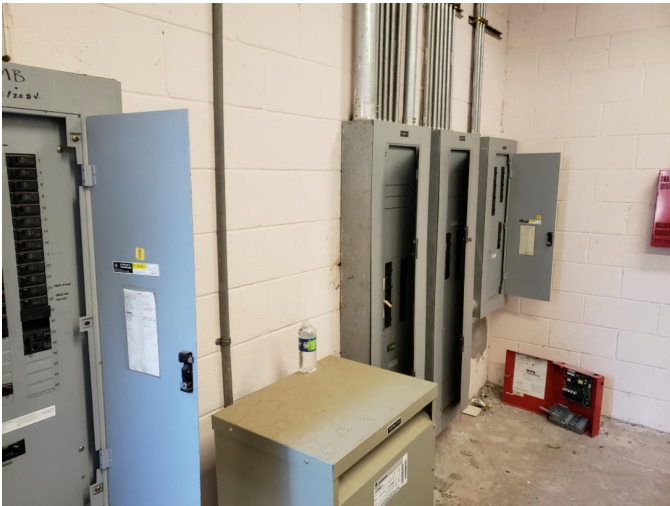
**System: D5020 - Branch Wiring**

**Location:** Throughout building  
**Distress:** Beyond Expected Life  
**Category:** Deferred Maintenance  
**Priority:** 3 - Necessary (Years 2-5)  
**Correction:** Renew System  
**Qty:** 13,454.00  
**Unit of Measure:** S.F.  
**Estimate:** \$66,893.00  
**Assessor Name:** Eduardo Lopez  
**Date Created:** 01/24/2020

**Notes:** The original branch wiring system is operating, but is aged, in poor condition, and should be replaced.

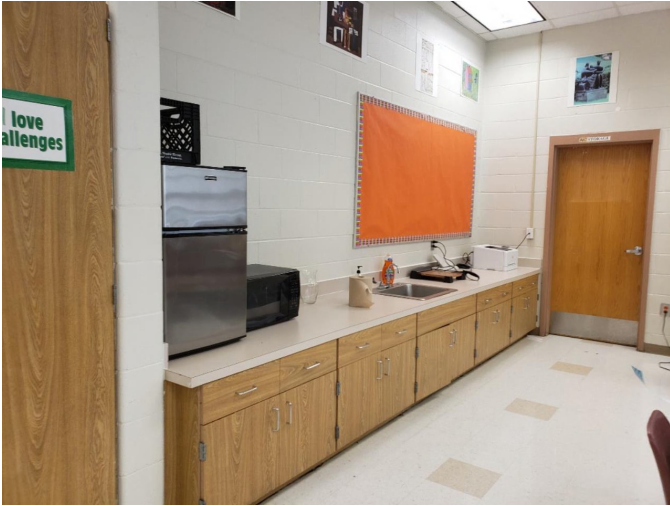
**System: E2010 - Fixed Furnishings**

**Location:** Throughout Building  
**Distress:** Beyond Expected Life  
**Category:** Deferred Maintenance  
**Priority:** 3 - Necessary (Years 2-5)  
**Correction:** Renew System  
**Qty:** 13,454.00  
**Unit of Measure:** S.F.  
**Estimate:** \$28,563.00  
**Assessor Name:** Eduardo Lopez  
**Date Created:** 09/30/2019

**Notes:** The fixed furnishings are aged, and should be replaced.

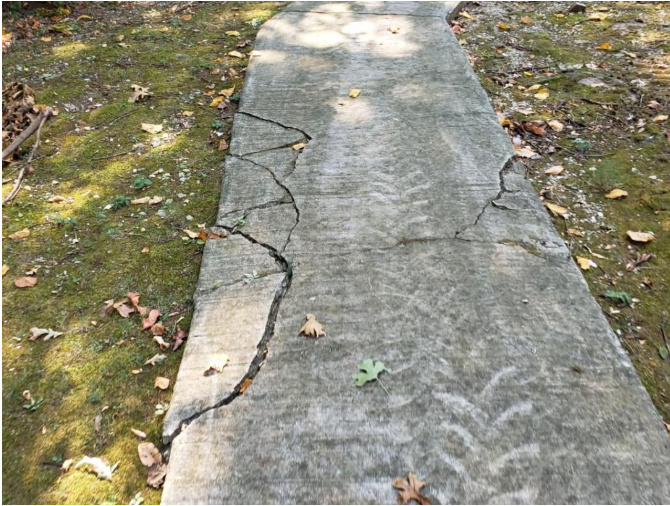
#### System: G2030 - Pedestrian Paving

**Location:** Site  
**Distress:** Damaged  
**Category:** ADA Compliance  
**Priority:** 1 - Critical Immediate Need  
**Correction:** Replace damaged sidewalks 5'wide X 4"thick  
**Qty:** 200.00  
**Unit of Measure:** L.F.  
**Estimate:** \$8,026.74  
**Assessor Name:** Jejuan Hall  
**Date Created:** 01/26/2020

**Notes:** The sidewalks are showing signs of damage and should be replaced.

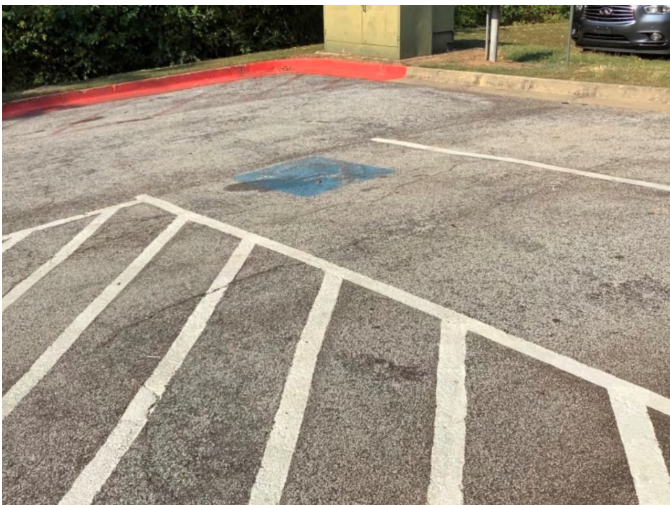
#### System: G2010 - Roadways

**Location:** Site  
**Distress:** Inadequate  
**Category:** Code Compliance  
**Priority:** 2 - Trending Critical (Year 1)  
**Correction:** Fire lane marking, incl. curb painting and with the words "No Parking, Fire Lane" painted in black  
**Qty:** 1,500.00  
**Unit of Measure:** L.F.  
**Estimate:** \$3,577.95  
**Assessor Name:** Eduardo Lopez  
**Date Created:** 01/26/2020

**Notes:** There is a section of curb painted in red on the side of the building. However, there is no indication it's a Fire Lane. Fire lane markings must include curb painting and with the words "No Parking, Fire Lane" to maintain it free of obstruction at all times. Provide Fire lane markings per Local Code requirements.

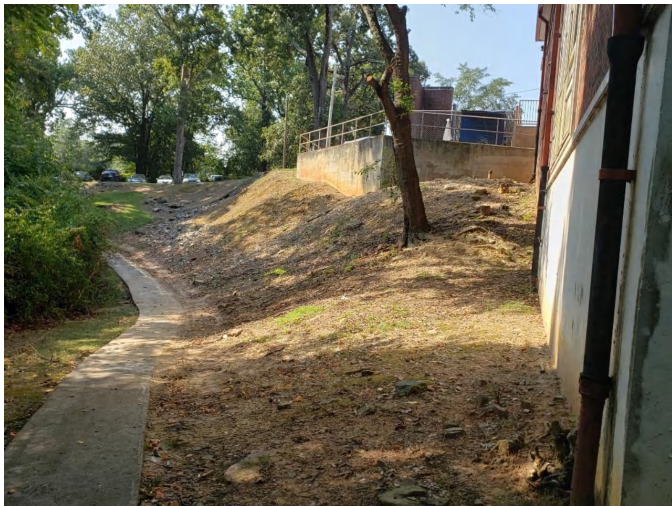
### **System: G2050 - Landscaping**

**Location:** Site  
**Distress:** Beyond Expected Life  
**Category:** Deferred Maintenance  
**Priority:** 2 - Trending Critical (Year 1)  
**Correction:** Renew System  
**Qty:** 57,910.00  
**Unit of Measure:** S.F.  
**Estimate:** \$91,729.00  
**Assessor Name:** Eduardo Lopez  
**Date Created:** 06/10/2014

**Notes:** There are different areas with significant erosion. Provide and install grass sod to control erosion.
