Atlanta Public Schools/ N. Atlanta Cluster

Sutton Sixth Grade Academy

School Assessment Report

November 10, 2020

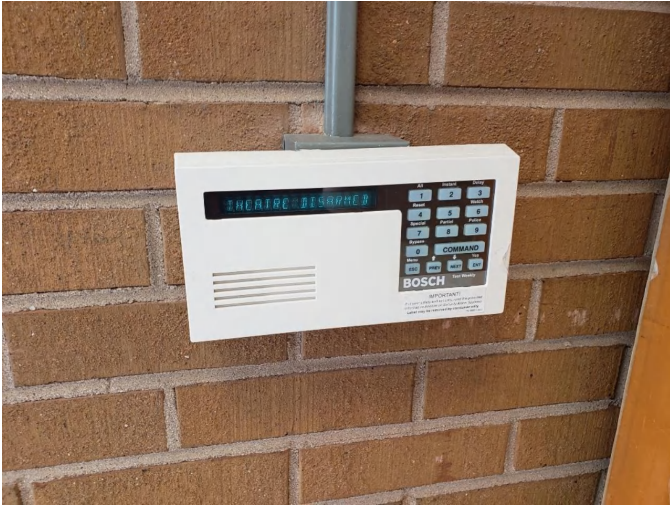
System: D5030810 - Security & Detection Systems

Location: Throughout building
Distress: Beyond Expected Life
Category: Deferred Maintenance
Priority: 3 - Necessary (Years 2-5)
Correction: Renew System
Qty: 5,288.00
Unit of Measure: S.F.
Estimate: \$8,783.00
Assessor Name: Homero Guerrero
Date Created: 01/31/2020

Notes: This facilities security and alarm system is operation and has been upgraded over the past years. This project provides a budgetary consideration to improve the facilities security and alarm system.

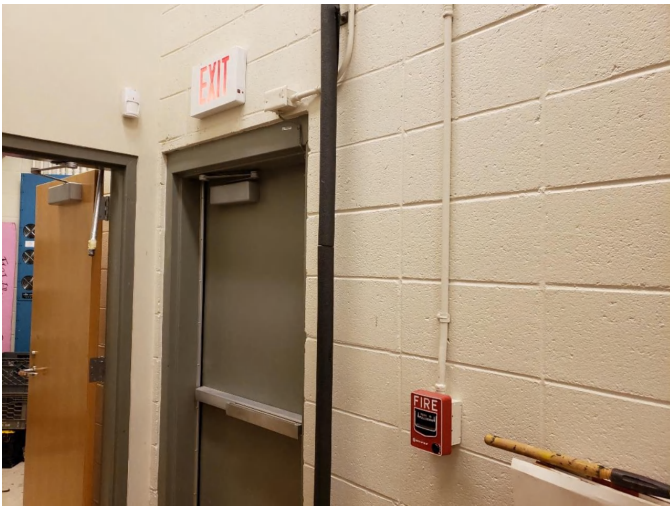
System: D5030910 - Fire Alarm Systems

Location: Throughout building
Distress: Beyond Expected Life
Category: Deferred Maintenance
Priority: 3 - Necessary (Years 2-5)
Correction: Renew System
Qty: 5,288.00
Unit of Measure: S.F.
Estimate: \$15,938.00
Assessor Name: Homero Guerrero
Date Created: 01/31/2020

Notes: The fire alarm system appears to be from original construction. There are components such as push stations, lights and alarm bells installed to support the fire life safety for this building. This system is nearing the end of its expected life and upgrades are warranted.

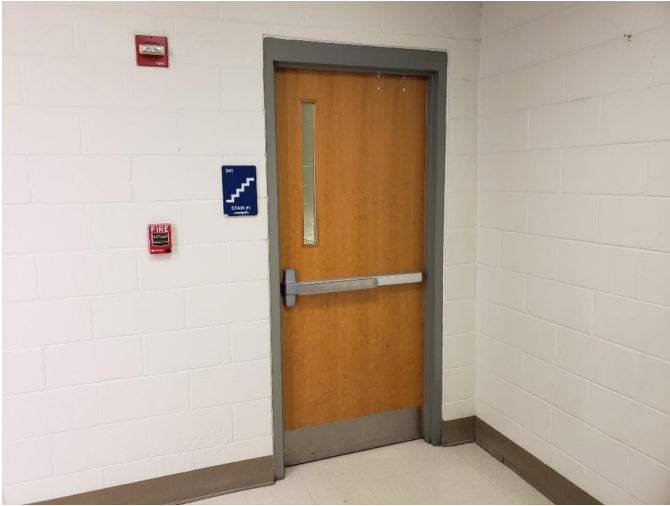
System: D5030910 - Fire Alarm Systems

Location: Throughout Building
Distress: Beyond Expected Life
Category: Deferred Maintenance
Priority: 3 - Necessary (Years 2-5)
Correction: Renew System
Qty: 33,782.00
Unit of Measure: S.F.
Estimate: \$101,819.00
Assessor Name: Eduardo Lopez
Date Created: 01/24/2020

Notes: The fire alarm system consists of the standard control station, pull stations, strobes. The systems are beyond their expected life and upgrades are warranted.
