Atlanta Public Schools/Relocation Sites

Towns Elementary School

School Assessment Report

November 10, 2020

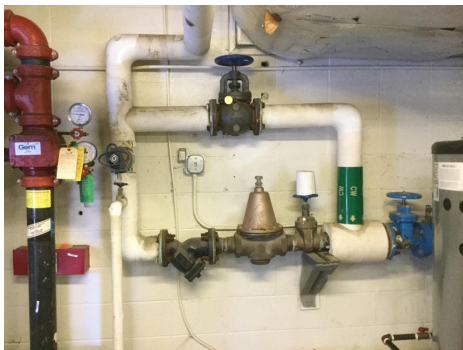
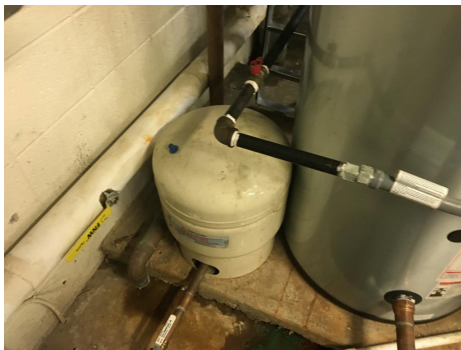
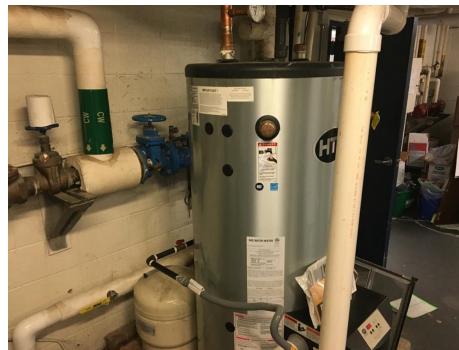
System: D2020 - Domestic Water Distribution

Note: New hot water heater installed 2013.

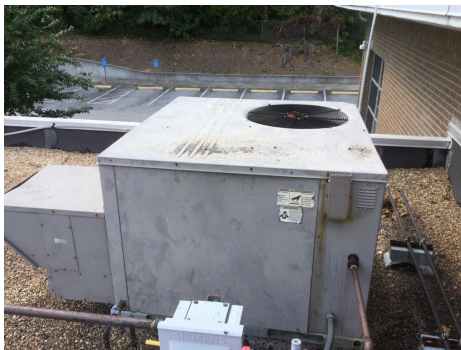
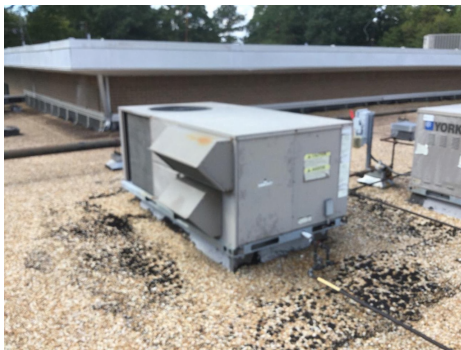
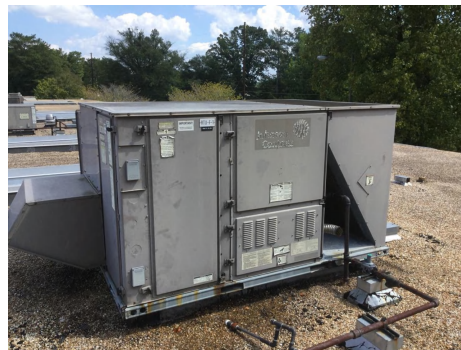
System: D3050 - Terminal & Package Units

Notes: Most of the Terminal and Package Units are on stand-by, out of service or not functioning as designed. Considering the current status of the school this deficiency provides a budgetary consideration for system renewal prior to the school reopening.

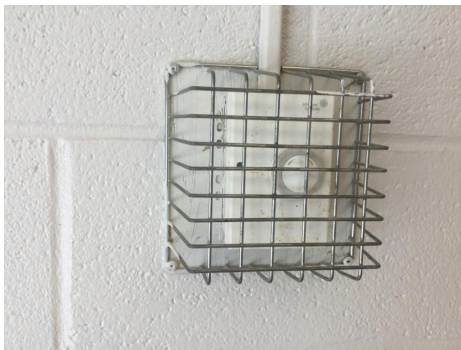
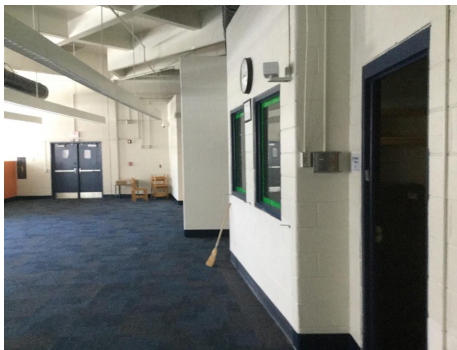
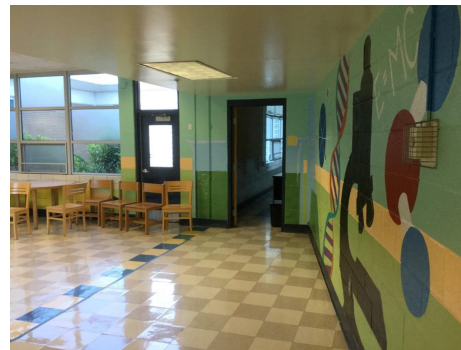
System: D3060 - Controls & Instrumentation

Notes: The heating generation systems, exhaust and ventilation systems, energy monitoring and controls as well as the building automation systems are either out of service or not functioning to standard. Several issues will develop as a result of the school no longer being maintained. Although isolated upgrades have taken place to support the systems prior to the school being taken out of service the systems are recommended for universal upgrade. This deficiency is expected to be completed with other HVAC upgrades.

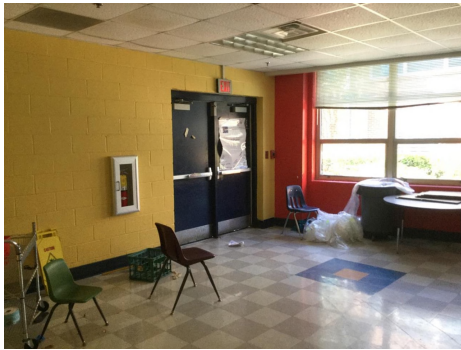
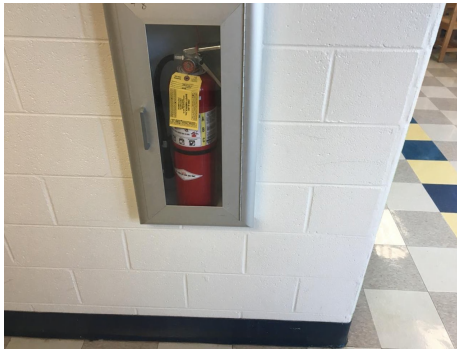
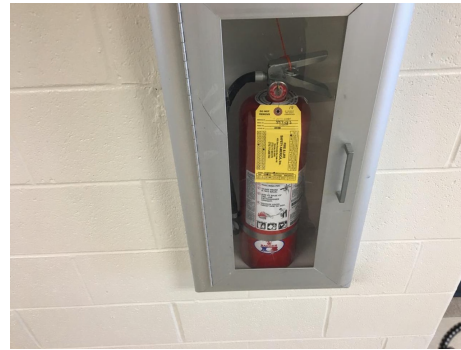
System: D4030 - Fire Protection Specialties

Notes: The fire extinguishers and cabinets are from original construction and do not include modern designs for ease of use. Upgrades are recommended to include all new aspects of design for ease of use.

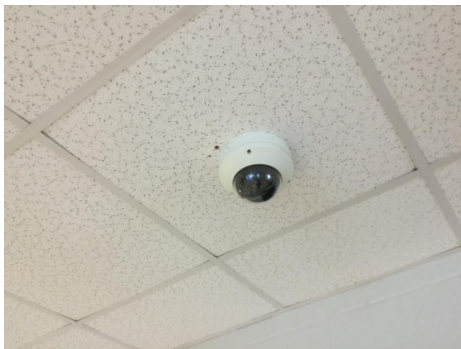
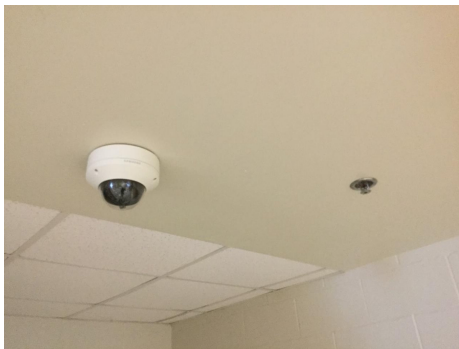
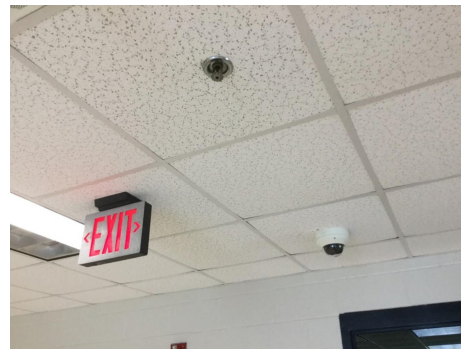
System: D5030810 - Security & Detection Systems

Notes: The school is not currently occupied. The security system main components could not be located however, the camera system remains. Considering the current status of the school this deficiency provides a budgetary consideration for security system renewal prior to the school reopening.

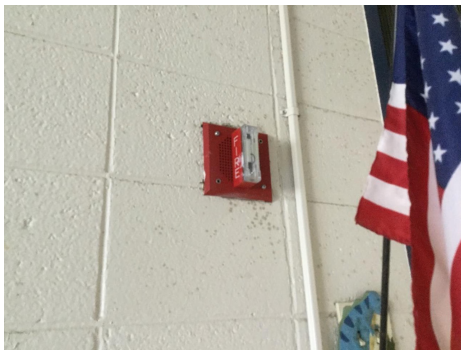
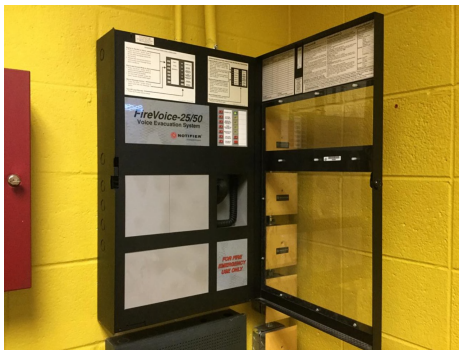
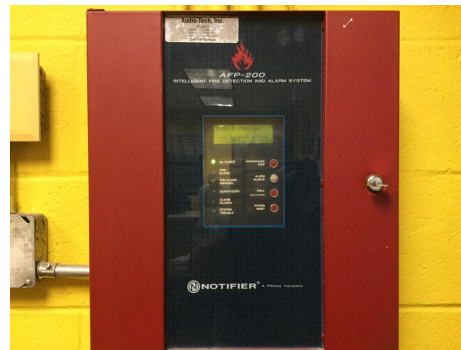
System: D5030910 - Fire Alarm Systems

Notes: The AFP-200 Notifier Fire Alarm System appears to be from original construction. There are components such as push stations, lights and alarm bells installed to support the fire life safety for this building. This system is no longer supported and upgrades are warranted. This deficiency provides a budgetary consideration for universal upgrades to the fire alarm system.

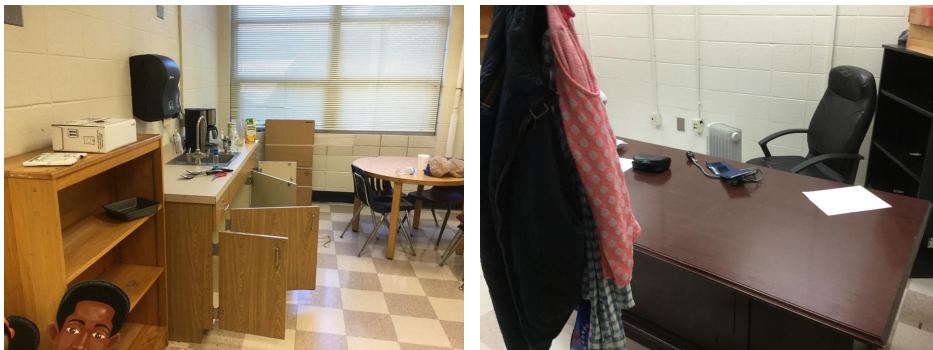
System: D5030920 - Data Communication

Note: The data hubs for this school have been reclaimed and only the chassis remains. Photos include the office data connections that remain.

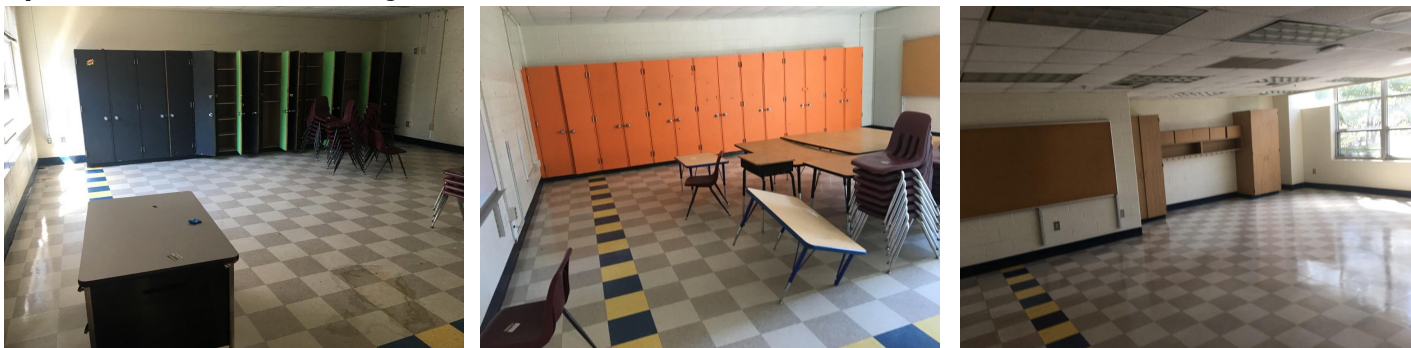
System: E2010 - Fixed Furnishings

Notes: Fittings include chalkboards; marker boards; tack boards; interior signage; metal lockers; toilet accessories and wood/metal/marble toilet partitions and fixed storage shelving. The system is nearing the end of its useful life and universal upgrades are recommended.

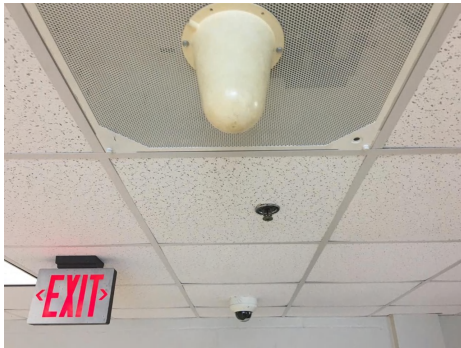
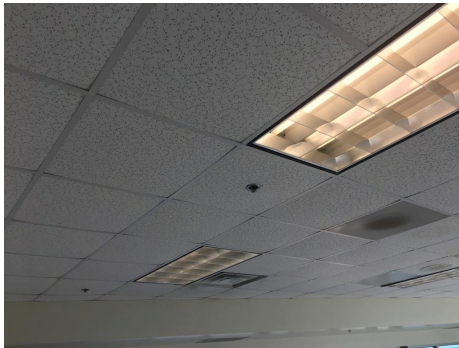
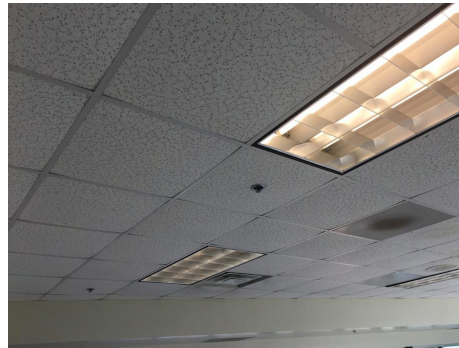
System: C3030 - Ceiling Finishes

Notes: The acoustic ceilings are aged and stained and should be scheduled for replacement.

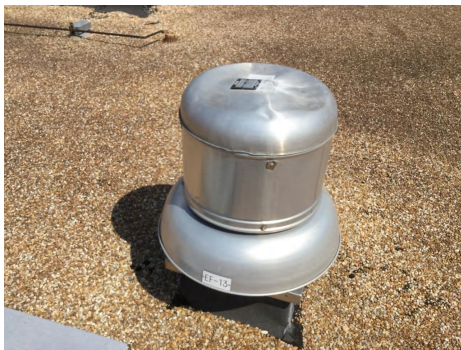
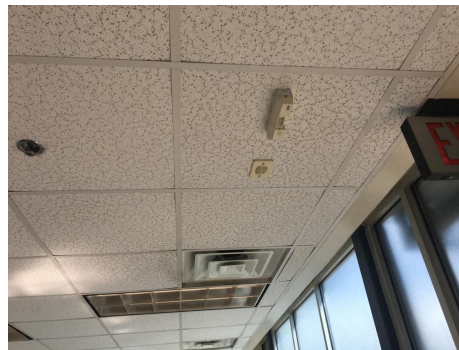
System: D3040 - Distribution Systems

Notes: The distribution system is beyond its expected service life and should be scheduled for replacement.

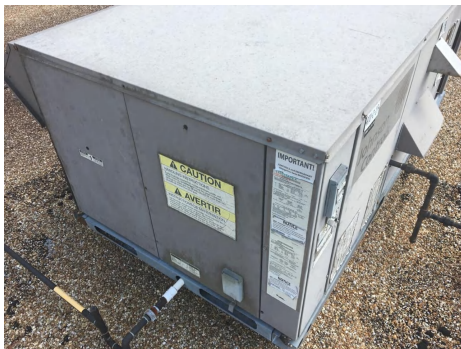
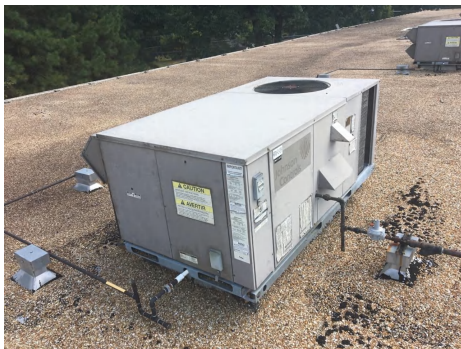
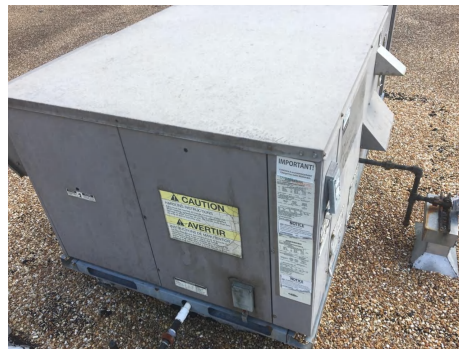
System: D3050 - Terminal & Package Units

Notes: Most of the Terminal and Package Units are on stand-by, out of service or not functioning as designed. Considering the current status of the school this deficiency provides a budgetary consideration for system renewal prior to the school reopening.

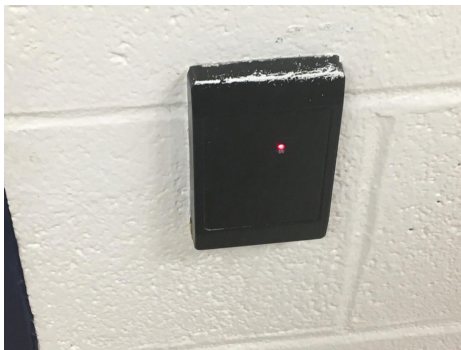
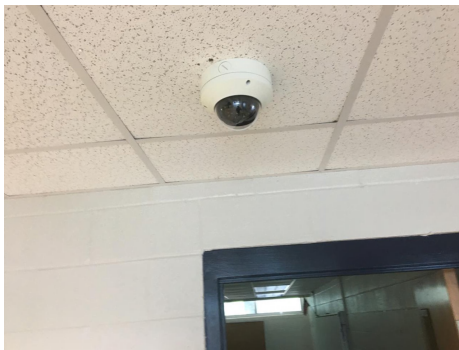
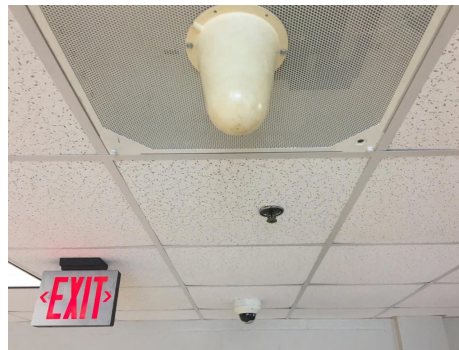
System: D5030810 - Security & Detection Systems

Notes: The school is not currently occupied. The security system main components could not be located however, the camera system remains. Considering the current status of the school this deficiency provides a budgetary consideration for security system renewal prior to the school reopening.

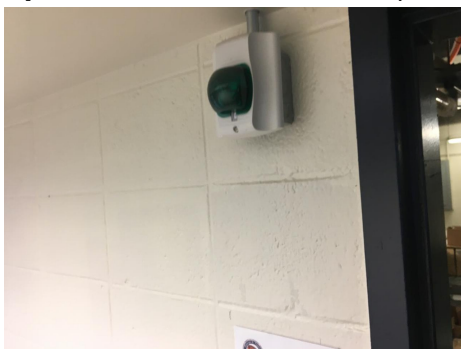
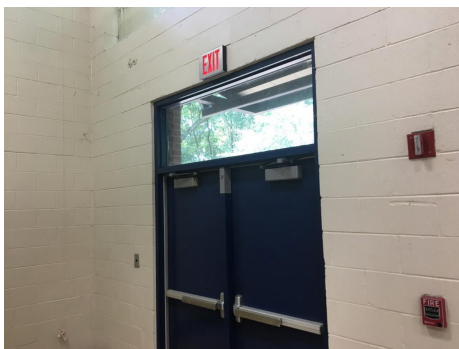
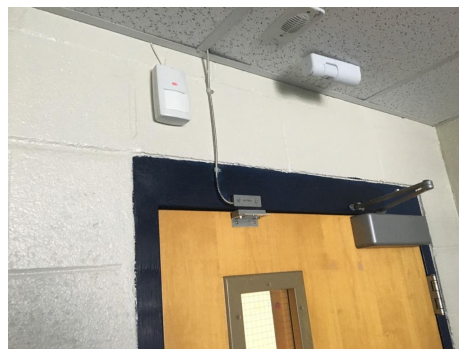
System: D5030910 - Fire Alarm Systems

The AFP-200 Notifier Fire Alarm System appears to be from original construction. There are components such as push stations, lights and alarm bells installed to support the fire life safety for this building. This system is no longer supported and upgrades are warranted. This deficiency provides a budgetary consideration for universal upgrades to the fire alarm system.

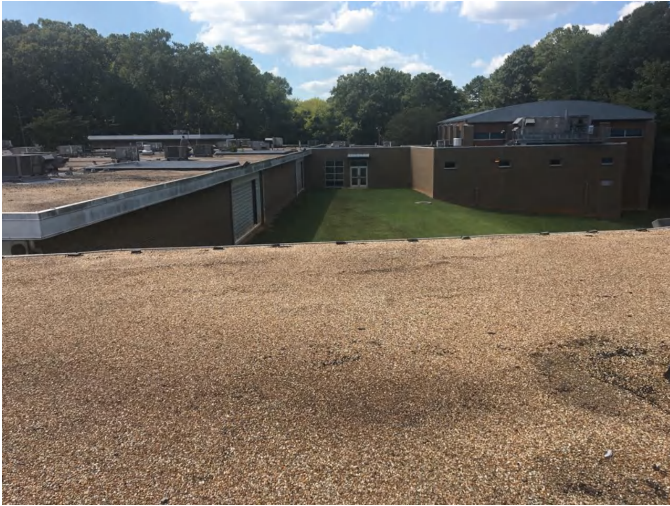
System: B3010105 - Built-Up

Location: Roof
Distress: Beyond Expected Life
Category: Deferred Maintenance
Priority: 3 - Necessary (Years 2-5)
Correction: Renew System
Qty: 26,704.00
Unit of Measure: S.F.
Estimate: \$299,766.00
Assessor Name: Eduardo Lopez
Date Created: 12/04/2019

The roof is from the 2000 roof upgrade project. There is evidence of water stains and damaged ceiling tiles. However, considering that the school is abandoned its either a HVAC or roof issue. This deficiency provides a budgetary consideration for future replacement of this system. This deficiency is expected to be completed with the recommended HVAC upgrades.
