Atlanta Public Schools/Charter Schools

Turner MS (KIPP Atlanta Collegiate)

School Assessment Report

March 12, 2021

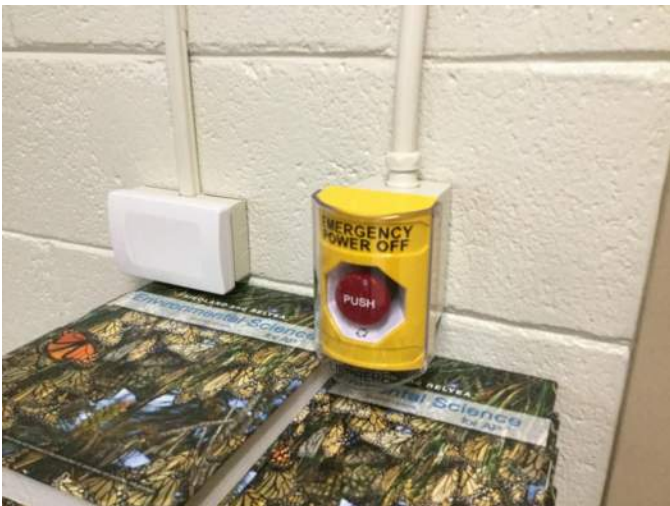
System: D3060 - Controls & Instrumentation

Location: Throughout building
Distress: Beyond Expected Life
Category: Deferred Maintenance
Priority: 3 - Necessary (Years 2-5)
Correction: Renew System
Qty: 103,864.00
Unit of Measure: S.F.
Estimate: \$252,493.00
Assessor Name: Eduardo Lopez
Date Created: 02/22/2020

The heating generation systems, exhaust and ventilation systems, energy monitoring and controls as well as the building automation systems are original. Several issues have surfaced over recent years and isolated upgrades have taken place to support the systems. This deficiency provides a budgetary consideration for a universal upgrade.

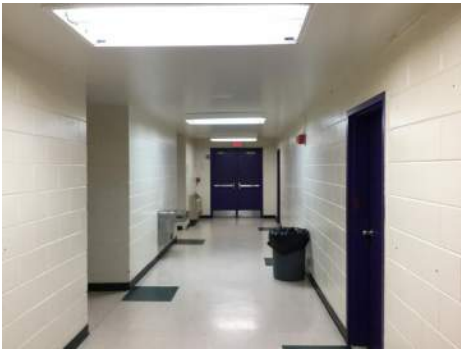
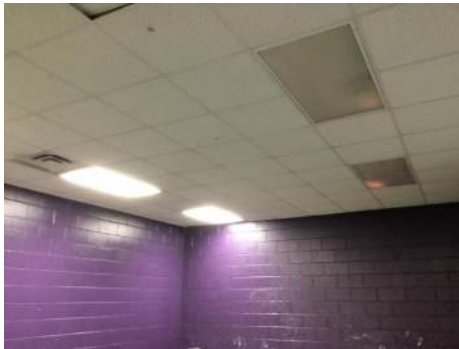
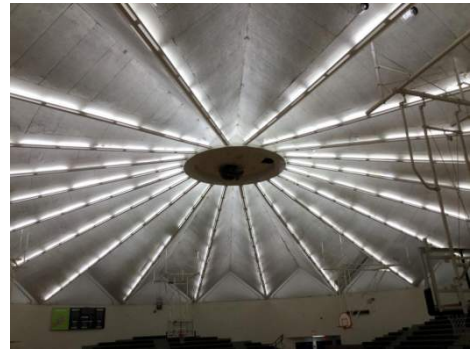
System: C3030 - Ceiling Finishes

The acoustical ceiling tile finish is beyond its expected service life and is recommended for replacement in conjunction with other recommended renovations.

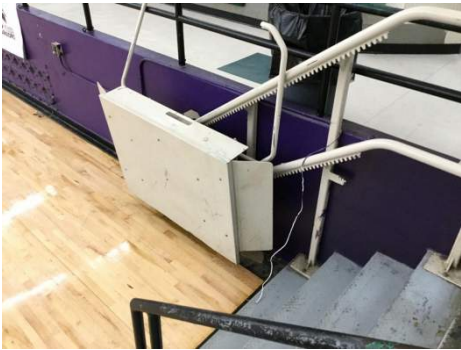
System: D1010 - Elevators and Lifts

The ADA elevator system has exceeded its life cycle and recommended for upgrade. All aspects of the current ADA standards are expected to be included in the new installation.

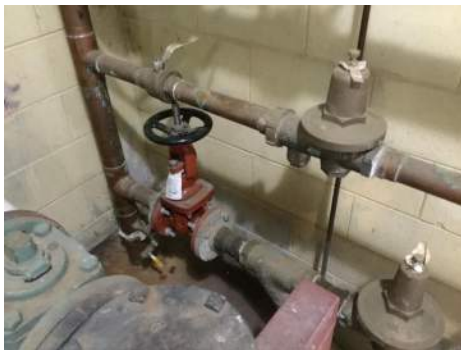
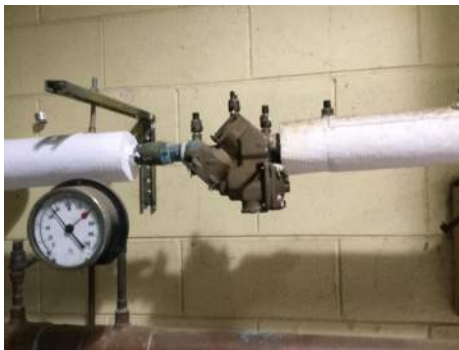
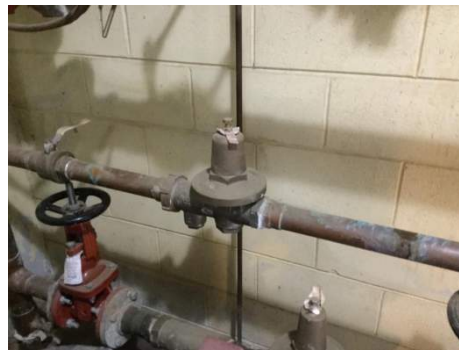
System: D2020 - Domestic Water Distribution

Notes: The domestic water distribution system consists of galvanized and copper pipes, valves and domestic water supply. The system is beyond its expected life cycle and upgrades are recommended.

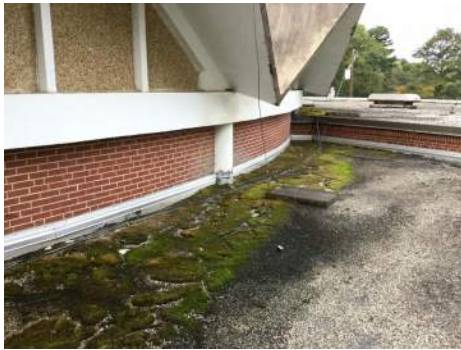
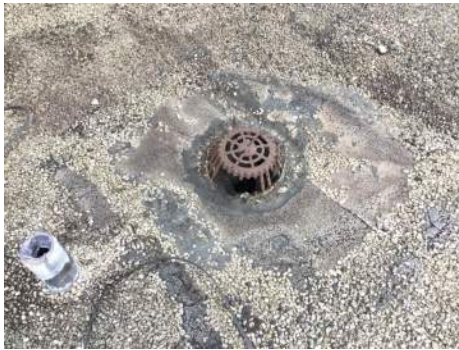
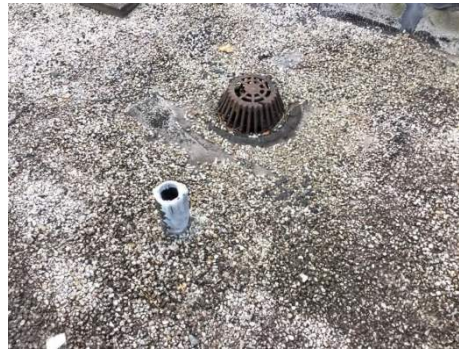
System: D2040 - Rain Water Drainage

Notes: The roof drains, insulation and fittings that support the water run off from this roof are original. The insulation is damaged from leaks and the drains have developed leaks. This deficiency provides a budgetary consideration for a new rainwater drainage system. This is expected to be completed as part of an overall effort to upgrade the roof and should be completed as part of the recommended roof upgrade also in this report.

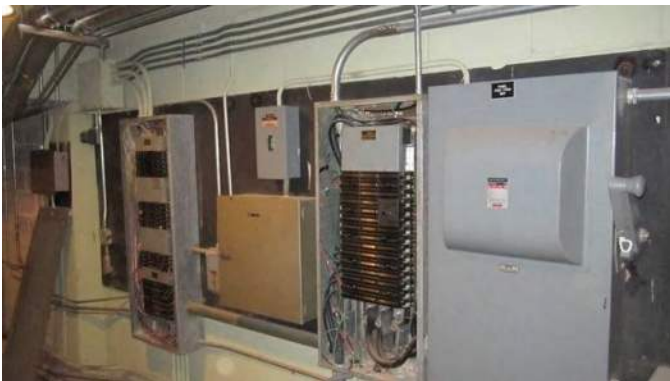
System: D5010 - Electrical Service/Distribution

Location: Throughout building
Distress: Beyond Expected Life
Category: Deferred Maintenance
Priority: 3 - Necessary (Years 2-5)
Correction: Renew System
Qty: 31,216.00
Unit of Measure: S.F.
Estimate: \$175,746.00
Assessor Name: Eduardo Lopez
Date Created: 10/22/2014
