Atlanta Public Schools/ Douglass Cluster

Usher-Collier Heights Elementary School

School Assessment Report

November 10, 2020

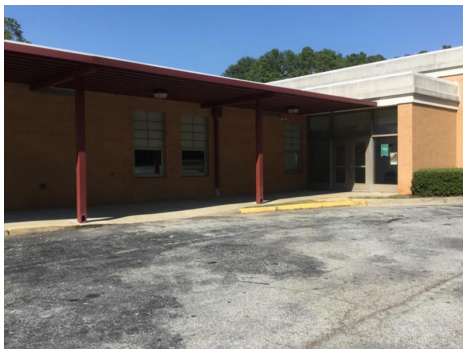
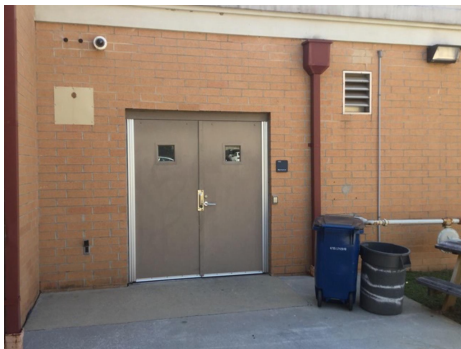
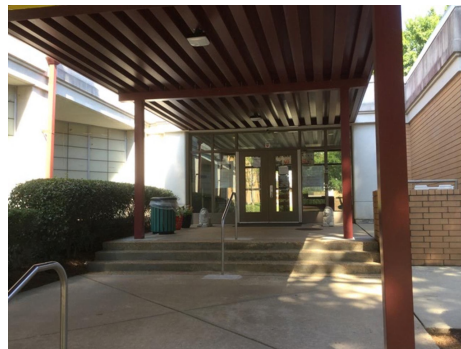
System: G4030 - Site Communication and Security

Notes: The security system is aged and should be replaced and upgraded.
