Atlanta Public Schools/Charter Schools

Waters ES (KIPP Visions Academy)

School Assessment Report

March 12, 2021

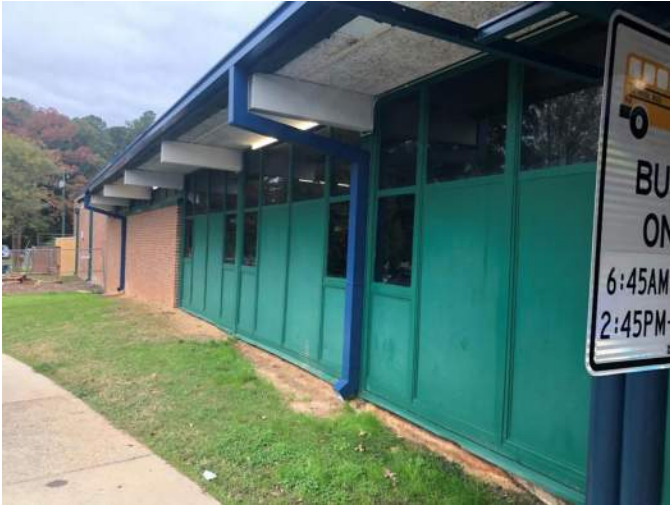
System: B2020 - Exterior Windows

Location: Throughout building
Distress: Beyond Expected Life
Category: Deferred Maintenance
Priority: 3 - Necessary (Years 2-5)
Correction: Renew System
Qty: 33,365.00
Unit of Measure: S.F.
Estimate: \$351,233.00
Assessor Name: Eduardo Lopez
Date Created: 02/22/2020

The windows in the classrooms were replaced in 2012 however most are original to the building age and should be replaced.

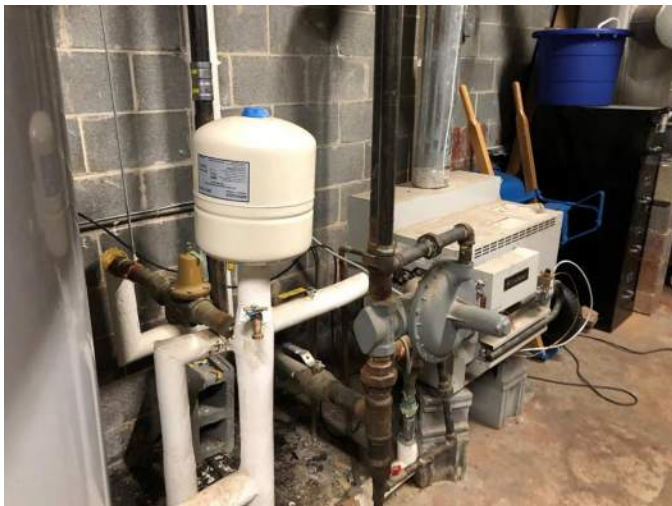
System: D2010 - Plumbing Fixtures

Location: Throughout building
Distress: Beyond Expected Life
Category: ADA Compliance
Priority: 3 - Necessary (Years 2-5)
Correction: Renew System
Qty: 33,365.00
Unit of Measure: S.F.
Estimate: \$259,113.00
Assessor Name: Eduardo Lopez
Date Created: 02/14/2020

Plumbing fixtures are beyond their expected service life and should be replaced and upgraded for ADA compliance.

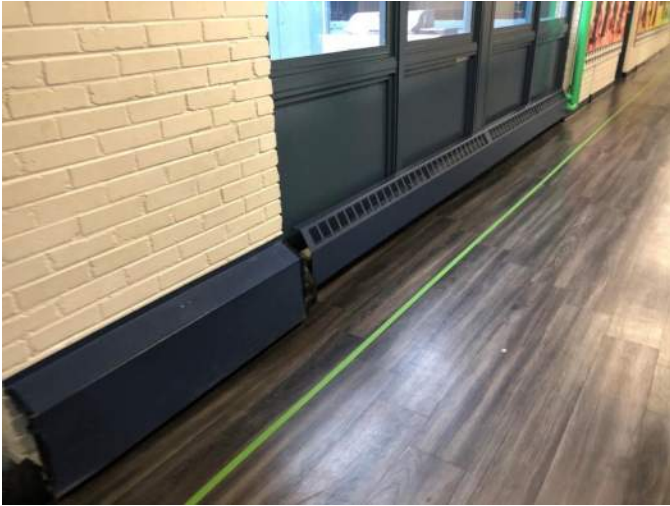
System: D3020 - Heat Generating Systems

Location: Throughout building
Distress: Beyond Expected Life
Category: Deferred Maintenance
Priority: 3 - Necessary (Years 2-5)
Correction: Renew System
Qty: 33,365.00
Unit of Measure: S.F.
Estimate: \$146,806.00
Assessor Name: Eduardo Lopez
Date Created: 02/14/2020

The heating generation system consist of ceiling mounted electric unit heaters. The systems are original and nearing the end of their useful life. This system is recommended for replacement with an in kind replacement.

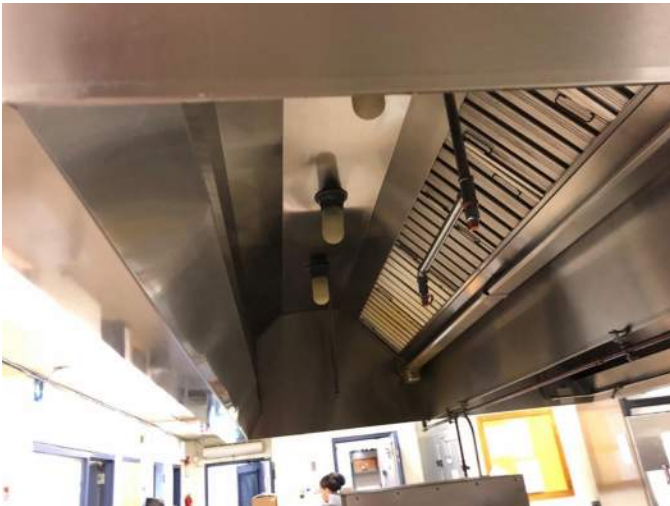
System: D4090 - Other Fire Protection Systems

Location: Kitchen
Distress: Beyond Expected Life
Category: Deferred Maintenance
Priority: 3 - Necessary (Years 2-5)
Correction: Renew System
Qty: 33,365.00
Unit of Measure: S.F.
Estimate: \$24,223.00
Assessor Name: Eduardo Lopez
Date Created: 02/14/2020

The exhaust hood system is original. This building high traffic use warrants upgrades to this system based on usage and age. This deficiency provides a budgetary consideration for universal upgrades to the system.

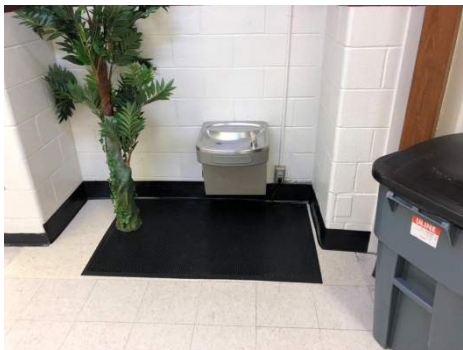
System: D2020 - Domestic Water Distribution

The domestic water distribution system consists of galvanized and copper pipes, valves and domestic water supply. The system is beyond its expected life cycle and upgrades are recommended.

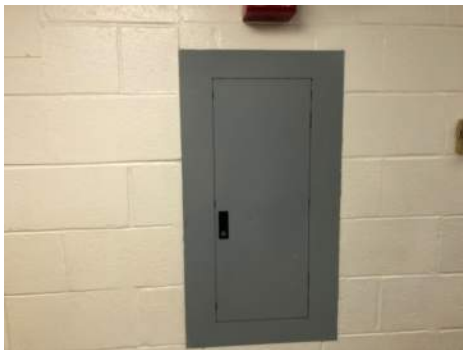
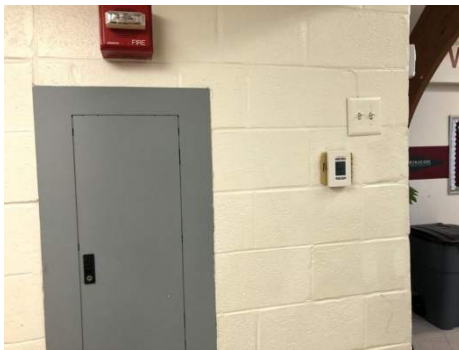
System: D5020 - Branch Wiring

The original branch wiring system is operational but is aged and should be replaced with an energy efficient system.

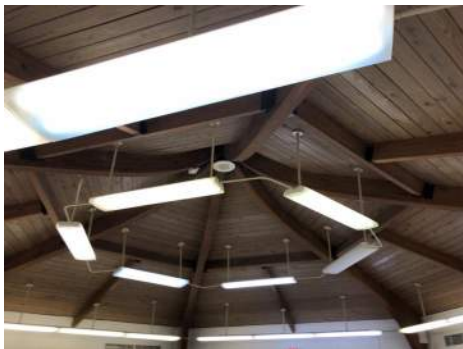
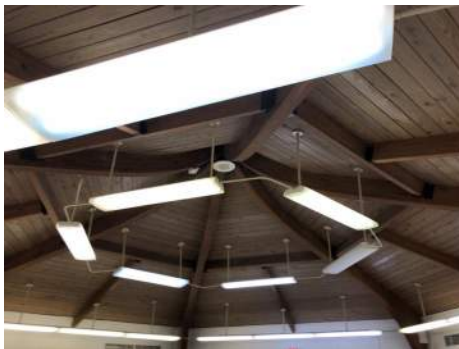
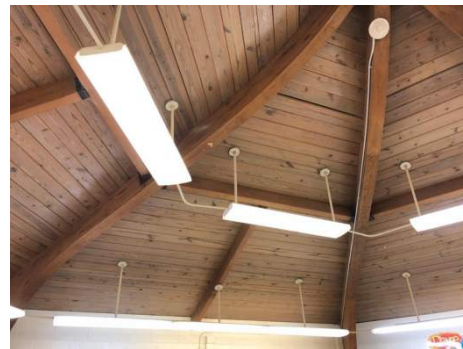
System: D5020 - Lighting

The original lighting System is operational but is aged and should be replaced with an energy efficient system.

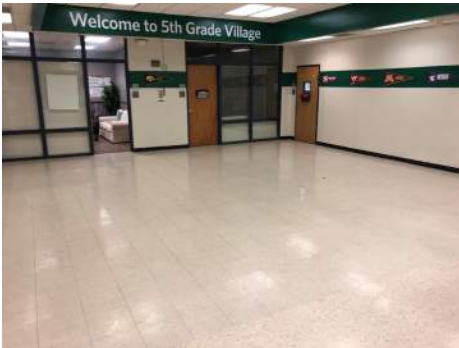
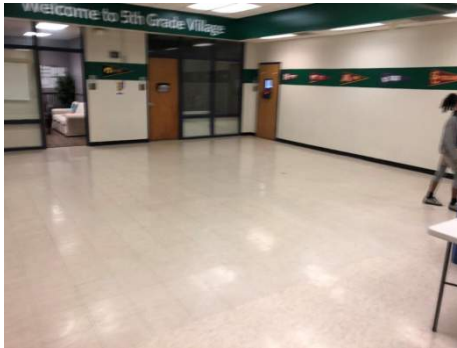
System: C3020903 - VCT

Notes: The VCT floor finish is beyond its expected service life, worn and damaged, and is recommended for replacement.

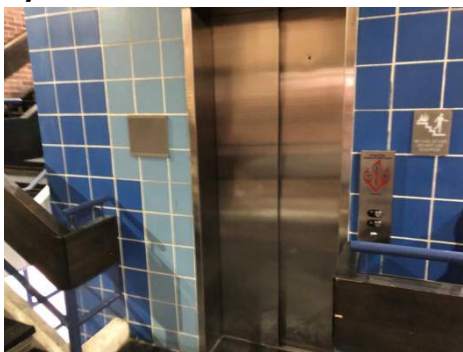
System: D1010 - Elevators and Lifts

The elevator system is from original construction. The elevator system has exceeded its life cycle and recommended for upgrade. All aspects of the current ADA standards are expected to be included in the new installation.

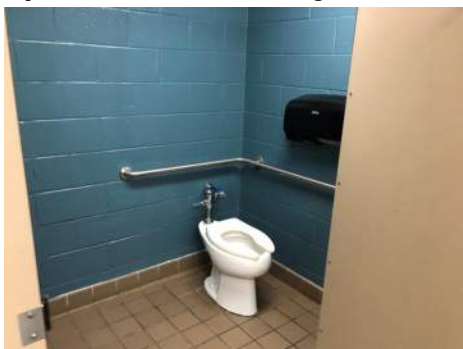
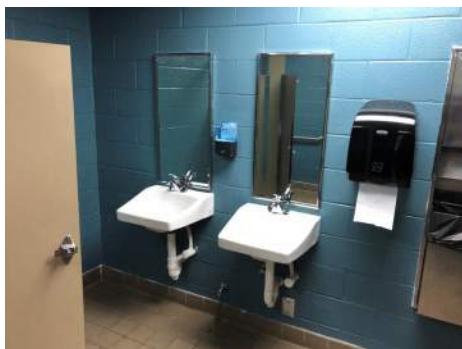
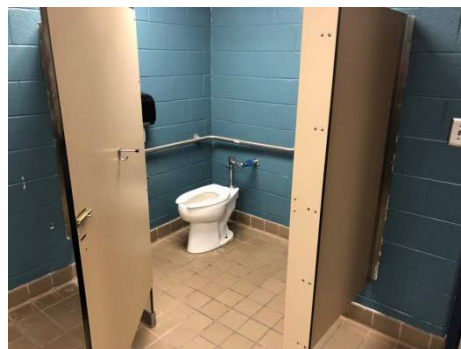
System: D2010 - Plumbing Fixtures

Plumbing fixtures are beyond their expected service life and should be replaced and upgraded for ADA compliance.

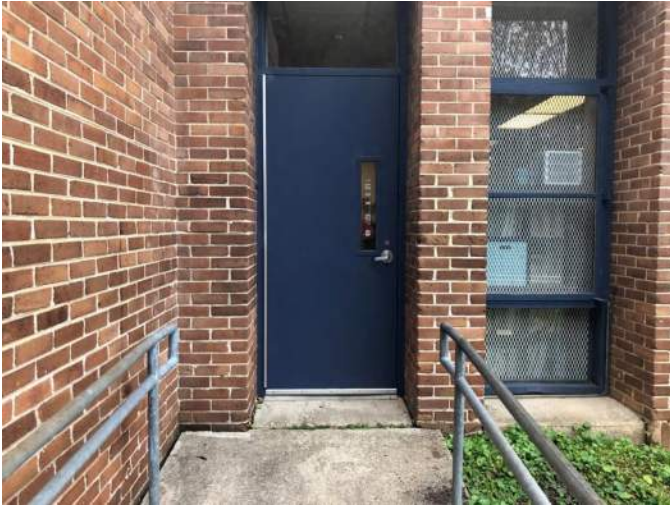
System: B2020 - Exterior Windows

Location: Throughout building
Distress: Beyond Expected Life
Category: Deferred Maintenance
Priority: 3 - Necessary (Years 2-5)
Correction: Renew System
Qty: 37,146.00
Unit of Measure: S.F.
Estimate: \$140,560.00
Assessor Name: Eduardo Lopez
Date Created: 02/22/2020

The exterior windows are a mix of the original metal framed single and double pane applications and a few replacement windows with a wooden frame double pane application. Some of the windows are operable while others no longer function. The exterior windows have exceeded the expected life cycle and are recommended for upgrade.

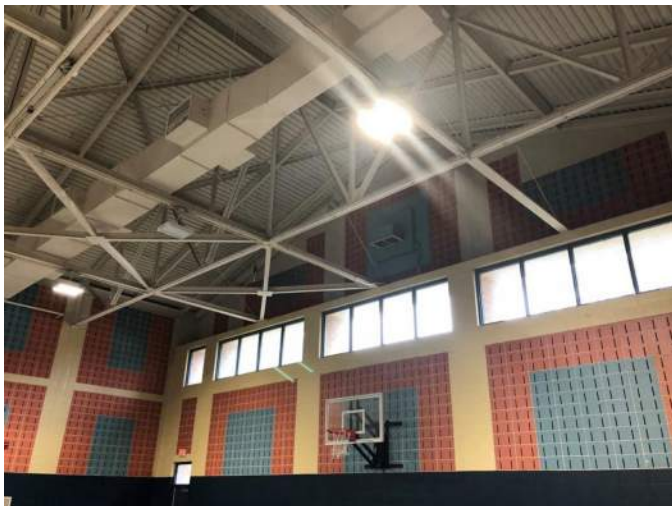
System: E1020 - Institutional Equipment

Location: Throughout building
Distress: Beyond Expected Life
Category: Deferred Maintenance
Priority: 3 - Necessary (Years 2-5)
Correction: Renew System
Qty: 37,146.00
Unit of Measure: S.F.
Estimate: \$121,765.00
Assessor Name: Eduardo Lopez
Date Created: 02/22/2020

The equipment is from the original construction of the school. The systems are in use and in fair condition however, the systems are beyond the expected life for this application and upgrades are warranted.

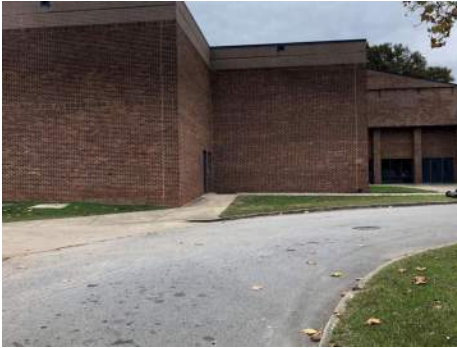
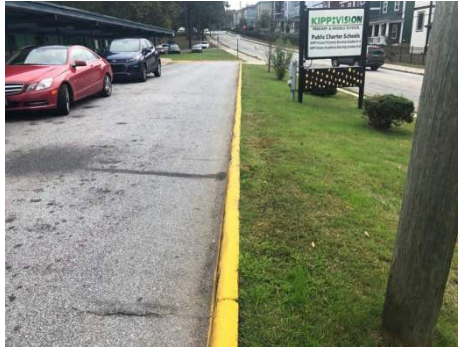
System: G2010 - Roadways

The asphalted roadways have cracks and potholes that should be repaired and resealed to extend to the life of this system.

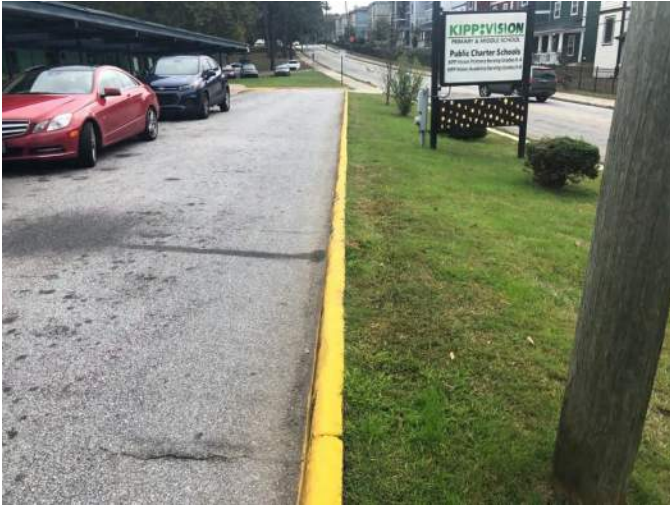
System: G2010 - Roadways

Location: Site
Distress: Beyond Expected Life
Category: Deferred Maintenance
Priority: 3 - Necessary (Years 2-5)
Correction: Renew System
Qty: 97,494.00
Unit of Measure: S.F.
Estimate: \$254,167.00
Assessor Name: Hayden Collins
Date Created: 02/22/2020

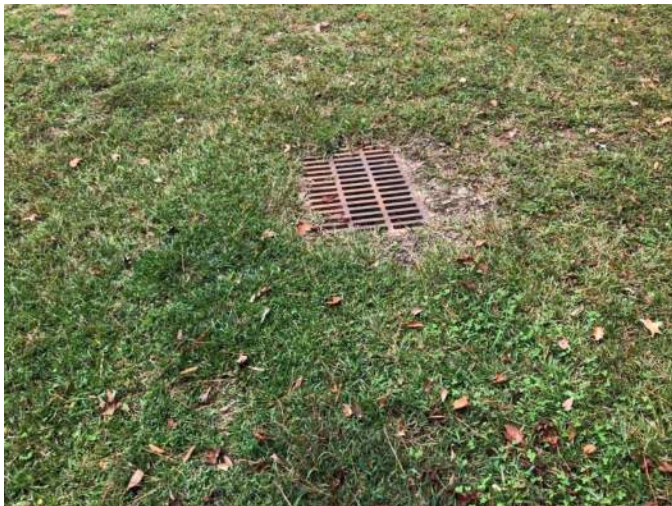
System: G3030 - Storm Sewer

Location: Site
Distress: Beyond Expected Life
Category: Deferred Maintenance
Priority: 3 - Necessary (Years 2-5)
Correction: Renew System
Qty: 97,494.00
Unit of Measure: S.F.
Estimate: \$134,054.00
Assessor Name: Hayden Collins
Date Created: 02/22/2020

Notes: The site storm drains that support the water runoff are functional however, have exceeded the expected life cycle.

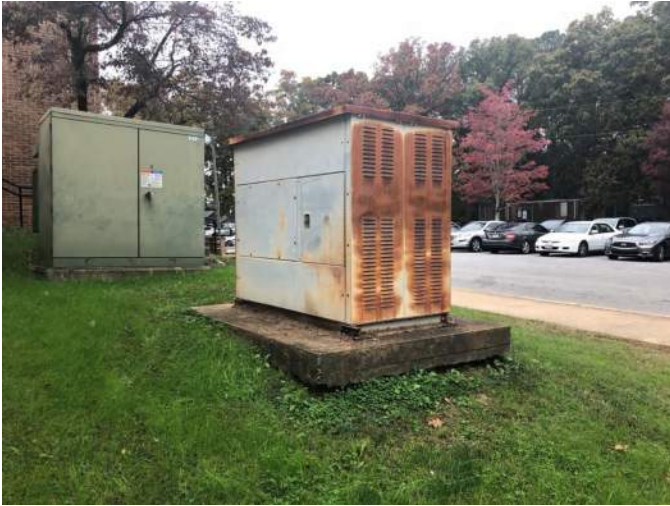
System: G4010 - Electrical Distribution

Location: Site
Distress: Beyond Expected Life
Category: Deferred Maintenance
Priority: 3 - Necessary (Years 2-5)
Correction: Renew System
Qty: 97,494.00
Unit of Measure: S.F.
Estimate: \$273,471.00
Assessor Name: Hayden Collins
Date Created: 02/22/2020

Notes: The site electrical services and distribution system consist of pole mounted transformers connecting the facility to the power net. This system has expired and will require upgrades.
