Atlanta Public Schools/ Mays Cluster

West Manor Elementary School

School Assessment Report

November 10, 2020

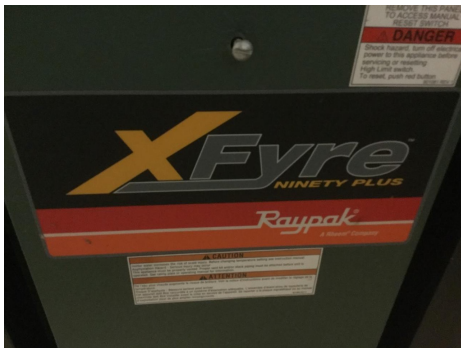
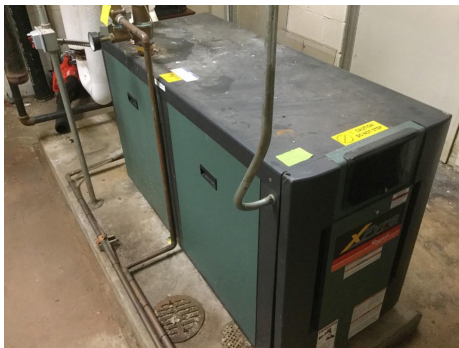
System: D3020 - Heat Generating Systems

Note: Heating generation system is located in 1956 Bldg 2010 but serves 1993 Bldg 2020 as well.

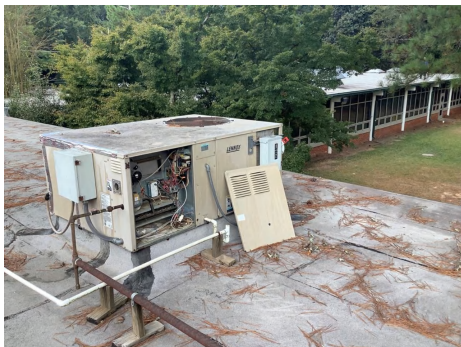
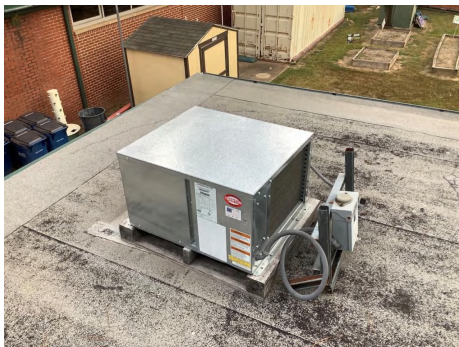
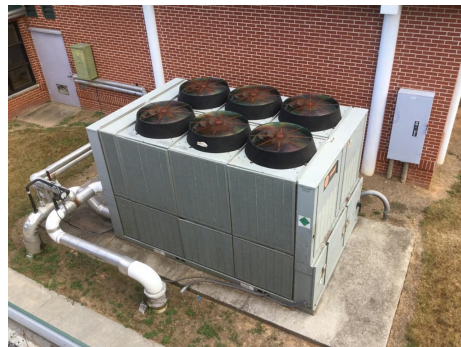
System: D3030 - Cooling Generating Systems

Note: Cooling generation system is located in/outside 1956 Bldg 2010 but serves 1993 Bldg 2020 as well.

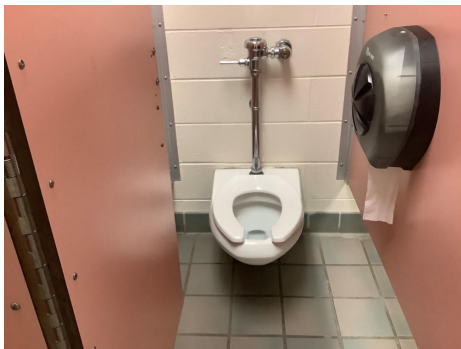
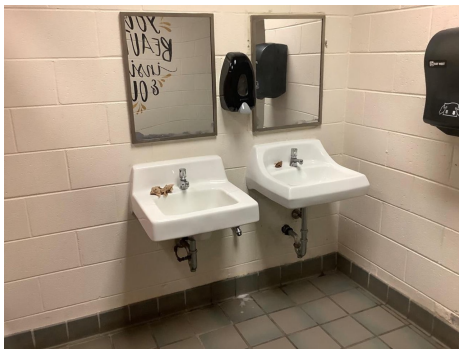
System: D2010 - Plumbing Fixtures

Notes: Plumbing fixtures are beyond their expected service life and should be replaced and upgraded for ADA compliance.

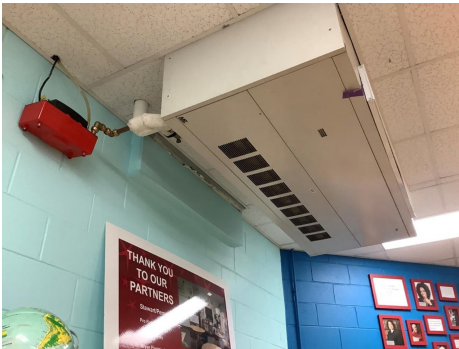
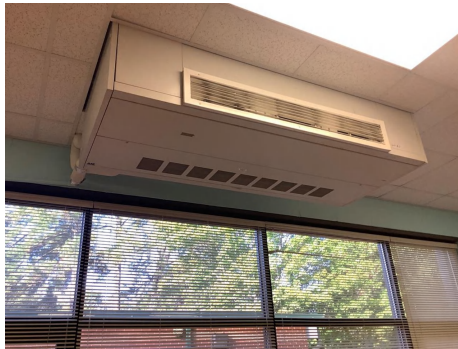
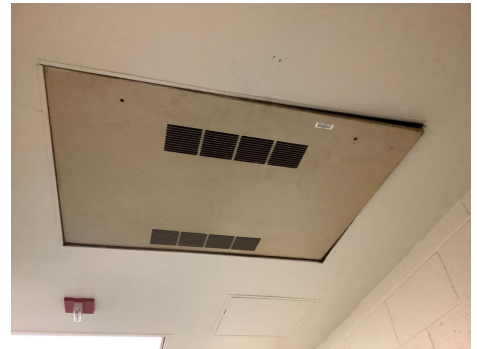
System: D3040 - Distribution Systems

Notes: The exhaust and ventilation systems, energy monitoring and controls as well as the building automation systems are original. Several issues have surfaced over recent years and isolated upgrades have taken place to support the systems. This deficiency provides a budgetary consideration for a universal upgrade.

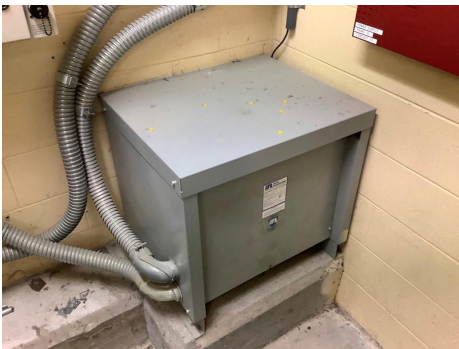
System: D5010 - Electrical Service/Distribution

Note: Main Power located in 1956 Bldg 2010

Notes: Main Power located in 1956 Bldg 2010. Most of the Electrical service and distribution system appears to be from the original construction. The system is showing signs of age and environmental damage and should be scheduled for replacement and upgrade.

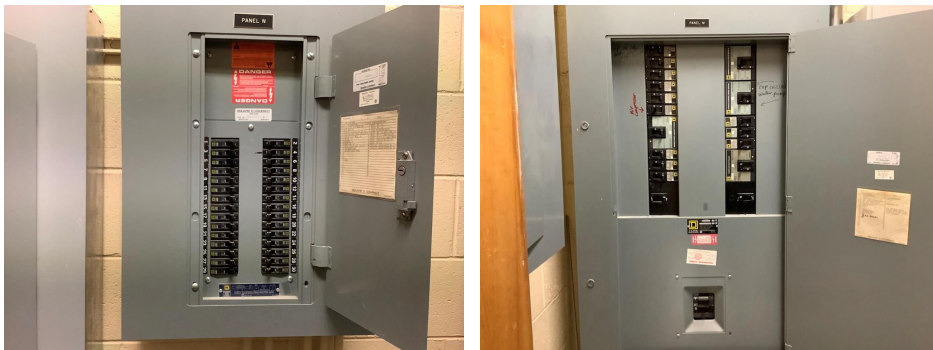
System: D5020 - Branch Wiring

Notes: Most of the branch wiring system appears to be from the original construction. The system is showing signs of age and and should be scheduled for replacement and upgrade.

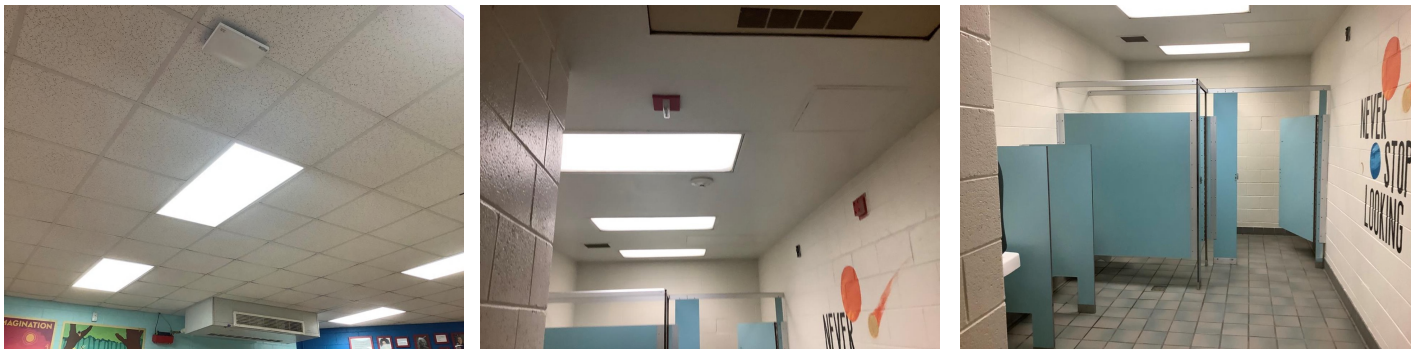
System: D5020 - Lighting

Notes: Most of the lighting system appears to be from the original construction. The system is showing signs of age and environmental damage and should be scheduled for replacement and upgrade.

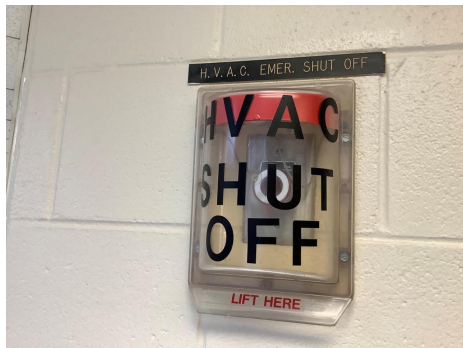
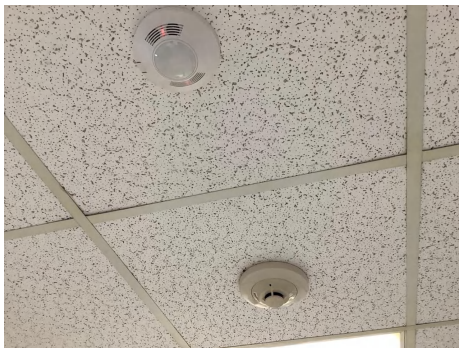
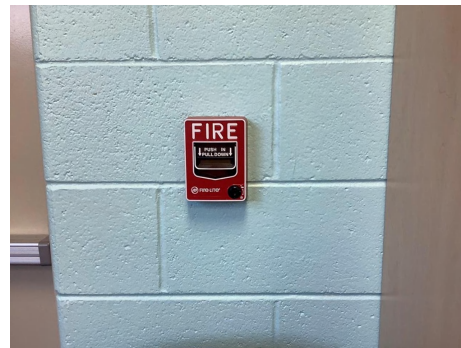
System: D5030910 - Fire Alarm Systems

Notes: This facility is protected by a central fire alarm system. The point addressable fire alarm control panel was Manufactured by Honeywell. The devices that serve this system include manual pull stations, audible/visible devices, and smoke detectors. Although the main board was upgraded the components and systems are beyond the expected life for this application. The system is recommended for upgrade.
