Atlanta Public Schools/Relocation Sites

# White Elementary School

## School Assessment Report

November 10, 2020

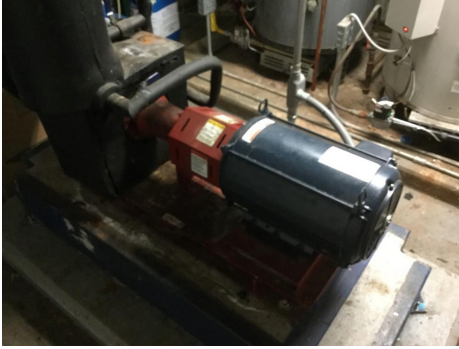
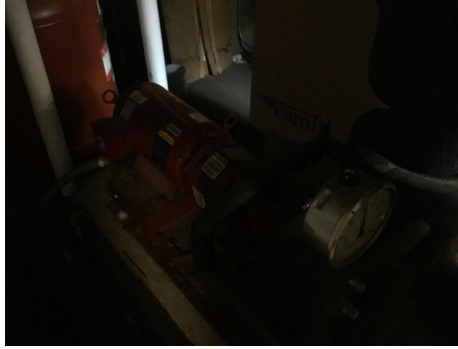
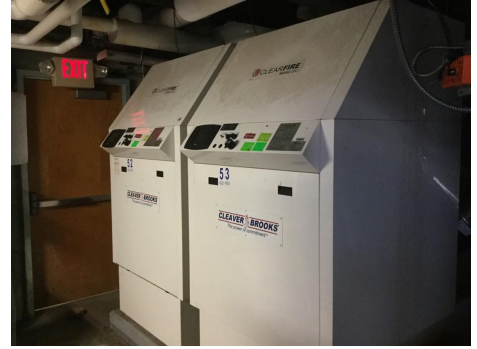
### System: D3020 - Heat Generating Systems

**Note:** Heating Hot Water Boilers located in mechanical room in Bldg 2010 serve Bldg 2010 as well as Bldg 2011.

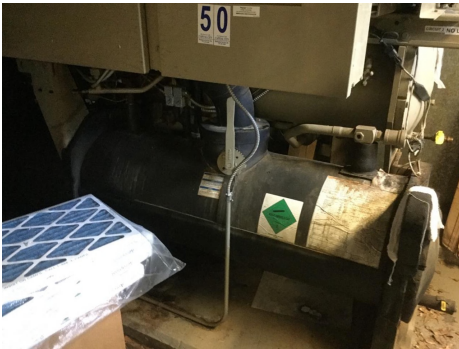
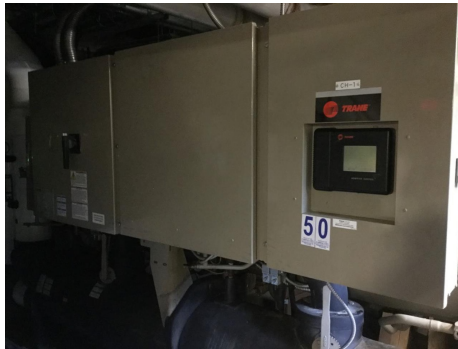
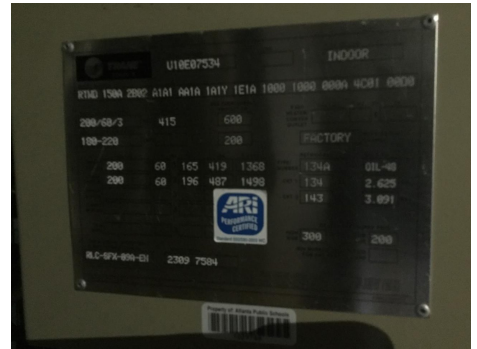
### System: D3030 - Cooling Generating Systems

**Note:** Water-cooled chiller and associated pumps located in mechanical room in Bldg 2010 serve Bldg 2010 as well as Bldg 2011.

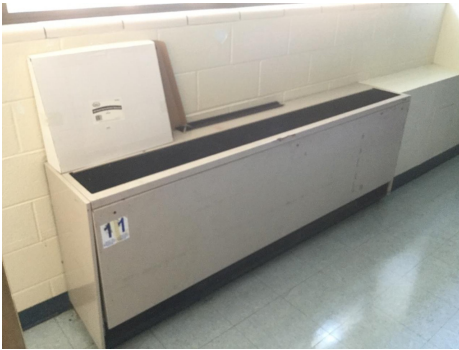
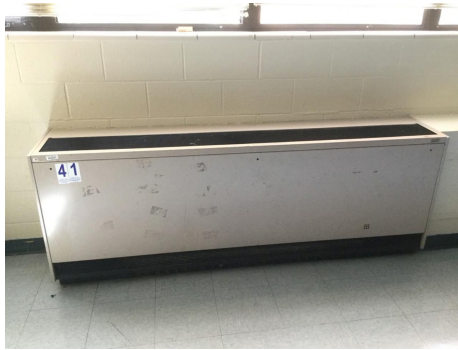
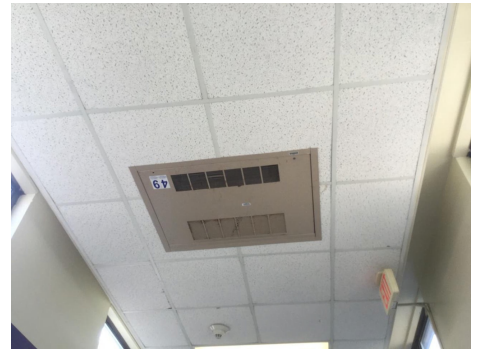
### System: D3040 - Distribution Systems

**Notes:** Most of the exhaust fans are out of service or not functioning as designed. Fan Coil units are no longer functioning and several sections of ducting have been out of service and will require either cleaning or replacement. Considering the current status of the school this deficiency provides a budgetary consideration for a general distribution system renewal prior to the school reopening.

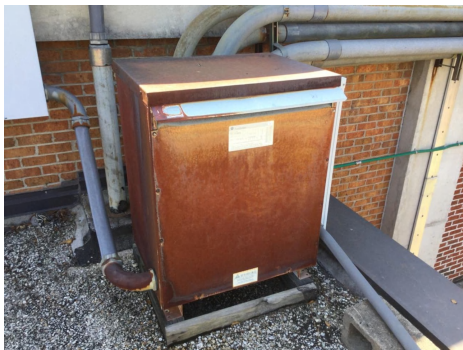
**System:** D5010 - Electrical Service/Distribution

**Note:** Transformers are located in the main mechanical room and on the roof. Due to existing power issues photos are limited.

**Notes:** The electrical services and distribution systems consist of a service disconnect, primary main, breaker system, switch box and conduit and wiring to equipment, interior and exterior lights. This system is a mix of the old and new. Some of the system was recently upgraded, however a majority of the system is original from original construction. Upgrades are recommended. This deficiency provides a budgetary consideration for repairs and modifications that should take place in conjunction with other recommended renovations.

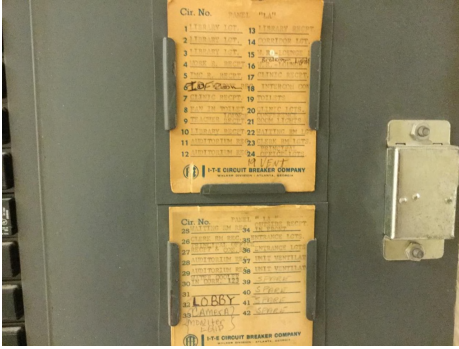
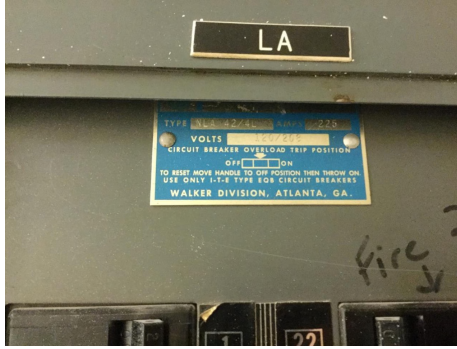
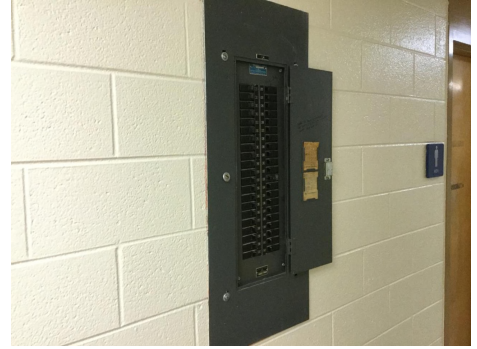
### System: D5020 - Branch Wiring

**Notes:** Most of the lighting and branch wiring system appears to be from the original construction. The system is showing signs of age and environmental damage and should be scheduled for replacement and upgrade in conjunction with other recommended renovations.

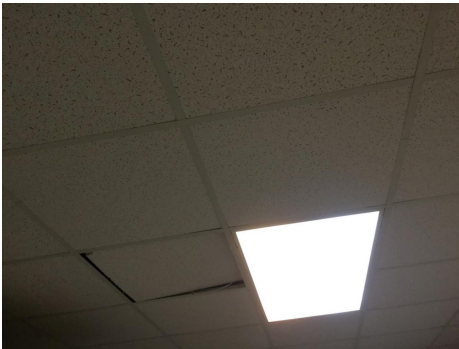
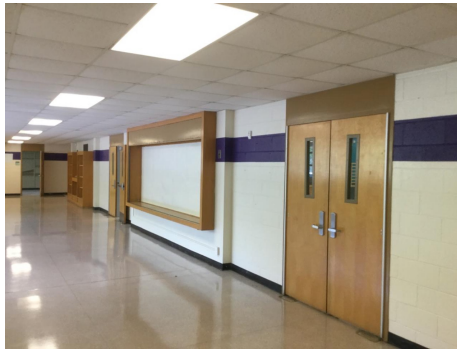
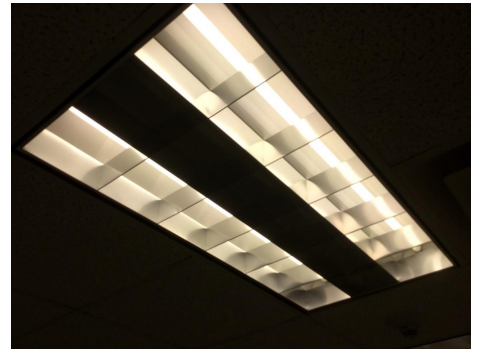
### System: D5020 - Lighting

**Note:** New lighting fixtures have been installed in the classrooms as well as the Administration area, Cafeteria, and Auditorium in 2010. These fixtures do not alone make up 70% of the Lighting and Branch Wiring system so the latest installed date was left at 1998.

**Notes:** New lighting fixtures have been installed in the classrooms as well as the Administration area, Cafeteria, and Auditorium in 2010. However, most of the remaining lighting system appears to be from the original construction. The system is showing signs of age and environmental damage and should be scheduled for replacement and upgrade in conjunction with other recommended renovations.

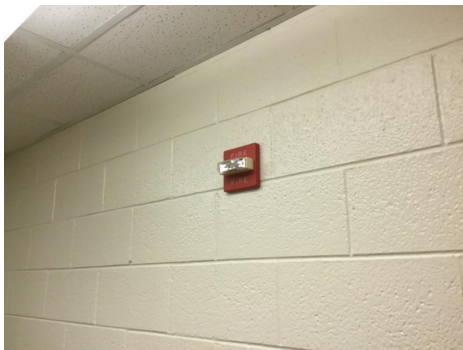
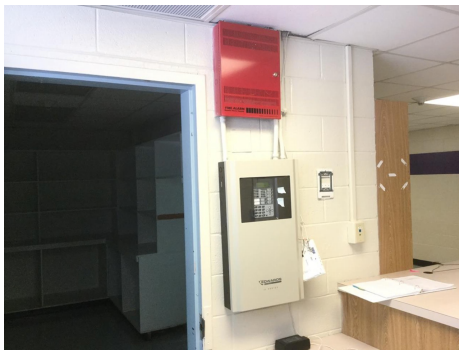
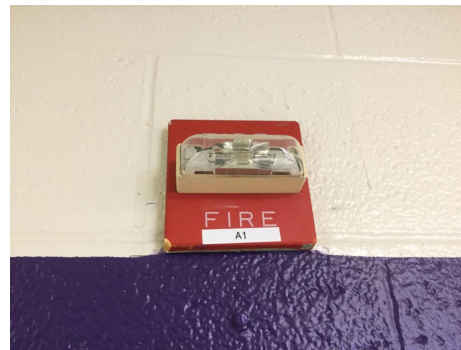
### System: D5030910 - Fire Alarm Systems

**Notes:** The Edwards fire alarm system appears to be from the 1998 installation. There are components such as push stations, lights and alarm bells installed to support the fire life safety for this building. This system is no longer supported and is nearing the end of its expected life and upgrades are warranted. This deficiency provides a budgetary consideration for universal upgrades to the fire alarm system.

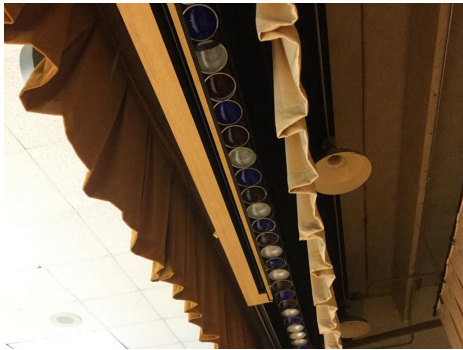
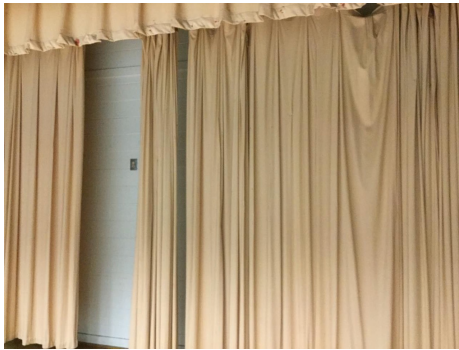
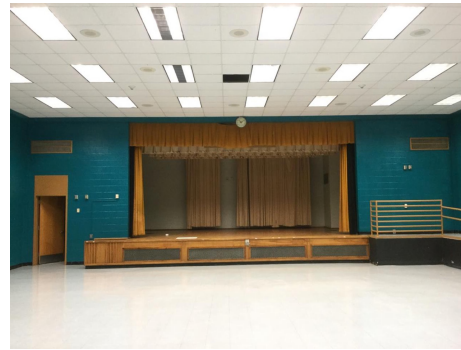
### System: E1020 - Institutional Equipment

**Note:** This school is abandoned in place. The normal library equipment, theater and stage equipment, instrumental equipment, audio-visual equipment has been removed.

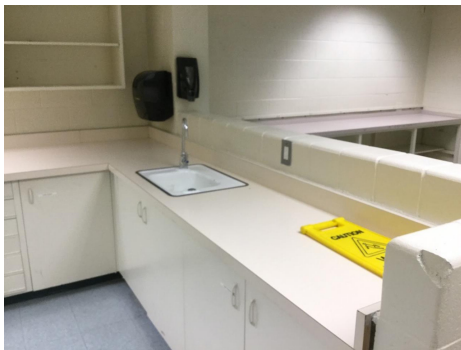
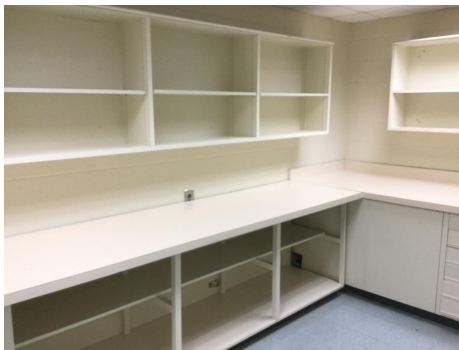
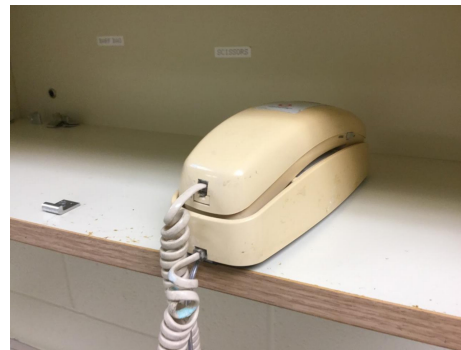
**System:** E1090 - Other Equipment

**Note:** This school is abandoned in place. The normal food service equipment, athletic, recreational, and therapeutic equipment (Nurses Office) has been removed.

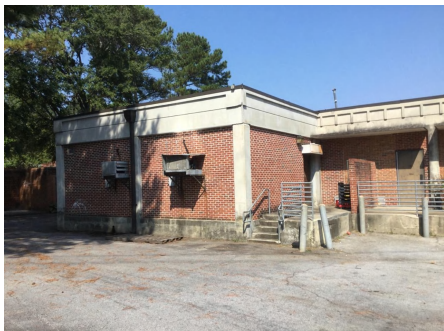
1). Southern Exterior Elevation - Dec 15, 2019

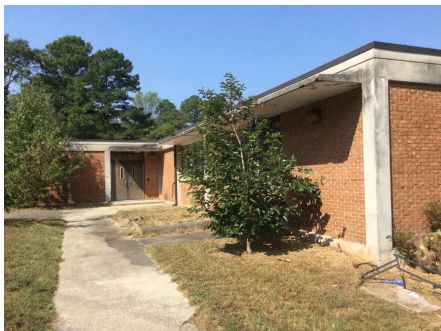
2). Western Exterior Elevation - Dec 15, 2019

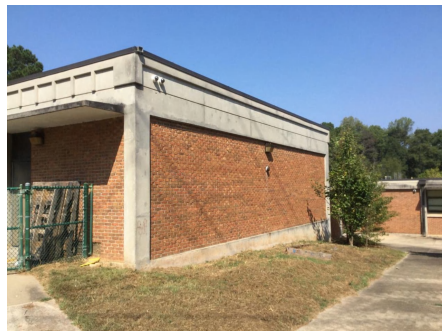
3). Eastern Exterior Elevation - Dec 15, 2019

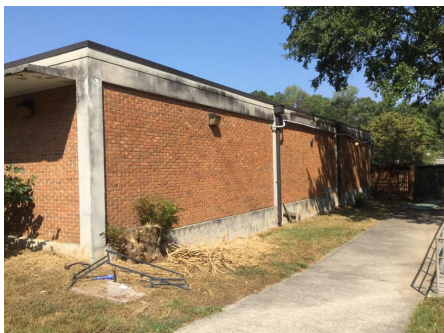
4). Northern Exterior Elevation - Dec 15, 2019

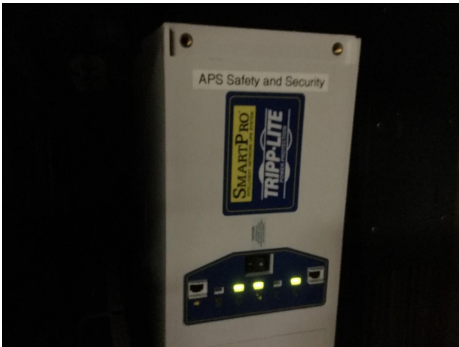
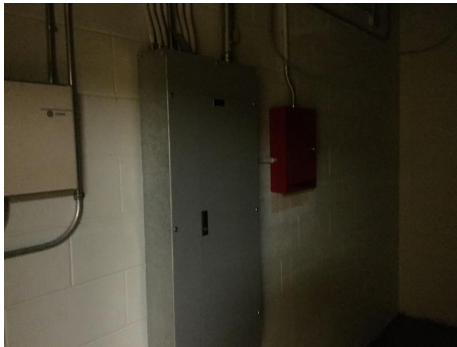
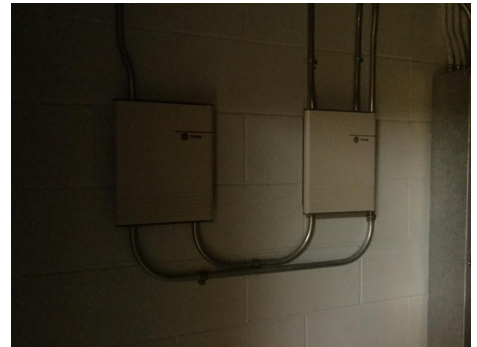
**System:** D3060 - Controls & Instrumentation

**Note:** Building is controlled by BLDG 2010.

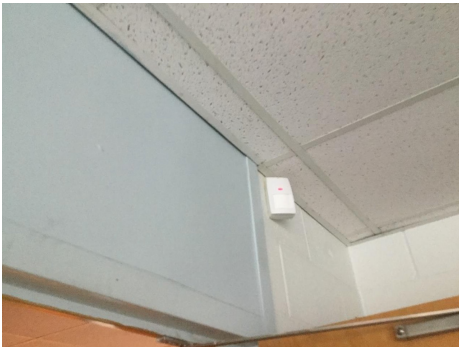
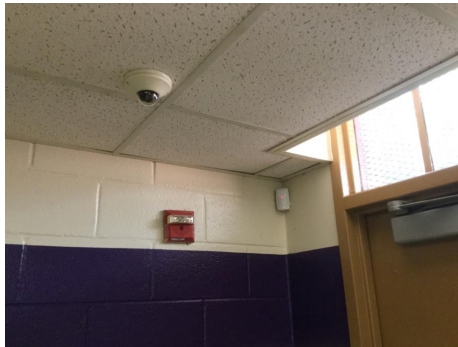
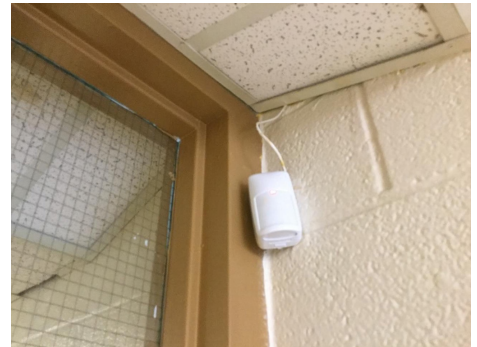
**System:** D5030810 - Security & Detection Systems

**Note:** Security System is provided by BLDG 2010.

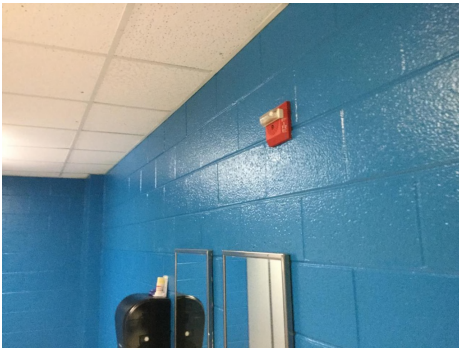
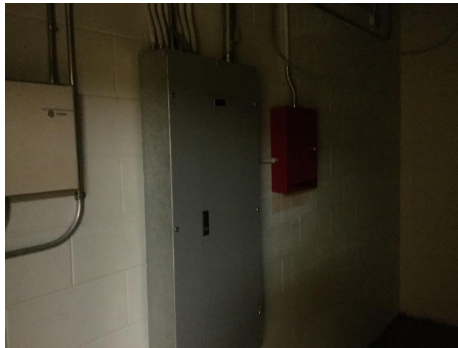
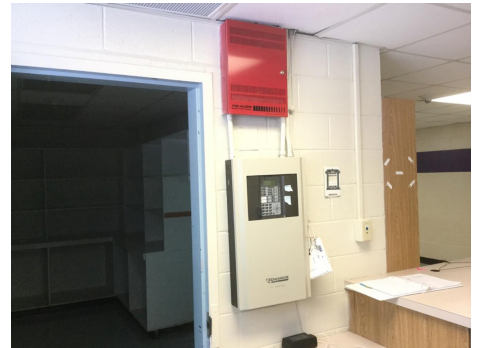
**System:** D5030910 - Fire Alarm Systems

**Note:** Fire Alarms service is provided by BLDG 2010.

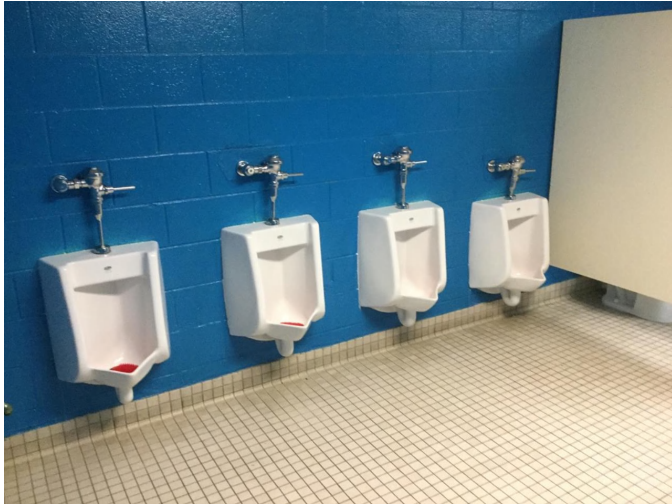
**Location:** Restrooms  
**Distress:** Beyond Expected Life  
**Category:** ADA Compliance  
**Priority:** 1 - Critical Immediate Need  
**Correction:** Renew System  
**Qty:** 23,308.00  
**Unit of Measure:** S.F.  
**Estimate:** \$163,319.00  
**Assessor Name:** Jejuan Hall  
**Date Created:** 09/30/2019

Plumbing fixtures are beyond their expected service life and should be replaced and upgraded for ADA compliance. This deficiency provides a budgetary consideration for repairs and modifications that should take place in conjunction with other recommended renovations.

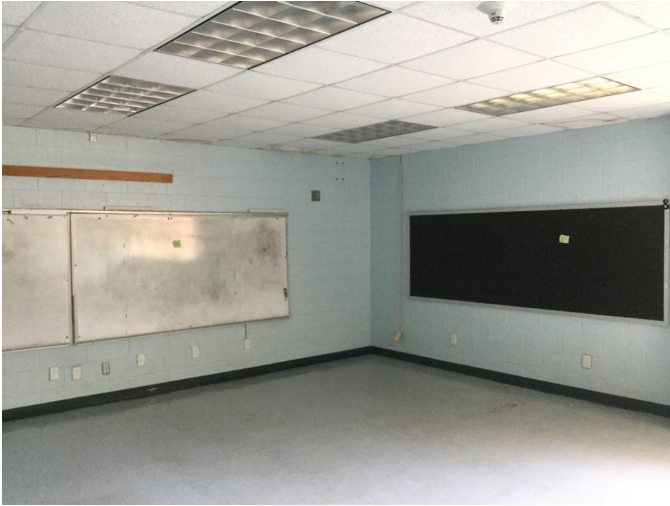
**Location:** Throughout building  
**Distress:** Beyond Expected Life  
**Category:** Deferred Maintenance  
**Priority:** 3 - Necessary (Years 2-5)  
**Correction:** Renew System  
**Qty:** 23,308.00  
**Unit of Measure:** S.F.  
**Estimate:** \$230,749.00  
**Assessor Name:** Homero Guerrero  
**Date Created:** 09/30/2019

The acoustical ceiling tile finish is beyond its expected service life and is recommended for replacement in conjunction with other recommended renovations.

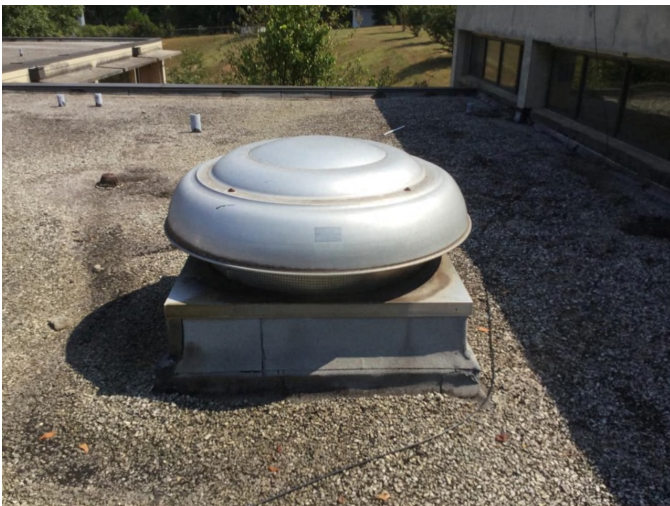
**Location:** Throughout building  
**Distress:** Beyond Expected Life  
**Category:** Deferred Maintenance  
**Priority:** 3 - Necessary (Years 2-5)  
**Correction:** Renew System  
**Qty:** 23,308.00  
**Unit of Measure:** S.F.  
**Estimate:** \$829,415.00  
**Assessor Name:** Homero Guerrero  
**Date Created:** 09/30/2019

Most of the exhaust fans are out of service or not functioning as designed. Fan Coil units are no longer functioning and several sections of ducting have been out of service and will require either cleaning or replacement. Considering the current status of the school this deficiency provides a budgetary consideration for a general distribution system renewal prior to the school reopening.

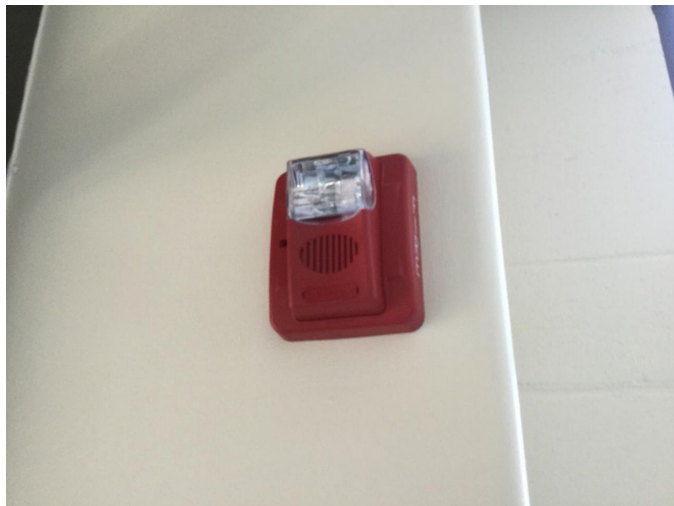
#### System: D5030910 - Fire Alarm Systems

**Location:** Throughout building  
**Distress:** Beyond Expected Life  
**Category:** Deferred Maintenance  
**Priority:** 1 - Critical Immediate Need  
**Correction:** Renew System  
**Qty:** 8,308.00  
**Unit of Measure:** S.F.  
**Estimate:** \$25,040.00  
**Assessor Name:** Homero Guerrero  
**Date Created:** 12/15/2019

The Edwards fire alarm system located in the main building appears to be from the 1998 installation. There are components such as push stations, lights and alarm bells installed to support the fire life safety for this building. This system is no longer supported and is nearing the end of its expected life and upgrades are warranted. This deficiency provides a budgetary consideration for universal upgrades to the fire alarm system.

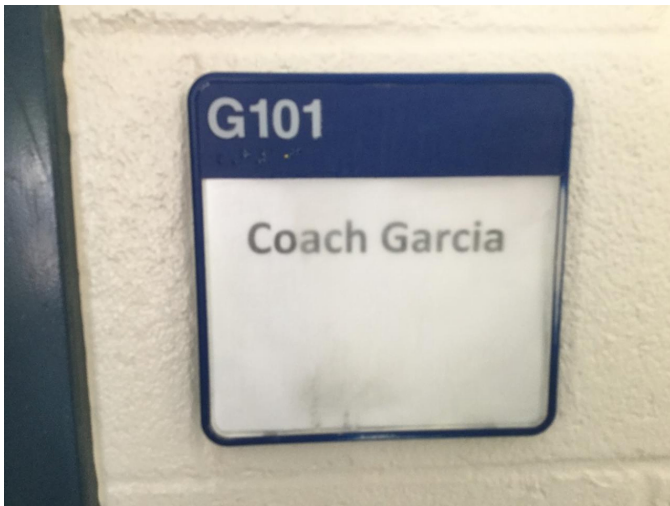
**System: C1030 - Fittings**

**Location:** Throughout building  
**Distress:** Beyond Expected Life  
**Category:** ADA Compliance  
**Priority:** 3 - Necessary (Years 2-5)  
**Correction:** Renew System  
**Qty:** 8,308.00  
**Unit of Measure:** S.F.  
**Estimate:** \$27,234.00  
**Assessor Name:** Jejuan Hall  
**Date Created:** 09/30/2019

Fittings, such as toilet partitions, lockers, signage and railing, are beyond their expected service life, outdated and missing in areas, and should be replaced and upgraded for compliance with ADA standards.

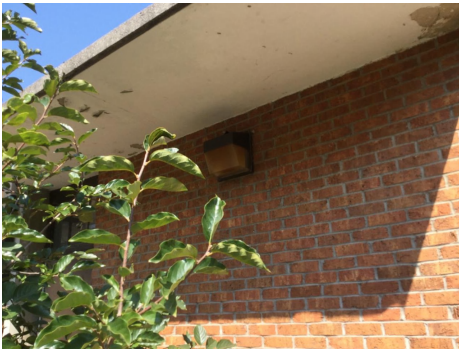
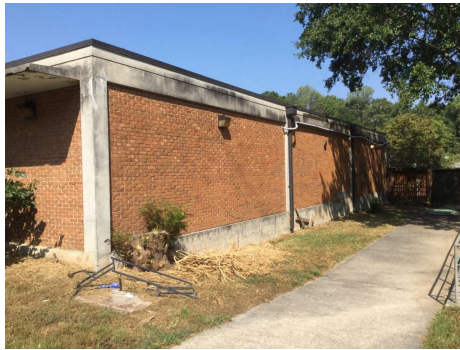
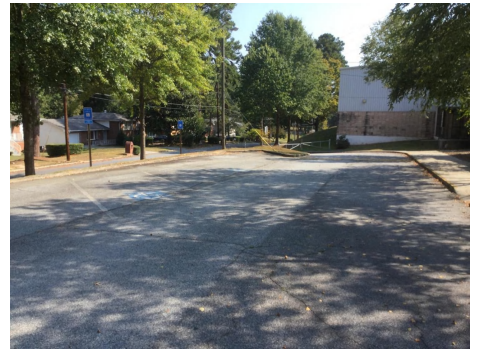
**System:** G4020 - Site Lighting

**Note:**
