# School Assessment Report

School: Stanton, D. H. Elementary School

Report: Nov 17, 2015

### School Name: Stanton, D. H. Elementary School

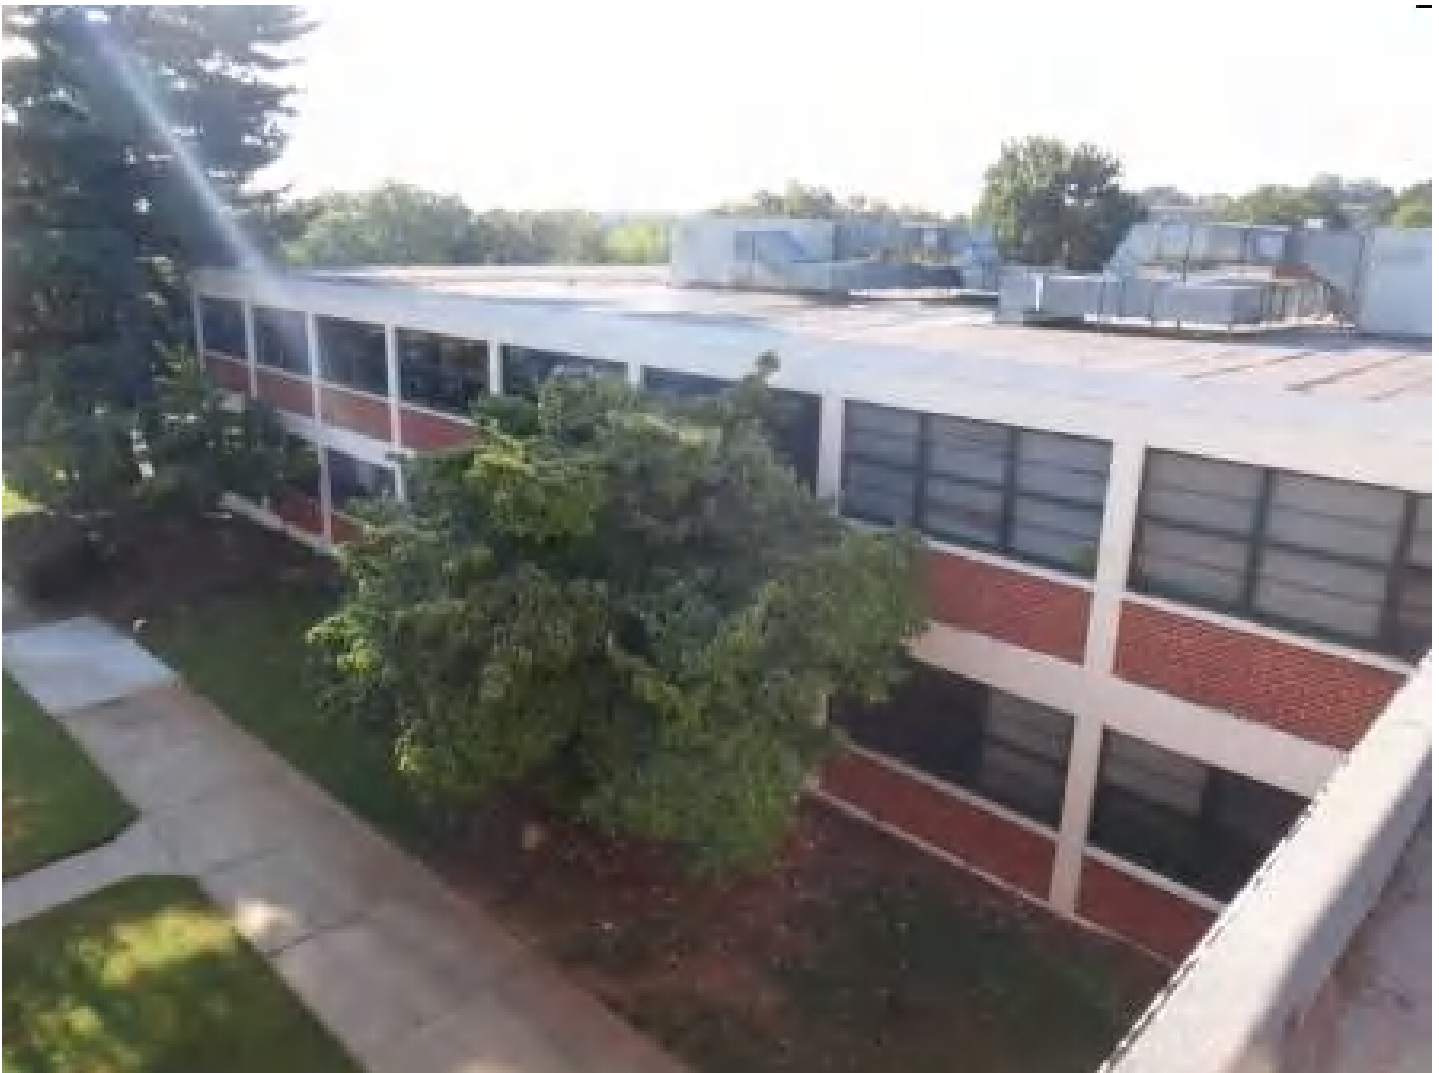
Year Built:	1958
Gross Area (SF):	75,646
Replacement Value:	\$14,619,939
Repair Cost:	\$3,381,534
Total FCI:	23.13%
Total RSLI:	32%

A portion of the superstructure is steel frame with load bearing CMU. Another portion is concrete framed. Floor construction is slab on-grade. Roof construction is both steel and concrete pan joist with lightweight concrete fill. The exterior enclosure is comprised of walls with brick veneer over CMU and pre-cast panels over CMU. Exterior windows are aluminum frame with fixed and operable panes. Exterior doors are both aluminum framed with glazing and hollow metal. Roofing is comprised of low sloped structure with built-up roof coverings. The roof is in poor condition with reported leaks.

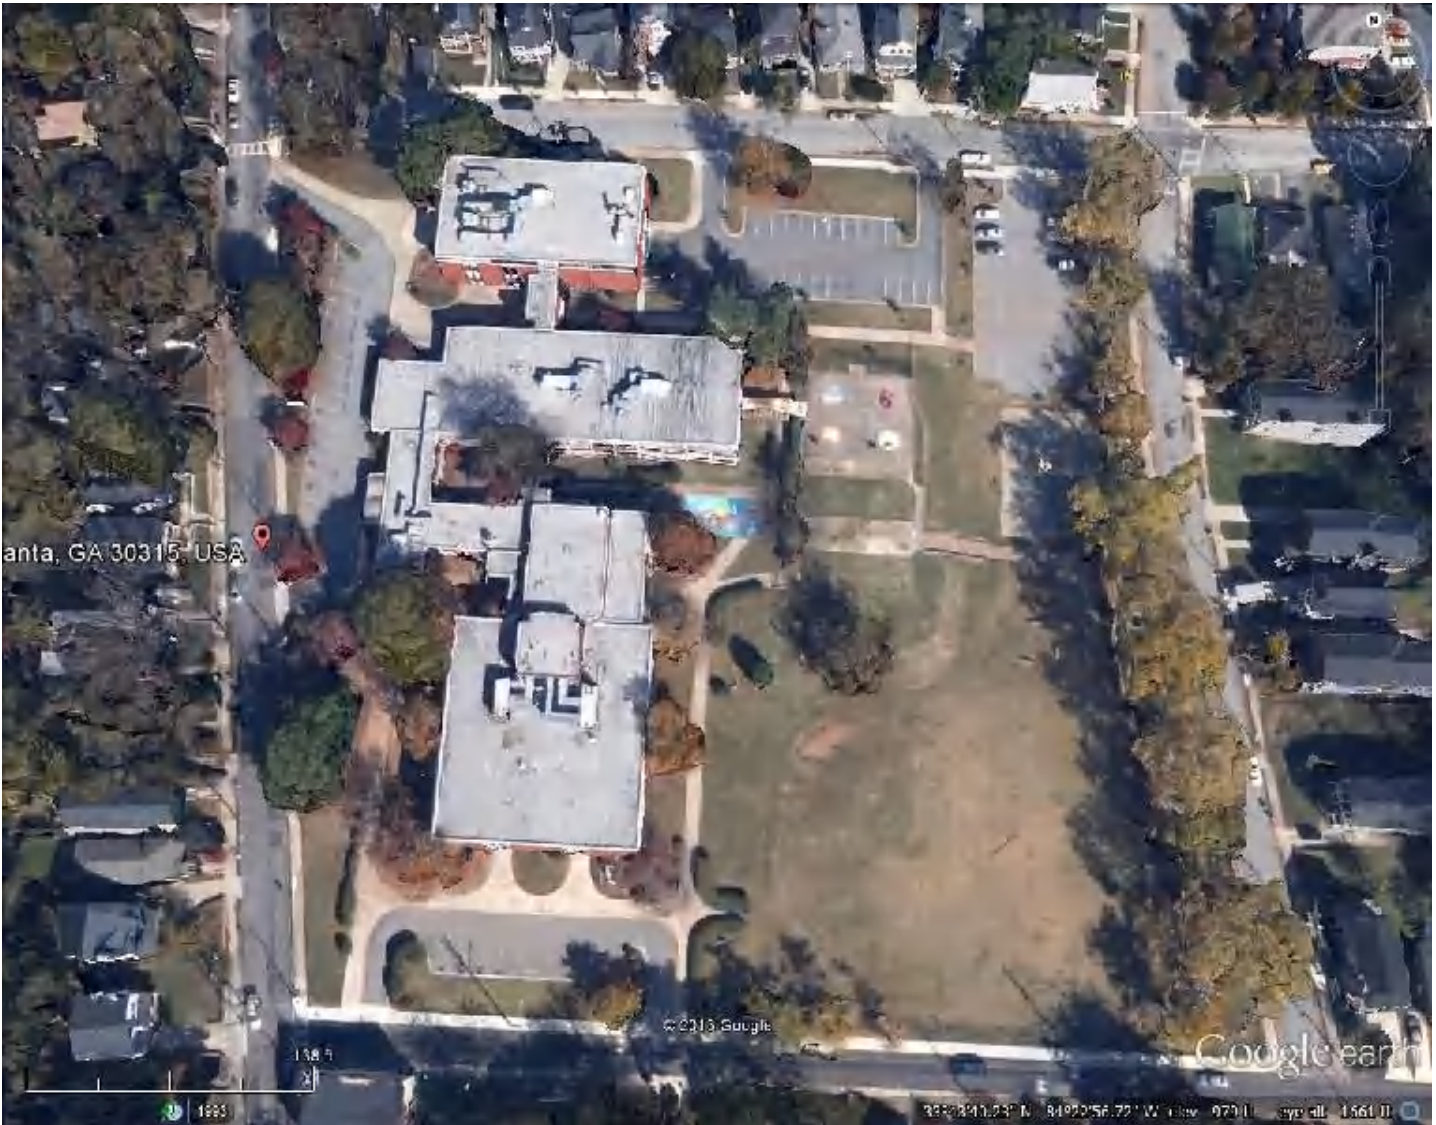
Site Summary

Site Acreage		Condition Budget:	\$607,582
Replacement Value:	\$2,126,732	Total FCI:	28.57%
		Total RSLI:	18%
		Condition Score:	76.18
