School Assessment Report

School: Slater Elementary School

Report: Nov 17, 2015 Condition Assessment: Suitability Assessment:

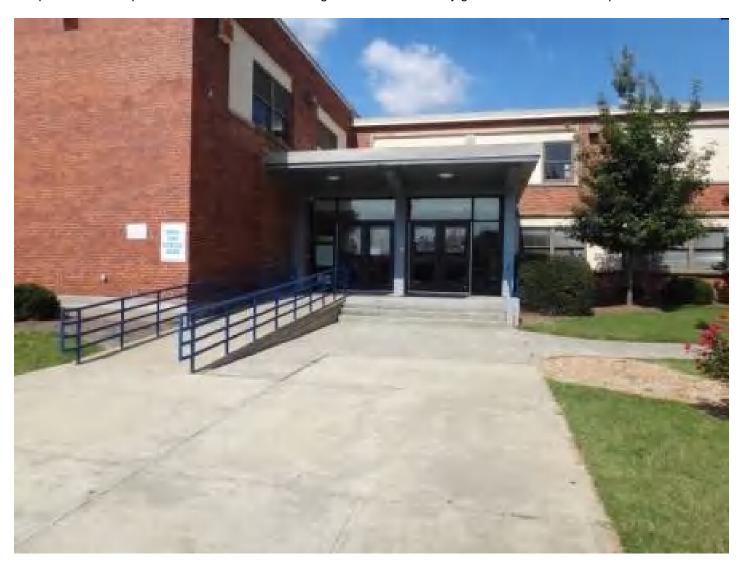
The superstructure is concrete frame. Floor construction is slab on-grade. Roof construction is concrete pan joists with lightweight concrete fill. The exterior enclosure is comprised of walls with brick veneer over CMU. Exterior windows are aluminum frame with fixed and operable panes. Exterior doors are hollow metal steel mostly with glazing. Roofing is comprised of low slope with modified bitumen coverings. The roof is in mostly good condition with no reported leaks.

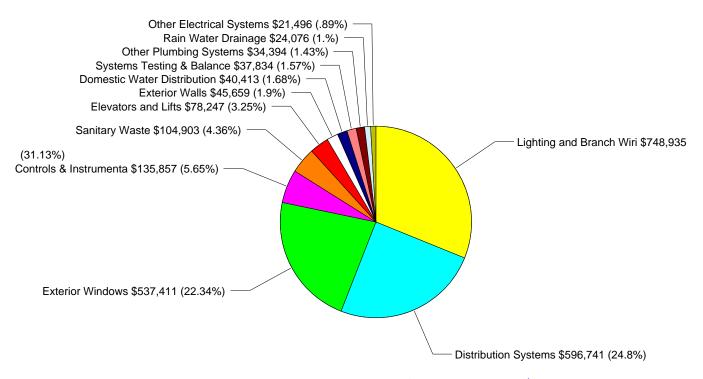
Current deficiencies included systems or components that have reached or exceeded their intrinsic useful life or components of the systems that are in need of repair. Systems that have reached the end their intrinsic useful life are identified as current deficiencies and assigned the distress 'Beyond Expected Life'. The following chart includes all current condition deficiencies associated with this facility.

1952_1953_1970 Bldg 2010_2011_2012 Condition Budget: \$2,405,966

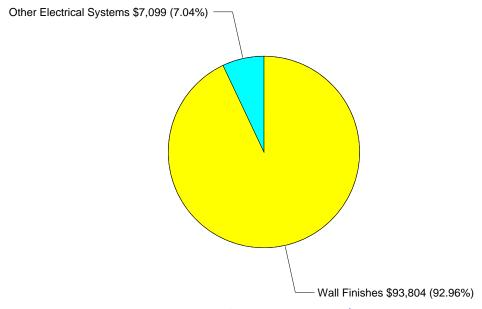
Current deficiencies included systems or components that have reached or exceeded their intrinsic useful life or components of the systems that are in need of repair. Systems that have reached the end their intrinsic useful life are identified as current deficiencies and assigned the distress 'Beyond Expected Life'. The following chart includes all current condition deficiencies associated with this facility.

2002 Bldg 2014 Condition Budget: \$100,903

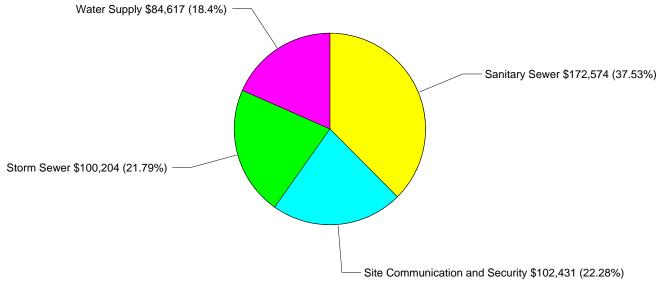
Site Condition Budget: \$459,827

Site Condition Deficiencies
