Atlanta Public Schools/Relocation Sites

Coan Middle School

School Assessment Report

November 10, 2020

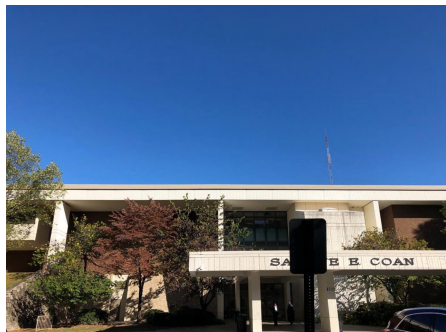
1). South elevation - Dec 17, 2019

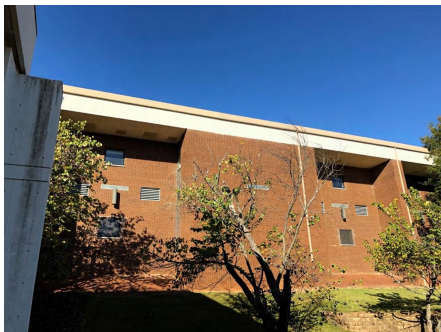
2). East Elevation - Dec 17, 2019

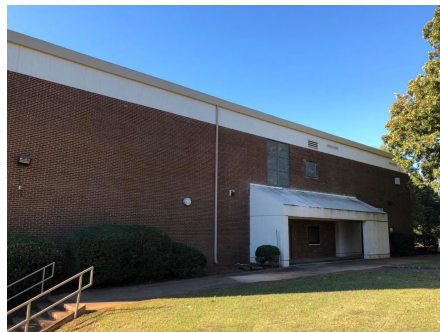
3). North elevation - Dec 17, 2019

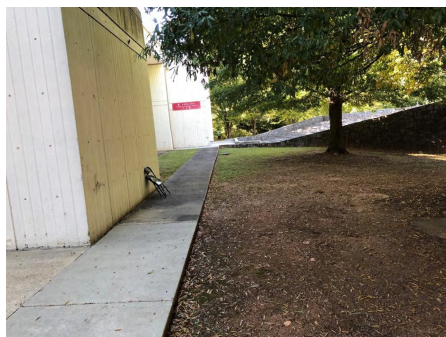
4). West Elevation - Dec 17, 2019
