Atlanta Public Schools/ Jackson Cluster

Crim HS -Phoenix Academy

School Assessment Report

November 10, 2020

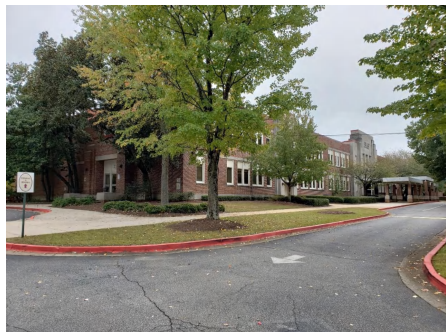
1). West Elevation - Nov 23, 2019

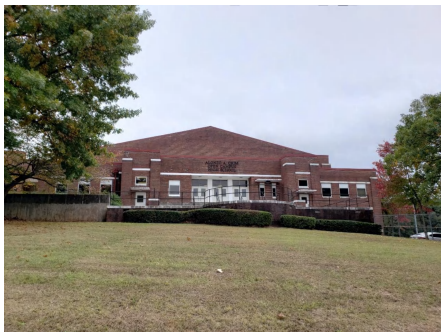
2). West Elevation - Nov 23, 2019

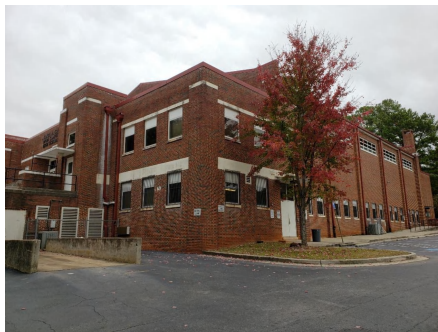
3). South Elevation - Nov 23, 2019

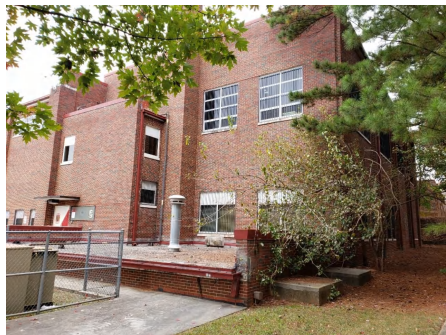
4). East Elevation - Nov 23, 2019

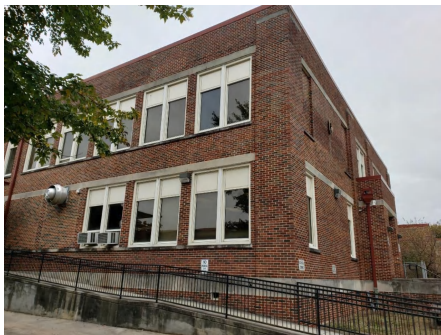
5). East Elevation - Nov 23, 2019

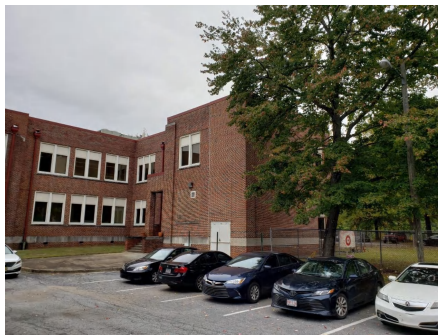
6). Northeast Elevation - Nov 23, 2019

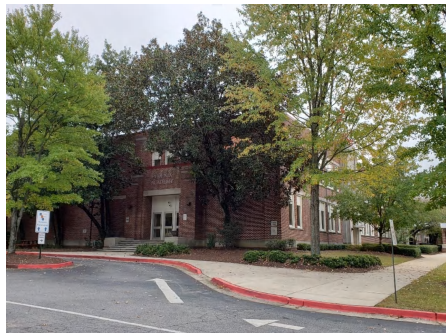
7). Northwest Elevation - Nov 23, 2019

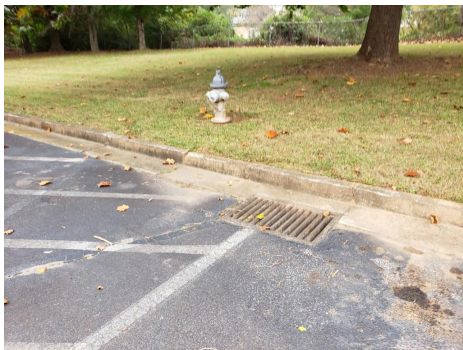
System: G3010 - Water Supply

Notes: The water supply system is original and beyond its service life and should be scheduled for replacement and upgrade.
