Atlanta Public Schools/ N. Atlanta Cluster

Smith, Sara Primary

School Assessment Report

November 10, 2020

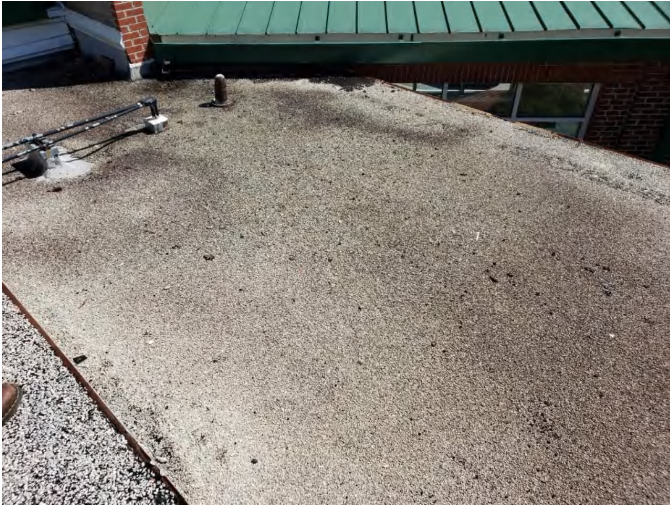
System: B3010105 - Built-Up

Location: Roof
Distress: Beyond Expected Life
Category: Deferred Maintenance
Priority: 3 - Necessary (Years 2-5)
Correction: Renew System
Qty: 32,456.00
Unit of Measure: S.F.
Estimate: \$364,335.00
Assessor Name: Homero Guerrero
Date Created: 01/27/2020

Notes: The roofing system is not expected to outlast the purview of this analysis. Future budgetary consideration should include provision for the renewal of the clay tile roofing system.

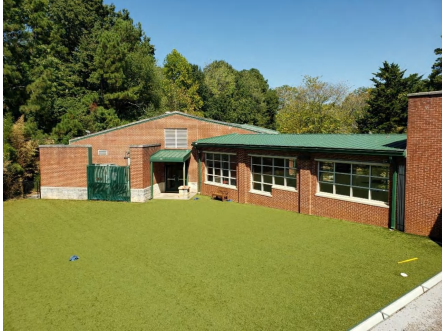
1). West Elevation, North Wing - Nov 18, 2019

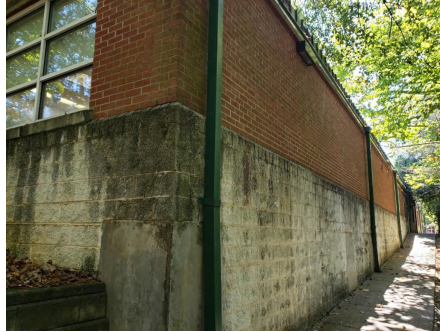
2). Northwest Elevation, North Wing - Nov 18, 2019

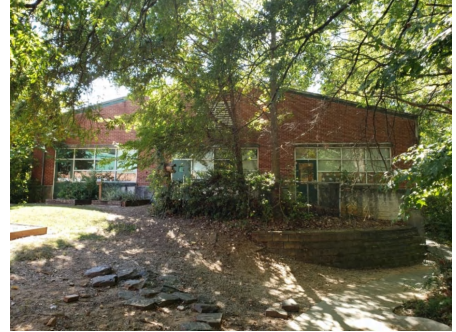
3). Northeast Elevation, North Wing - Nov 18, 2019

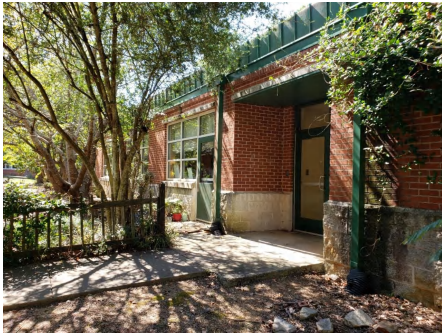
4). Southeast Elevation, North Wing - Nov 18, 2019

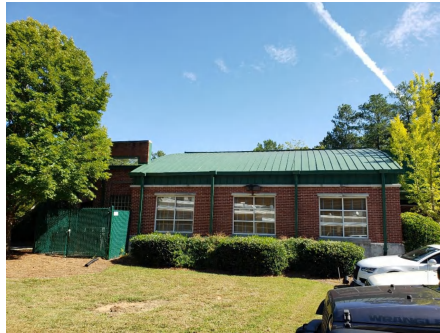
5). Southwest Elevation, South Wing - Nov 18, 2019

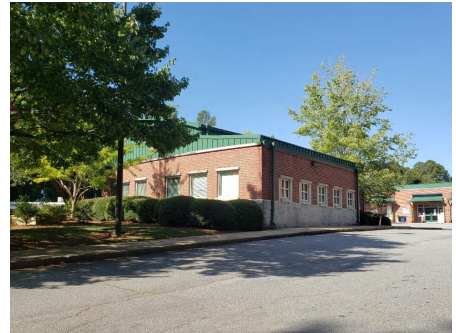
6). Southeast Elevation, South Wing - Nov 18, 2019

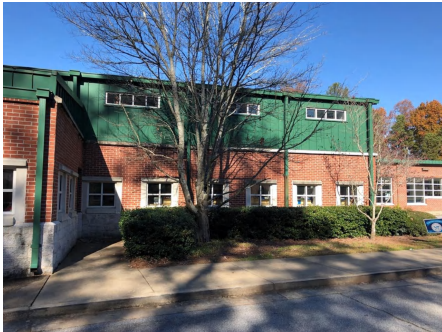
7). Northeast Elevation, South Wing - Nov 23, 2019

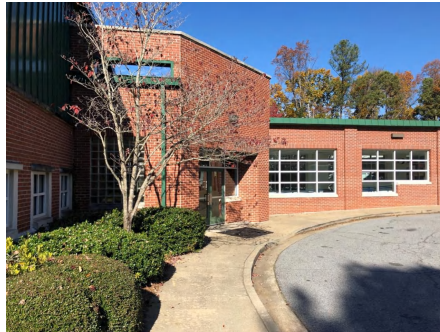
8). Northeast Elevation, South Wing - Nov 23, 2019

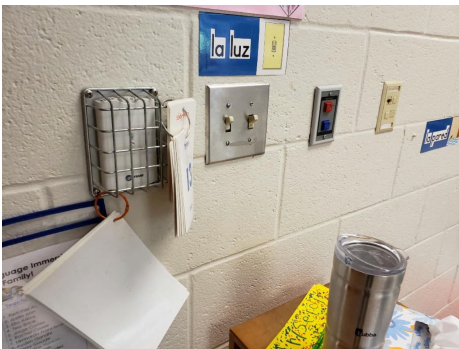
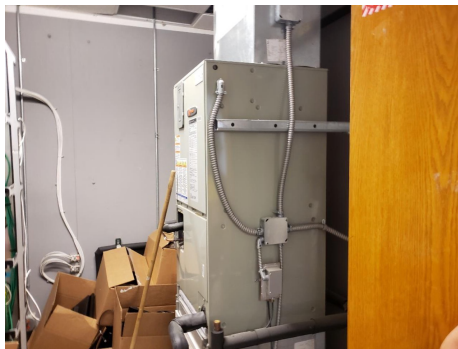
System: D3060 - Controls & Instrumentation

Note: Rooftop units are original to addition (2005). Condensing units on roof were installed in 2010.
