Atlanta Public Schools/Other Facilities

Venetian Hills Elementary School

School Assessment Report

November 10, 2020

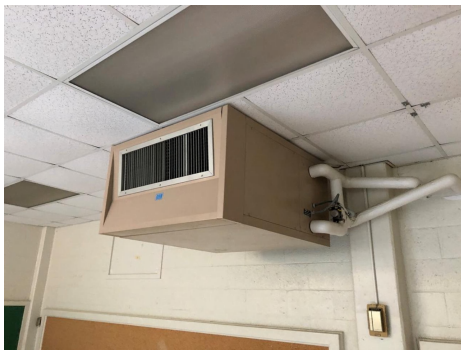
System: D3050 - Terminal & Package Units

Note: New condensing units installed in 2010 for Media Center and Administrative spaces.

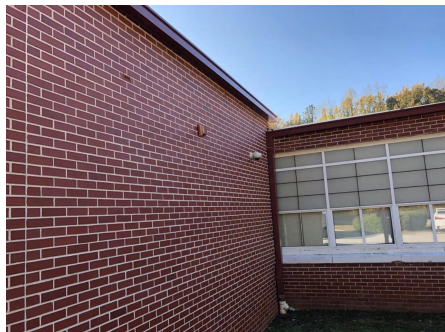
1). West elevation - Feb 10, 2020

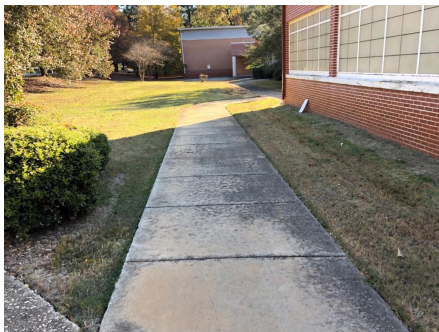
2). North elevation - Feb 10, 2020

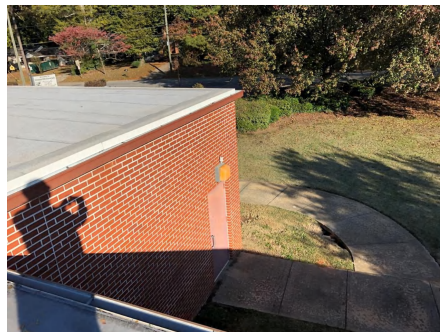
3). East elevation - Feb 10, 2020

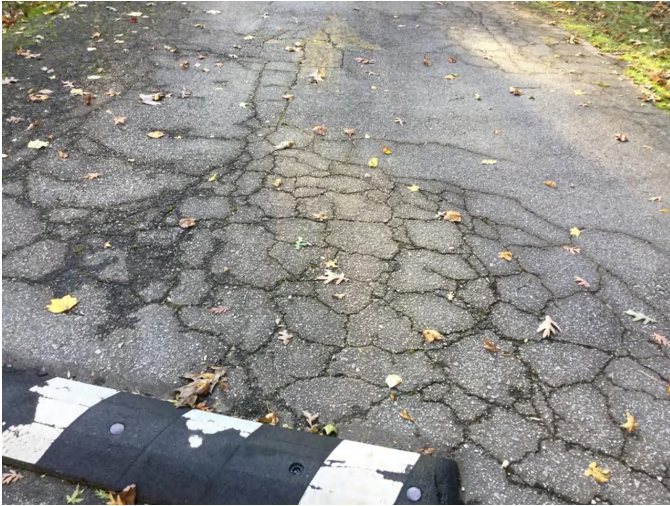
System: G2010 - Roadways

Location: Site
Distress: Beyond Expected Life
Category: Deferred Maintenance
Priority: 3 - Necessary (Years 2-5)
Correction: Renew System
Qty: 60,924.00
Unit of Measure: S.F.
Estimate: \$158,829.00
Assessor Name: Hayden Collins
Date Created: 02/22/2020
